Preliminary Information

PIP5889 Diagnostic Tip: DTC P0299 Set As Current Or In History

Involved Region or Country:	North America
Condition:	DTC P0299 set as current or in history
Cause:	Possible Charge Air Bypass Valve sticking open intermittently.

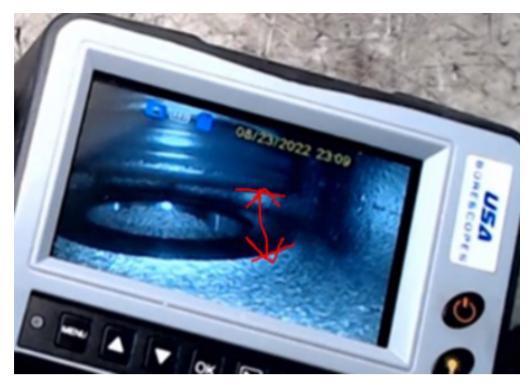
The bore scope picture below is showing the Charge Air Bypass Valve in a stuck open position.

If the Charge Air Bypass Valve is found to be stuck open or is causing an intermittent DTC p0299 replace the Charge Air Bypass Valve using current service parts listed in EPC. Clear any remaining DTC's using GDS and evaluate.

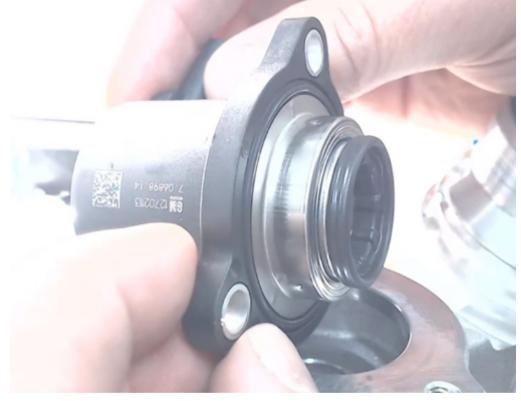
Picture below shows Charge Air Bypass Valve in stuck open position (plunger fully retracted)

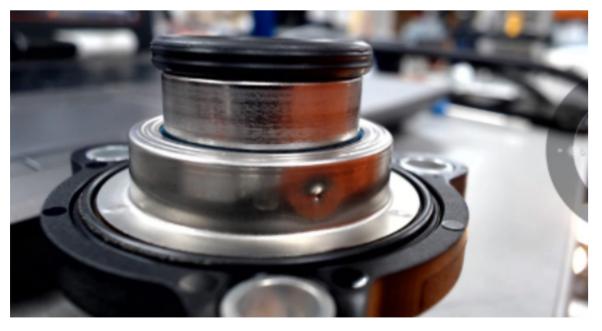
Picture below shows Charge Air Bypass valve fully extended or closed position
