Release Date	12/06/2022	Technical Service Bulletin		
09D8 UPDATE Tire and loading information overlay (NVLW)

This Update has been proactively released to prevent the following condition(s) from occurring in the vehicle:	
Criteria	Technical Background
01, 02 or 03	The tire and loading information on the Safety Certification label is incorrect.

Criteria	Remedy
01, 02 or 03	Apply an overlay, which contains the correct tire and loading information.

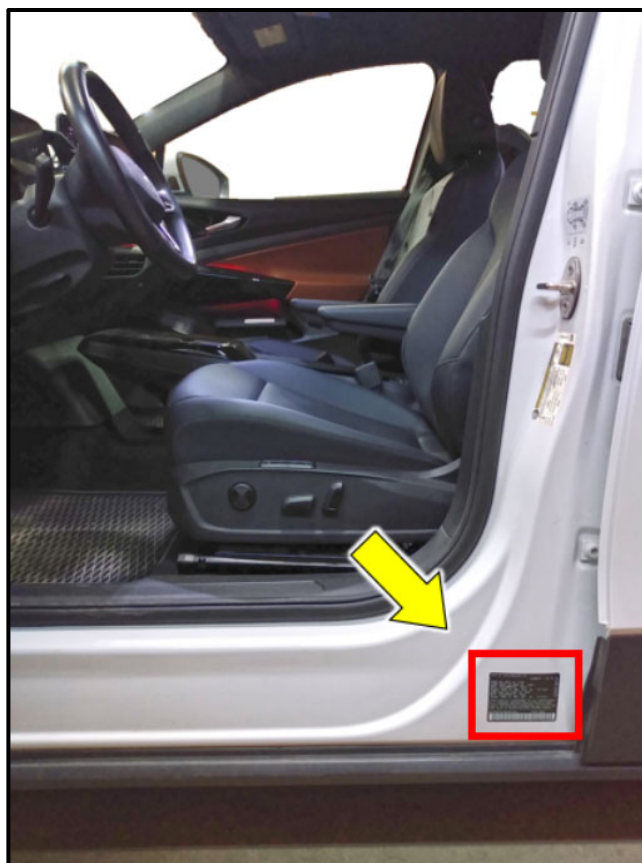
- Locate the "Safety certification" label on the lower B-pillar.
- Clean the surface of the existing label.
- Peel the new label off the backing paper.
- Affix the new label over the existing label.
- Ensure minimal air bubbles are created when installing the new label.

- The surface of the existing label must be clean, dry, and free from oil residue prior to applying the new label.
- Handle the new label carefully. Do not touch the adhesive backing.

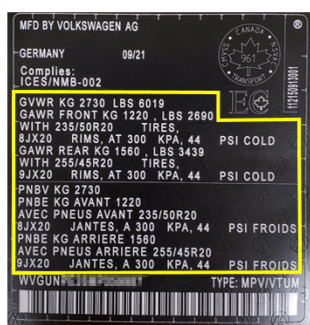
- Apply the label overlays so only the affected data is covered. Do not cover any additional data on the existing label.
