GROUP	MODEL
Service Campaign	2022-2023MY Multiple Models Listed
NUMBER	DATE
SC252	December 2022

VOLUNTARY SERVICE CAMPAIGN

SUBJECT: **HECU INSPECTION /REPLACEMENT (SC252A/B/C)**

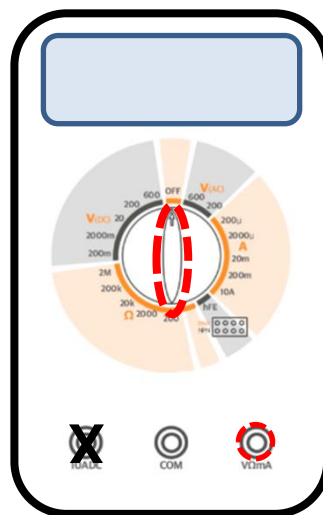
2. Turn the selection knob to the right and set it to **200uA**.

Select 200μ setting (Microamps)
