SIB 65 20 22

2022-11-30

KNEE AIR BAG CHECK CONTROL MESSAGE

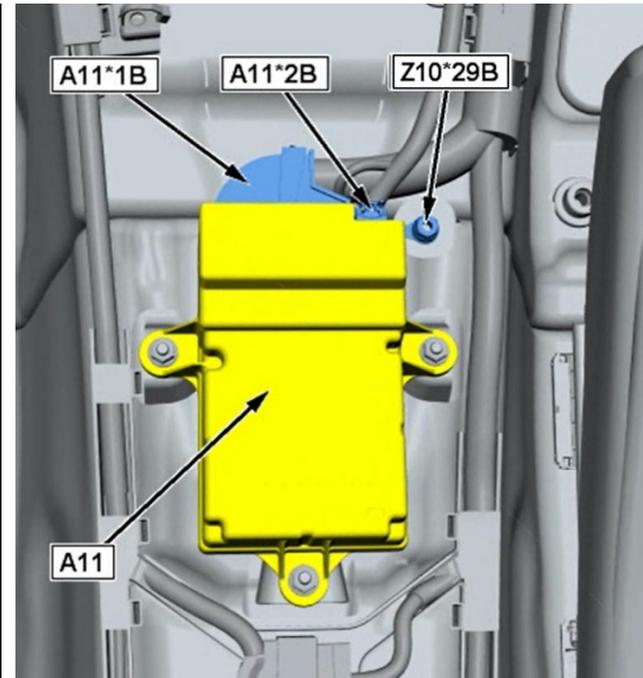
2- Remove the center console as per Repair Instructions 51 16 165 to access the Air Bag Control Module A11 (ACSM) wiring connector (A11*2B).
--	--

Check the ACSM module for signs of corrosion within the electrical connectors.

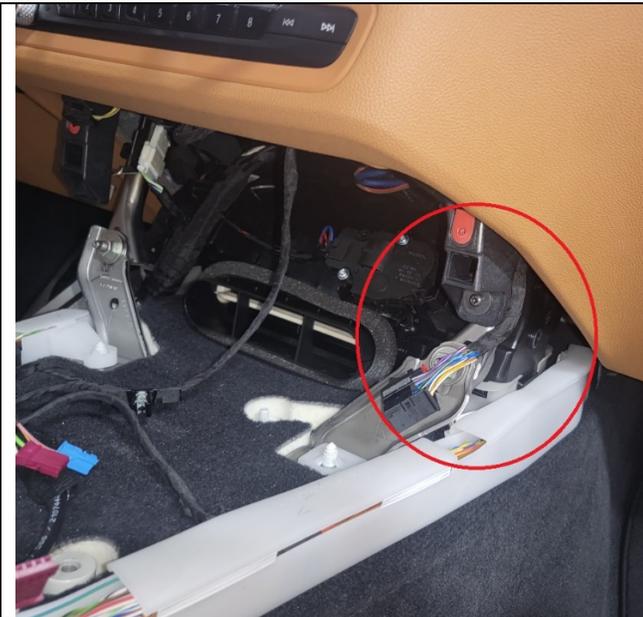
The wiring harness going to the knee air bag(s) may be rubbing against the support tube of the instrument panel.

5- Apply felt tape to the location pictured on the passenger side.
 Glue the felt generously onto the support tube or to the corresponding edge.
 (Felt tape part number **54 34 7 248 700**).
 Important: The felt must be glued around the edge!

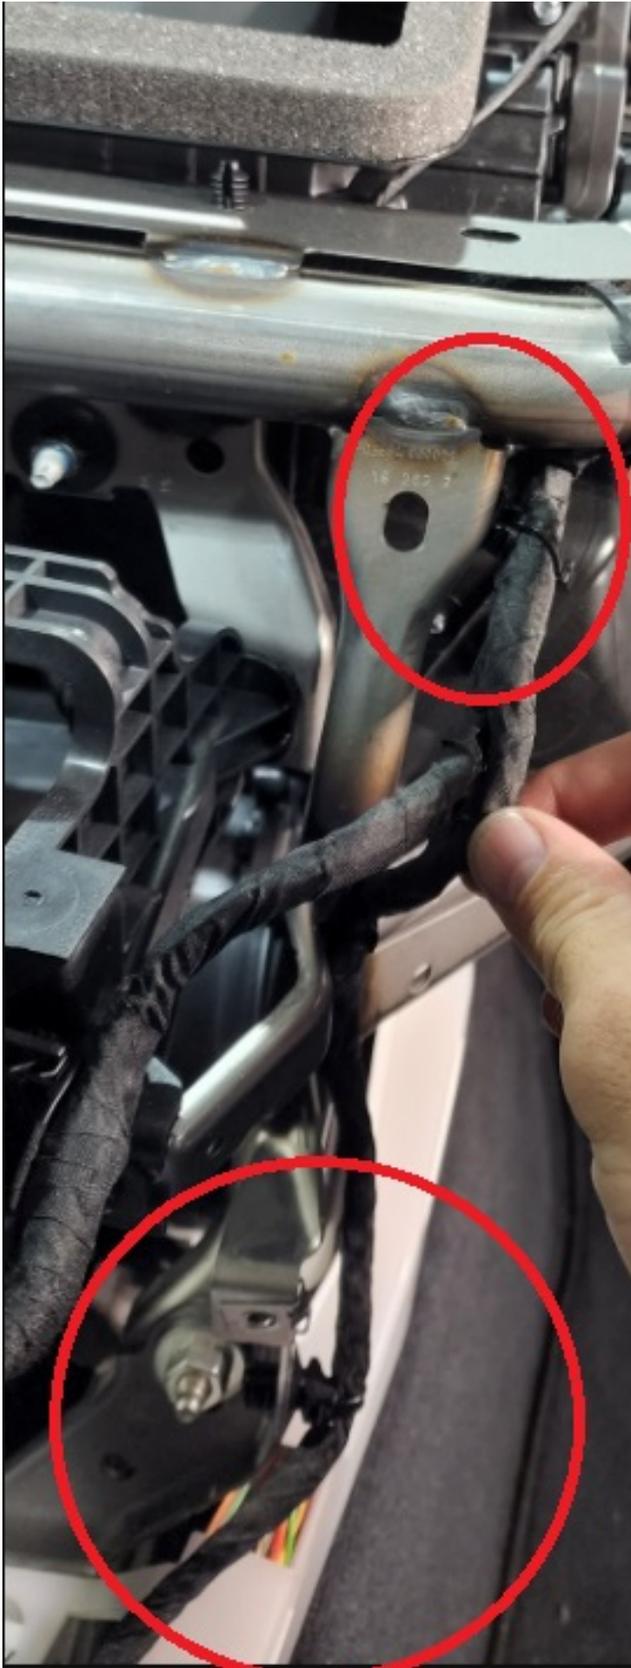
6- Apply felt tape to the location pictured on the passenger side.

The top area is behind the dashboard cover but can be accessed once the passenger knee air bag has been removed. The lower area is the same pictured above.

Glue the felt generously onto the support tube or to the corresponding edge.
(Felt tape part number **54 34 7 248 700**).
Important: The felt must be glued around the edge!

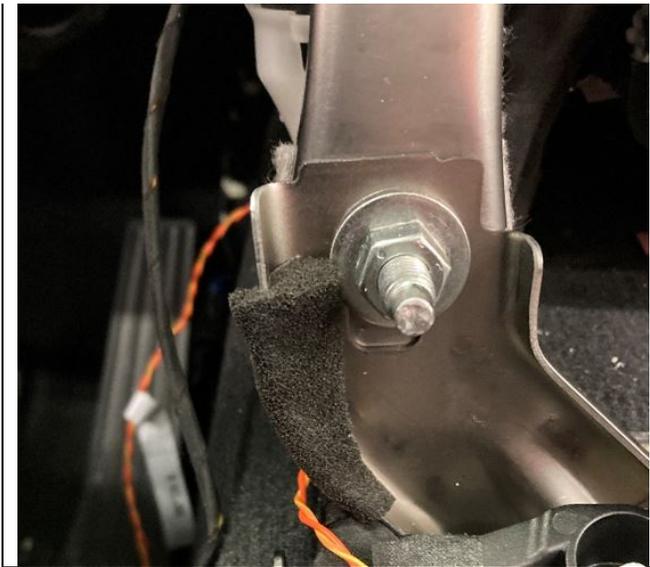
7- The driver knee air bag wiring should be protected from chafing at the dash support bracket.
Glue the felt generously onto the support tube or to the corresponding edge.
(Felt tape part number **54 34 7 248 700**).

Important: The felt must be glued around the edge!
