STAR ONLINE PUBLICATION

Case Number: S2208000086

Symptom/Vehicle Issue: Driver Heated Seat Inoperative, DTC B1E99 Front Left Heater Circuit

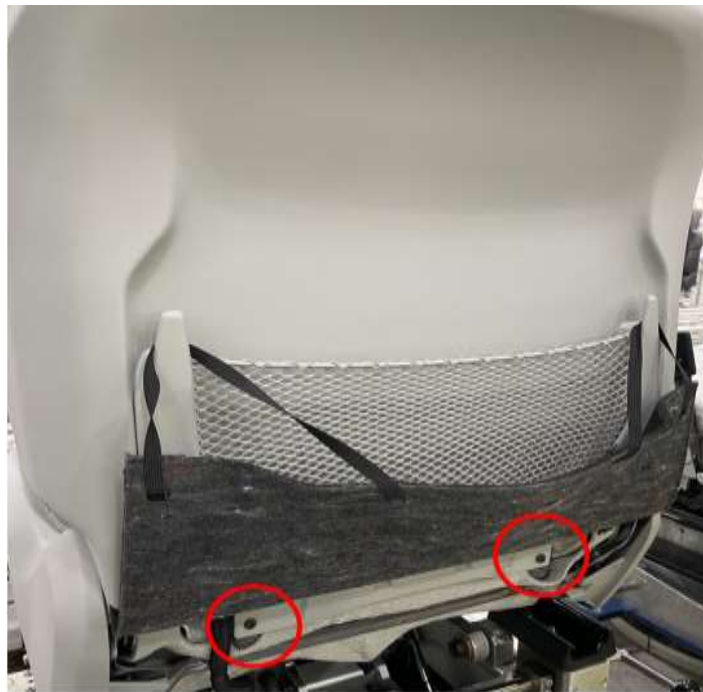
Pg 1

1. Unhook toe kick straps from underneath seat
2. Remove screws circled below

Repair Procedure: Inspect the harness routing at the rear seat panel driver side, ensure no harness pinching at harness retaining clip position as shown, pg's 1- 4.

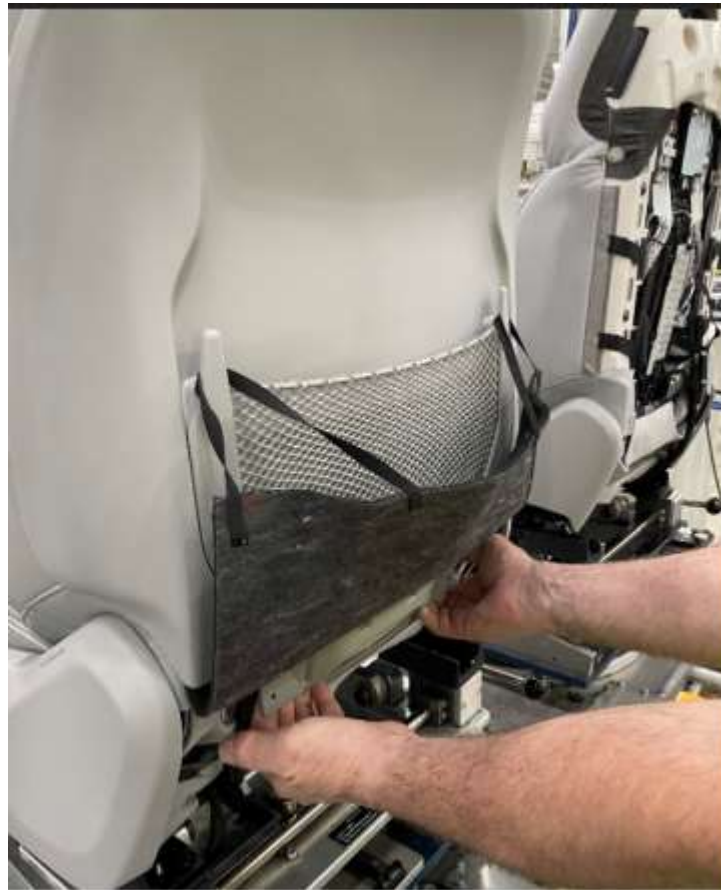
Pg 2

3. Remove panel from button like shown below

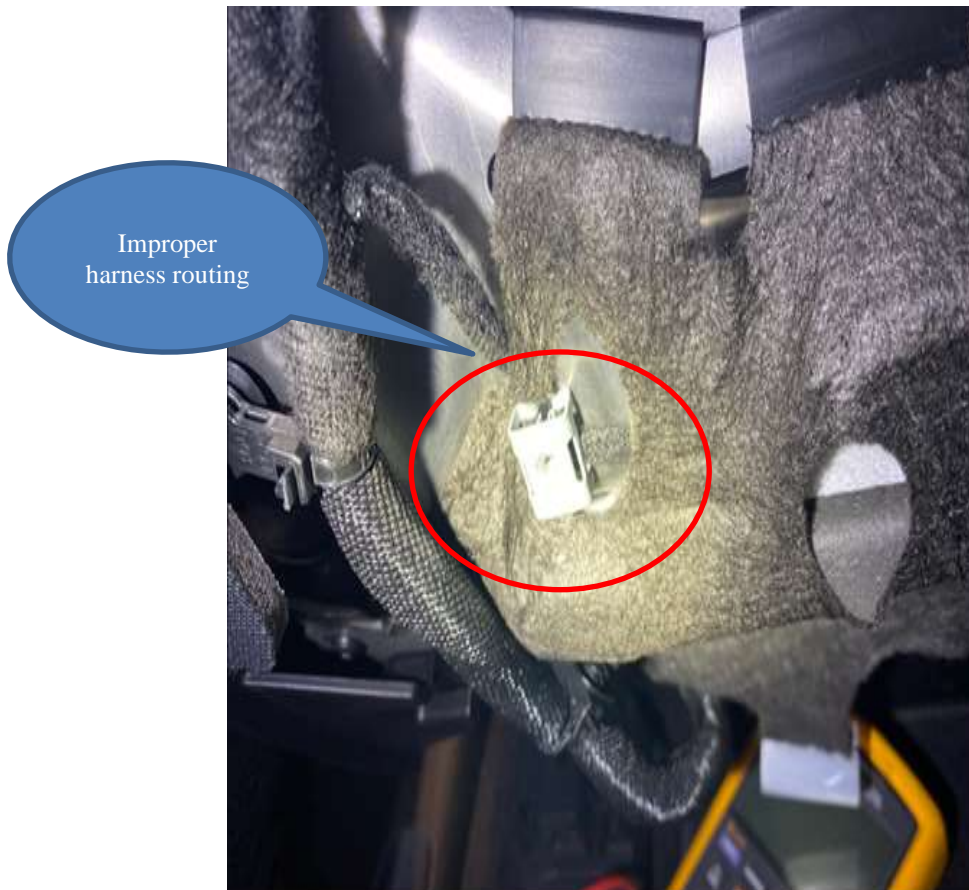
Pg 3

Examine harness routing at clip area, repair and reposition harness as needed if pinched at this location; see proper harness routing pg 4.

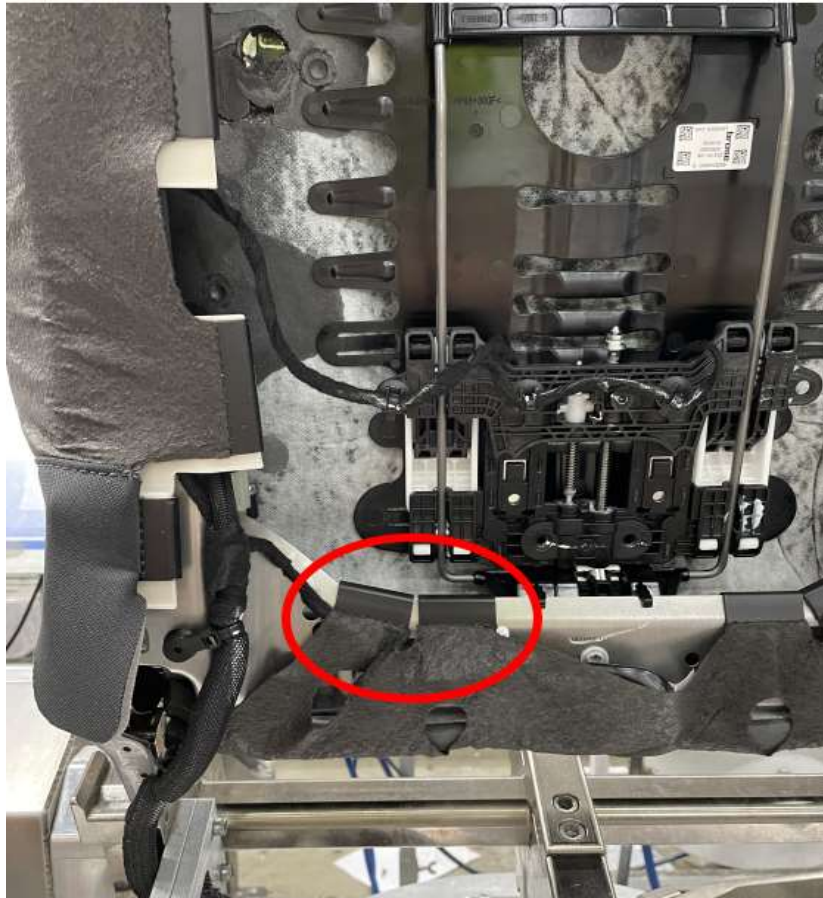
Pg 4

4. Reroute harness as seen above
5. Reattached J clips
6. Verify no new wrinkles on seat bottom cushion upon reassemble.
7. Reattach Back Panel, test operation
