Technical Service Bulletin

Mazda North American Operations
Irvine, CA 92618-2922

Subject: WHITE STAINS FROM UNDER OUTER MIRROR BASE	Bulletin No.: 09-001/22
	Last Issued : 12/01/2022

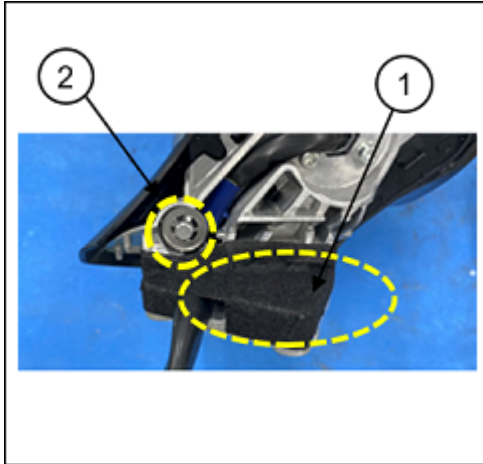
d. Remove the felt tape (1) and the push-nut (2).

NOTE: When assembling the inner base, replace the felt tape (1) and the push-nut (2) with new ones.

(1) Felt tape
(2) Push-nut

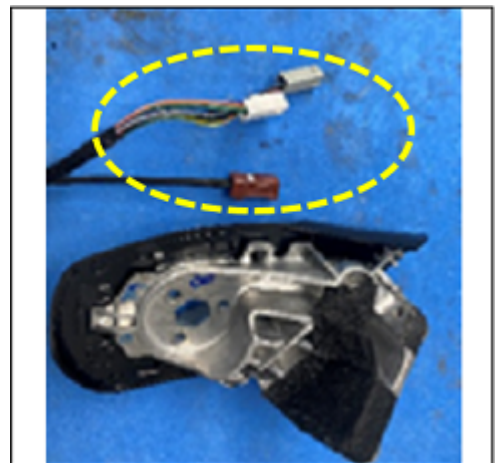
f. Remove the harnesses (1), (2), and (3) from the inner base.

NOTE: Removal order - 1st: White (1), 2nd: Gray (2), 3rd: Brown (3)

Finished to pull out

- (1) Connector: White
- (2) Connector: Gray
- (3) Connector: Brown

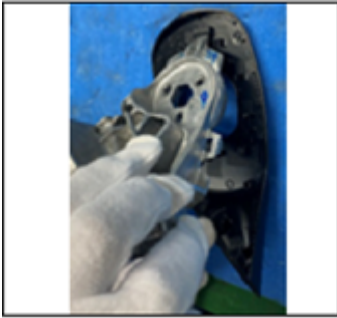
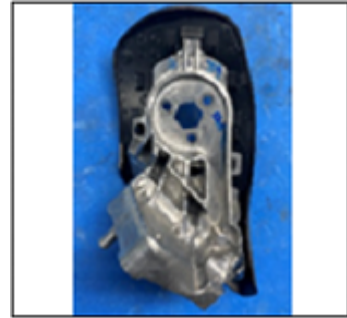
h. Pass the harnesses through the inner base with the base cover (upper).

NOTE: Pass the harnesses through the inner base in the reverse order of pulling them out.

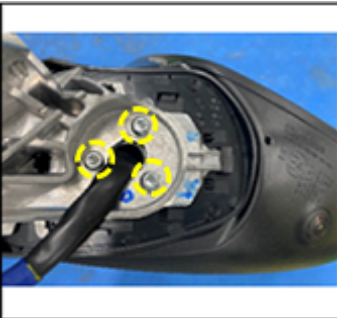
i. Screw the inner base to the outer mirror base.

Specified tightening torque: 4.4±0.7 ft-lb (6.0±1.0 Nm)

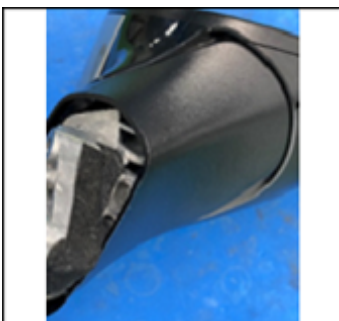
l. Align the outer edges of the base cover (upper) and the base cover (lower) and assemble them so that there are no gaps.

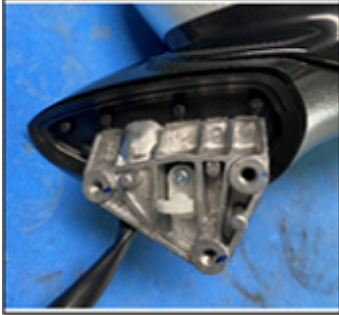
m. Assemble the seal rubber and the clip to the outer mirror base so that the seal rubber fits properly.

Specified tightening torque of the seal-rubber fastening screws: 11±1.7 in-lb (1.25±0.2 Nm)**NOTE:**

- Reuse the seal rubber, the clip, and the screws fastening the seal rubber, which are removed at step 2.
- The seal rubber should not be curled and/or deformed.

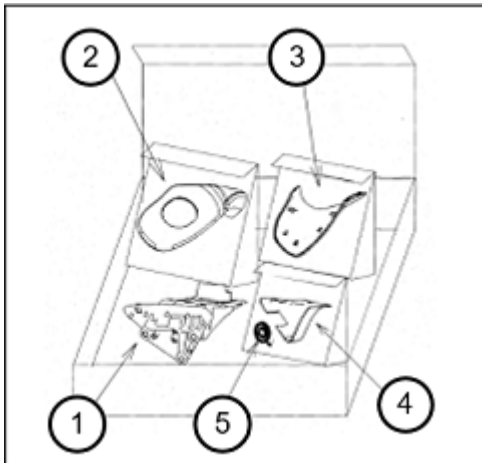
Each kit includes following parts:

- (1) Inner base (with electrodeposition coating)
- (2) Base cover (Upper)
- (3) Base cover (Lower)
- (4) Felt tape
- (5) Push-nut
