IDMA (Interactive Display Module A) Screen Rattle / Vibration

23MY New Range Rover Sport

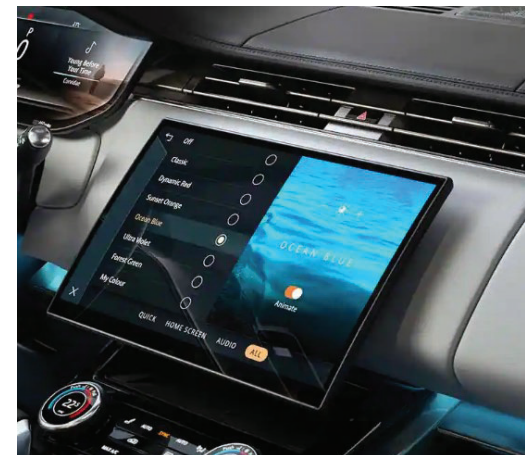
IDMA bracket gap between the locator hole and peg is above specification, and in some cases the bracket fixings are not torqued correctly

1. Remove the IDMA screen and the center trim panel*
2. Remove and refit the IDMA bracket fixings (x8 bolts), torque to 5Nm, see attachment
3. Fit 2x Nitto foam** strips (4cm x 1.5cm)
4. Refit center trim panel and IDMA screen.
