<b>Topic</b>	Continental GT Convertible – Front seat belt webbing twisted
<b>Market area</b>	Russische Föderation (5RU),Australia E04 Bentley rest Asia and Australia (6E04),China 796 VW Import Comp. Ltd (Vico), Beijing (6796),Germany E02 Bentley rest Europe (6E02),Japan E03 Bentley Japan (6E03),Korea, (South) E08 Bentley South Korea (6E08),United Arab Emirates E06 Bentley Middle East and Africa (6E06),United Kingdom E01 Bentley UK (6E01),United States E05 Bentley USA and rest America (6E05)
<b>Brand</b>	Bentley
<b>Transaction No.</b>	2068645/1
<b>Level</b>	EH
<b>Status</b>	Released for publishing
<b>Release date</b>	18-Nov-2022

### Continental GT Convertible

Front seat belt webbing twisted

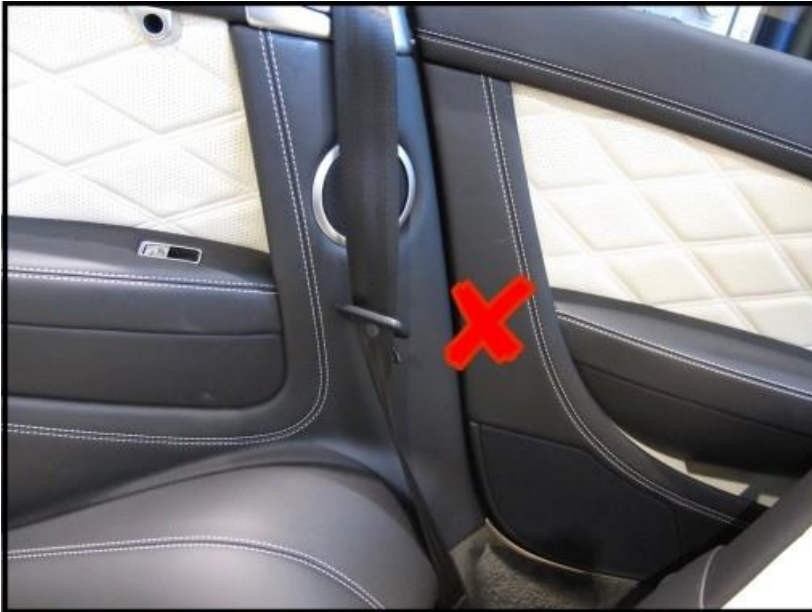
The front seat belt webbing is twisted this is evident in both the stowed position and also when the seat belt is worn see Figure 1

The plastic seat belt webbing guide, a plastic moulding incorporated in the seat belt upper 'D' loop assembly, may not have been fully clipped onto the metal 'D' loop. When this is the case a twist in the seat belt webbing is possible

In the event of a twist being identified in a front seat belt then carry out the following check on that specific seat belt

2. Referencing figure 3 and 4 inspect the seat belt webbing plastic guide (A). Ensure the three clipping points (C) are securely clipped to the 'D' ring (B).
3. If the guide is not securely clipped then remove and discard the guide and fit a new replacement guide.
4. On completion the guide must be correctly secured to the 'D' ring paying close attention to both outer clipping features (C)

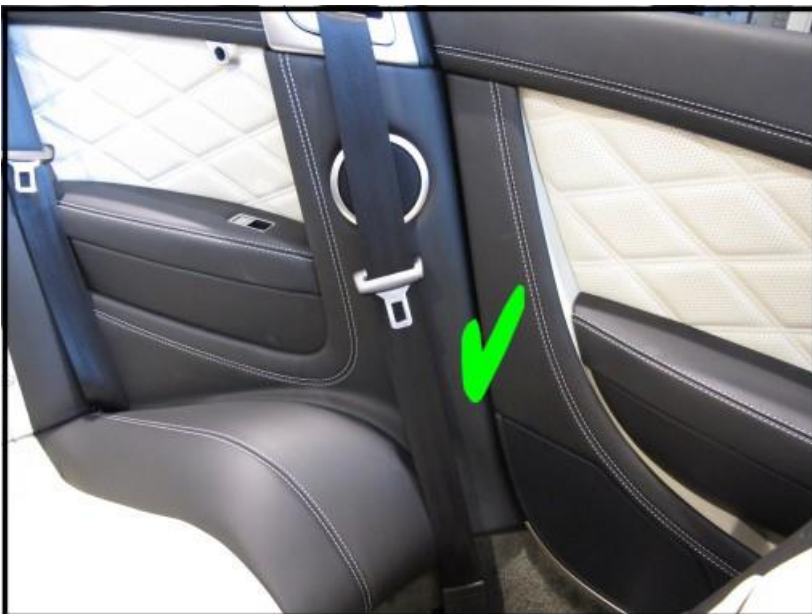
Figure 2

The front seat belt in the stowed position should be as shown in figure 2
