Staining/Surface Damage on Door Trim Bars and Side Window Trim Element

Topic number	LI72.00-P-075656
Version	1
Function group	72.00 - General
Date	12/5/22
Validity	MODEL 247.6 / 243.6
Reason for change

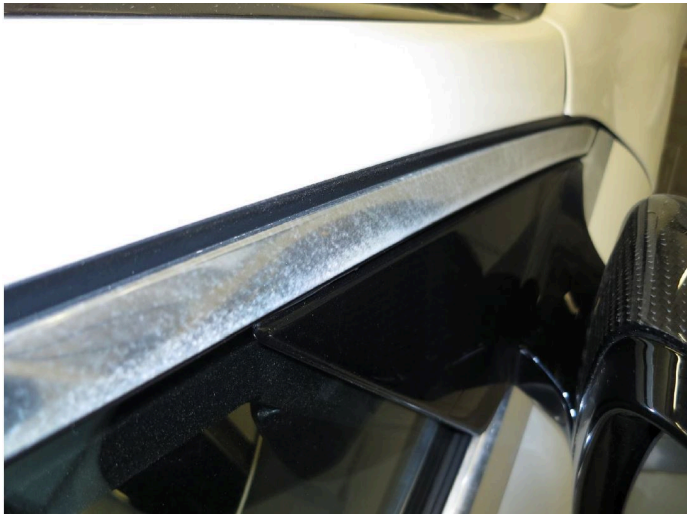
Example of complaint relating to door upper trim strip in silver look
Bild 3.jpg	Example of door trim bar complaint on models with code P59 Black optics

Damage to protective coating of door beltline trim strips, door upper trim strips and side window trim element.

1. Check if the problem cannot be rectified by polishing the trim bars with the polishing paste.
2. If the complaint cannot be rectified, replace the door beltline trim bars, door upper trim bars and rear side window with trim element with optimized protective coating.

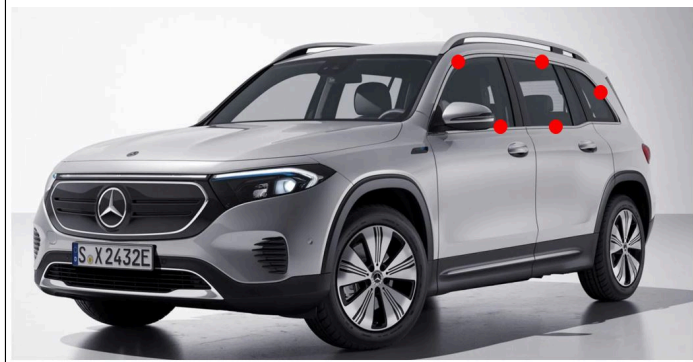
Bild1.JPG

Overview of affected component parts
