Technical product information

Topic	Driver/Passenger door creak on close
Market area	Russische Föderation (5RU),Australia E04 Bentley rest Asia and Australia (6E04),China 796 VW Import Comp. Ltd (Vico), Beijing (6796),Germany E02 Bentley rest Europe (6E02),Japan E03 Bentley Japan (6E03),Korea, (South) E08 Bentley South Korea (6E08),United Arab Emirates E06 Bentley Middle East and Africa (6E06),United Kingdom E01 Bentley UK (6E01),United States E05 Bentley USA and rest America (6E05)
Brand	Bentley
Transaction No.	2061605/6
Level	EH
Status	Approval
Release date

New Continental GT - New Continental GTC and New Flying Spur

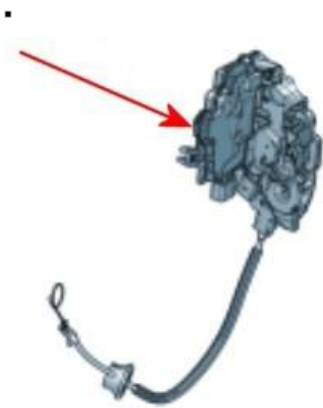
Figure 1

Refer to the vehicle repair history to check/confirm if any previous work which has been conducted regarding door latch replacement (Figure 1)

In the event the door latch date of manufacture is unknown (No notes within the vehicle repair history) the date of manufacture of each door latch must be confirmed and recorded

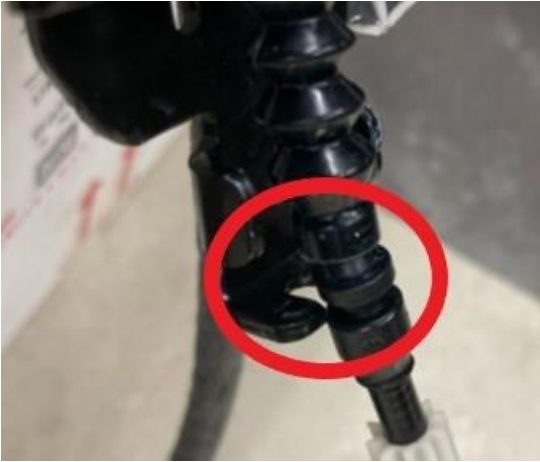
Figure 4

3) Unclip the cable from the latch (Figure 4)

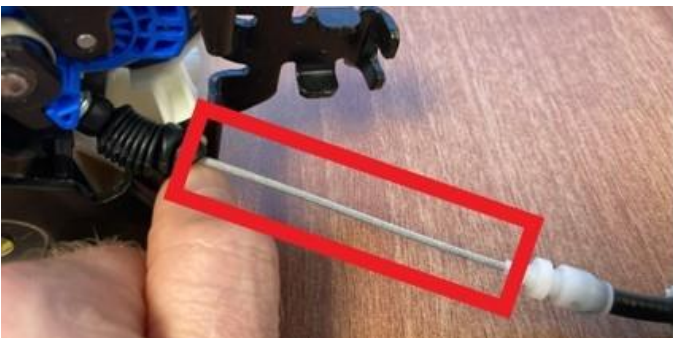
5) Referring to Figure 6 - Compress the rubber boot and apply Dow corning Molycote 33 extreme – Low temperature grease to the cable in the location shown

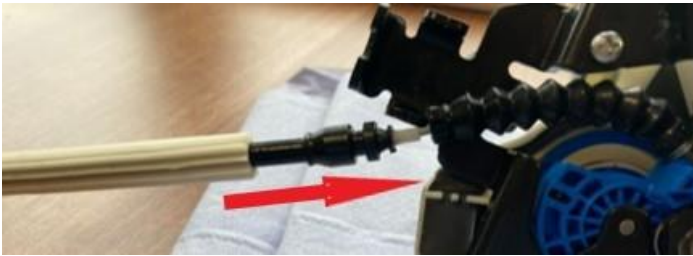
Figure 7

6) Slide the cable towards the latch (Figure 7)

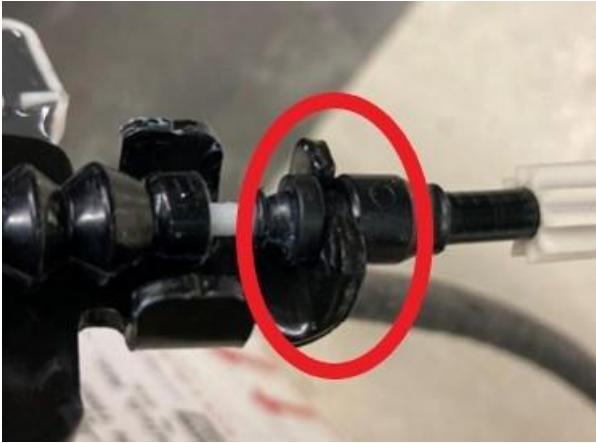
Figure 8

7) Re-clip the Bowden cable into the latch (Figure 8)

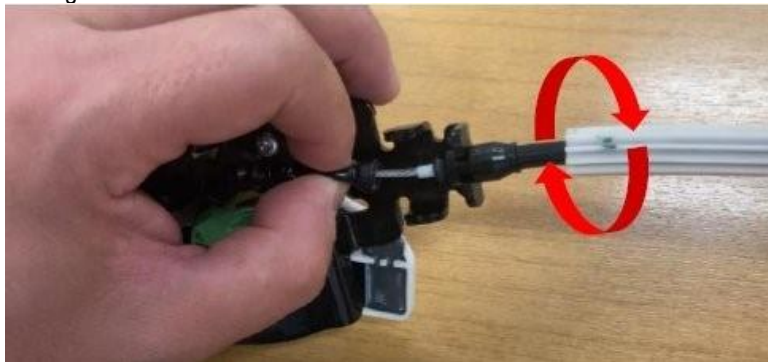
8) Referring to Figure 9 - Distribute the grease by holding the inner cable and rotate the outer cable housing 180 degrees clockwise x2 and then 180 degrees anticlockwise

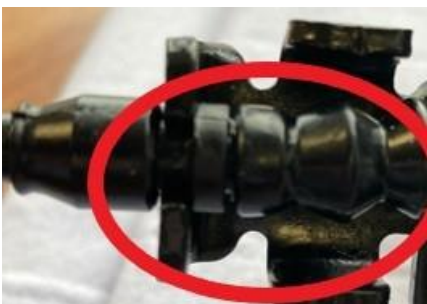
- Refit the rubber boot shown in Figure 10
