STAR ONLINE PUBLICATION

Case Number: S2023000037 Rev. B

Symptom/Vehicle Issue: Wind Whistle Noise From Dash A Pillar Area While Driving

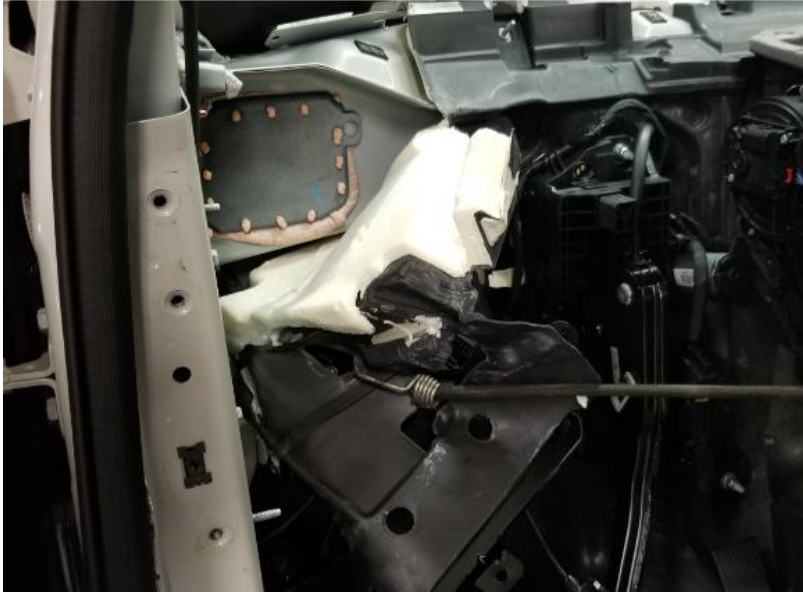
IP rolled back and deadener pad moved to provide access on WS

NOTE>> Images below have the dash removed for clarity. On WS vehicles the Instrument Panel (IP) will have to be “rolled” to access the area due to a sound deadener pad installed.

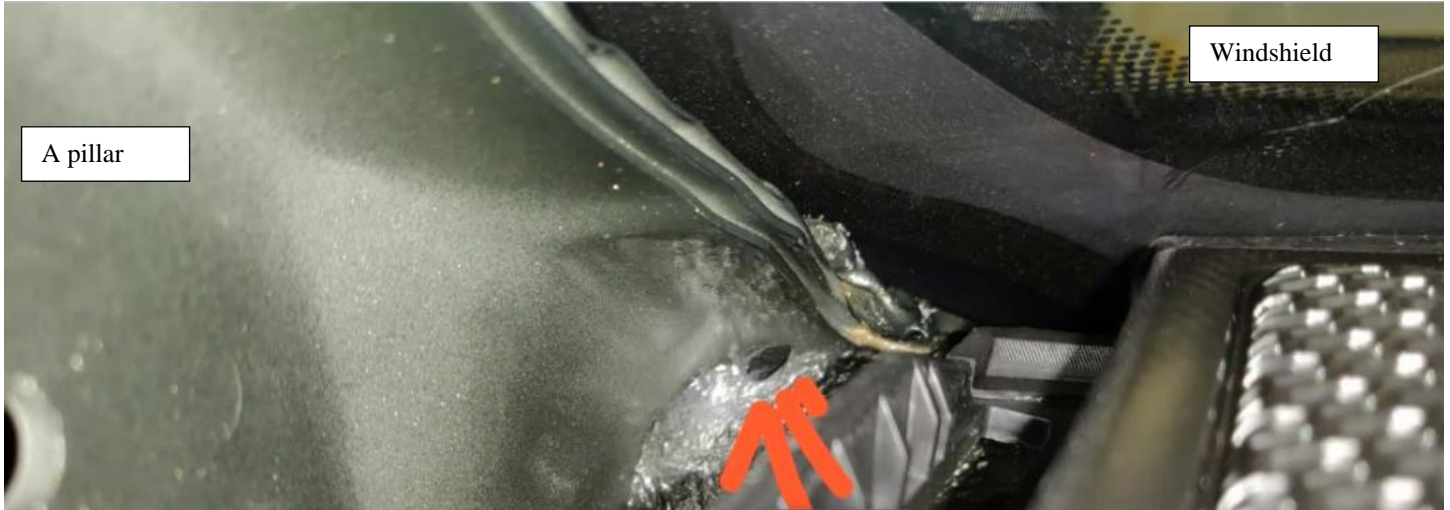
Example of a void in sealer viewed with A Pillar trim removed

Discussion: Customer may complain of a light whistle or rushing wind noise from the drivers A pillar or dash board area near the windshield when driving above 30 mph. Use of a mechanics stethoscope, chassis ear, or a section of heater hose held to your ear will help confirm area of noise. It may help to have an assistant drive while duplicating and isolating. Remove the A-Pillar and dash speaker trim and listen with a chassis ear or stethoscope below the speaker area. Change from fresh air to recirculation. Recirculation HVAC mode will increase airflow through voids and may help isolate the noise easier. If the noise is loudest in this area, inspect the sealer shown in the areas below. A mechanic borescope may help view the area. Bubble testing using soapy water with compressed air can also be helpful. If sealer has voids, use butyl or seam sealer to repair the air leak path. The opening for the speaker is small and butyl may be easier to control when applying by hand.

Sealers: Kent Products High-Tech clear sealer p10200 or equivalent
Mopar Butyl 04076274AB or equivalent
Loctite 5510 sealer

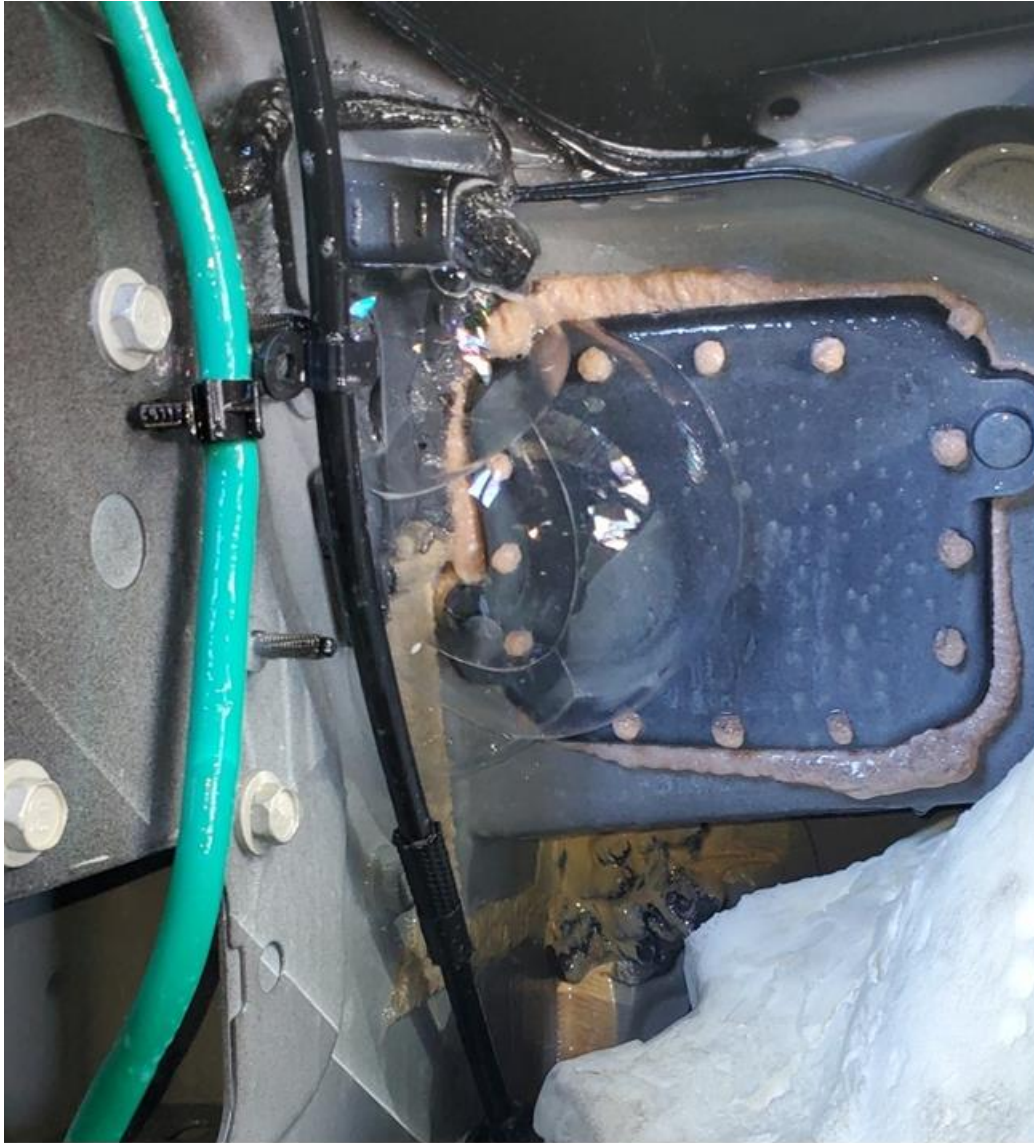
Use of soapy water sprayed on the area and a blow gun on exterior of the cowl used to force air through the leak area for pinpoint testing.
