STAR ONLINE PUBLICATION

Case Number: S2208000193 Rev. A

Symptom/Vehicle Issue: Check Engine Light On, P057B - Brake Pedal Position Sensor "A" Circuit Performance

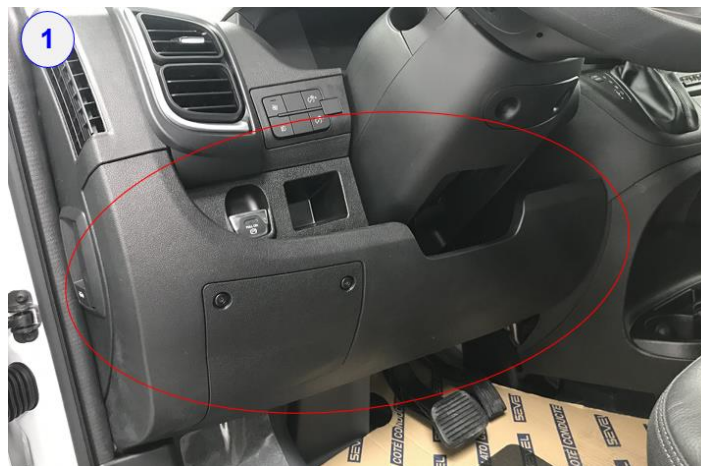
1. Remove the driver's knee blocker trim per standard procedure.

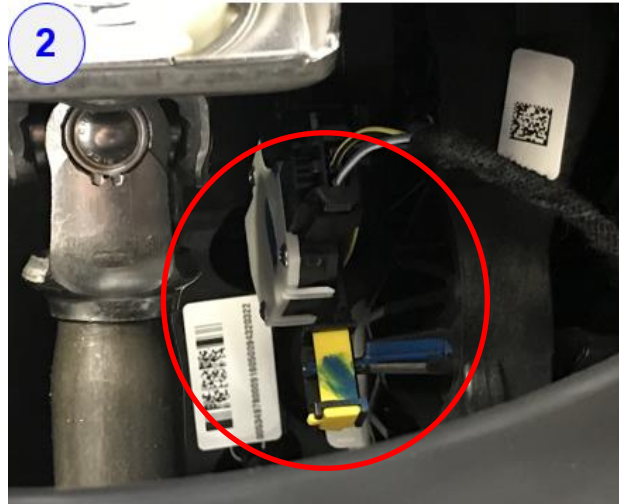
2. Locate the brake pedal position sensor.

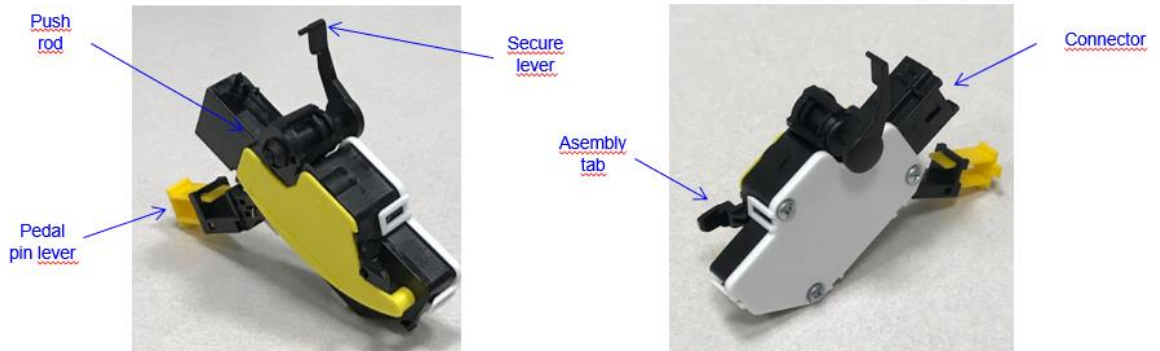
Key Elements

3. Verify the brake pedal position sensor installation according to the steps indicated below.

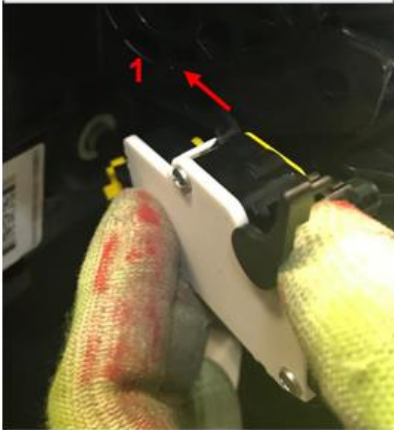
Insert tab into pedal
box hole

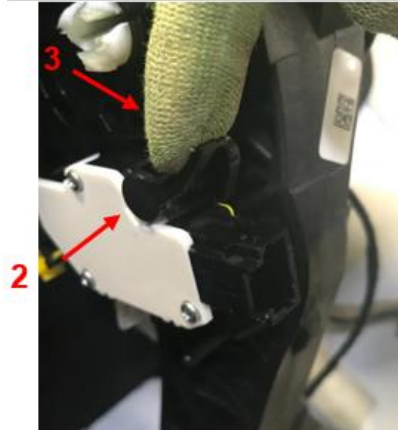
Push clip rod and pull
lever until secure

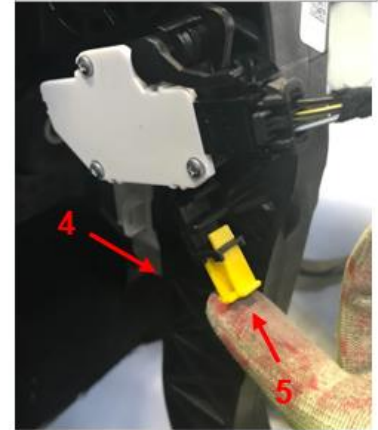
Pull lever and
push until secure

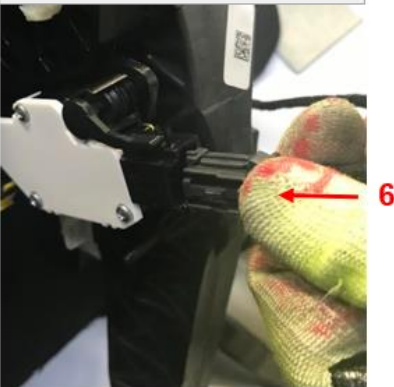
Connect wiring
harness
