STAR ONLINE PUBLICATION

Case Number: S2208000205

Symptom/Vehicle Issue: Three Way Coolant Valve Hoses Misrouted. P0E80-00-Coolant Bypass Valve "B" Control Stuck Closed

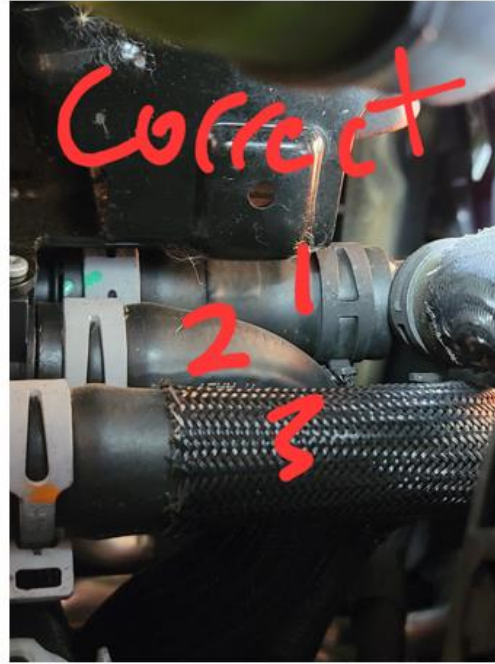
It has been found that the F shaped hose attached to lower port of valve and the other two hoses may have shifted one position each.

Commonly Found Misrouting VS Correct Routing

Review Images on Page 2 to determine current location of hoses 1, 2 and 3.

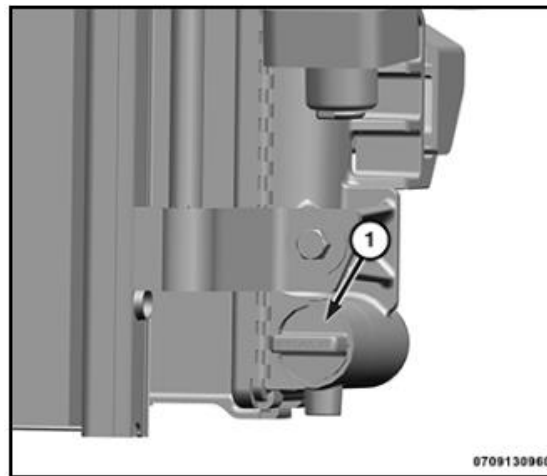
1 - Draincock

- A. Drain the high temperature cooling system. Reference Service Library: Engine Cooling Standard Procedure (DRAINING)
- B. 1. Remove the front air dam (Refer to 13 - Frame and Bumpers/Bumpers/AIR DAM, Front/Removal and Installation).
- C. 2. Verify the system is not pressurized and open the draincock.
- D. 3. If equipped and necessary, remove the cylinder block drain plug(s).
