REFERENCE:	TSB: 31-002-22 GROUP 31 - Collision Bulletins	Date:	December 15, 2022	REVISION:	31-002-20
VEHICLES AFFECTED:	2019 - Current (DT) RAM 1500 Pickup 2020 - Current (JT) Jeep Gladiator 2019 - Current (BV) Jeep Renegade 2015- Current (4C) Alfa Romeo 4C 2017- Current (BA) FIAT 124 Spider (Convertible) 2013- Current (FF) FIAT 500 2017- Current (GA) Alfa Romeo Giulia 2018- Current (GU) Alfa Romeo Stelvio 2014- Current (KL) Jeep Cherokee 2013-2016 (PF) Dodge Dart 2013-2017 (ZD) Dodge Viper 2013- Current (DS) RAM 1500 Pickup 2013- Current (WK) Jeep Grand Cherokee 2013- Current (WD) Dodge Durango 2017- Current (RU) Chrysler Pacifica 2015-2018 (BU) Jeep Renegade 2018- Current (JL) Jeep Wrangler 2015- Current (LA) Dodge Challenger 2013-2014 (LC) Dodge Challenger 2013- Current (LD) Dodge Charger 2013- Current (LX) Chrysler 300 2017- Current (MP) Jeep Compass 2015-2017 (UF) Chrysler 200 2013- Current (JC) Dodge Journey 2013-2014 (JS) Chrysler 200 /Dodge Avenger 2013- Current (RT) Chrysler Town & Country/Dodge Grand Caravan 2019- Current (D2, DD, DF, DJ and DP) RAM Heavy Duty Trucks	MARKET APPLICABILITY:	<input checked="" type="checkbox"/> NA <input checked="" type="checkbox"/> SA <input

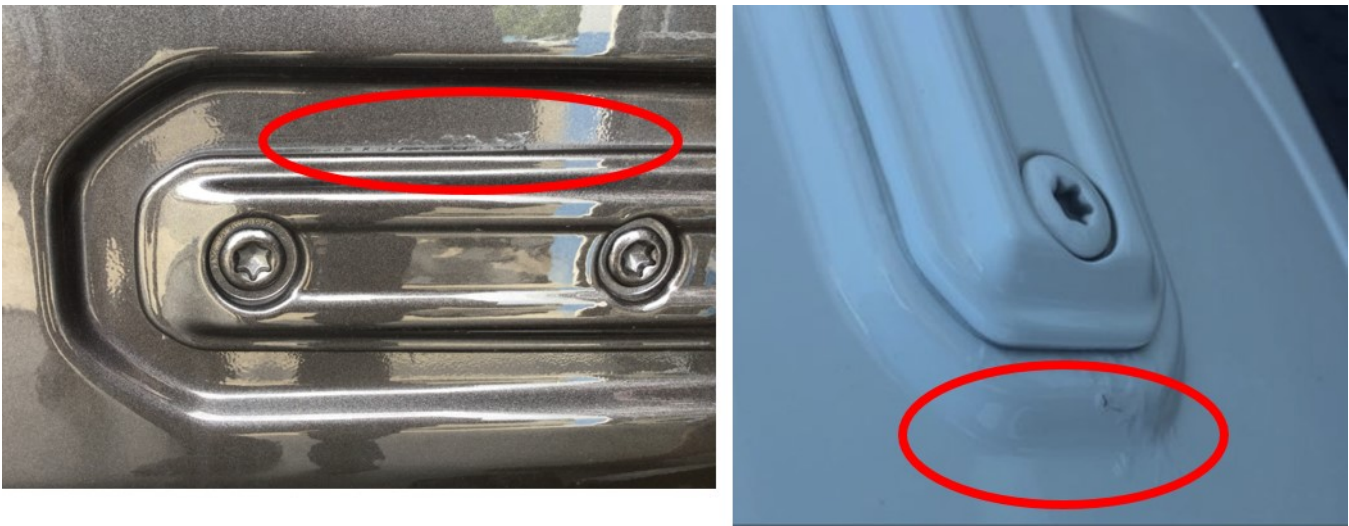
Fig. 2
Examples of Bubbling

Aluminum corrosion or bubbling on the doors and/or hinges (Fig. 2) .

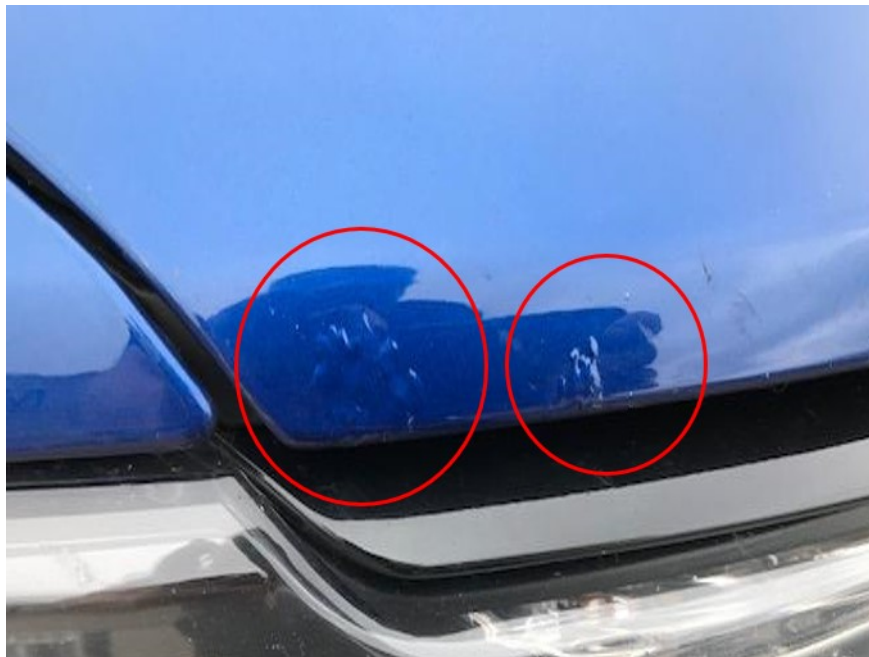
Fig. 3
Examples of Corrosion Along Leading Edges

Aluminum corrosion along the leading edge of hood or other exterior surface areas of the doors, fenders or liftgates (Fig. 3) .

Is corrosion evident on the aluminum panel surface (Fig. 3) ?

- YES>>> Must receive authorization from vehicle digital imaging and/or Regional Office. Once approval is received from digital imaging or Regional Office, Proceed to [Step 1](#) of the diagnosis procedure.
 - NO>>> Submit the vehicle digital image for further analysis.
1. Remove blistered paint from the panel surface with 80 grit grinding disc.
 2. After digital imaging or Regional Office approval and removing the initial blistered paint from the panel surface with 80 grit grinding disc, is severe pitting exhibited that cannot be removed with sandpaper, 3M Clean and Strip Disc or equivalent (Fig. 4) ?
