## STAR ONLINE PUBLICATION

**Case Number:** S2123000052 Rev B

Wind or Whistle Noise from Exterior Side Mirror at Highway Speeds. Noise can be heard with front windows down between 30 and 60 MPH from both LH and RH exterior rear view mirrors.

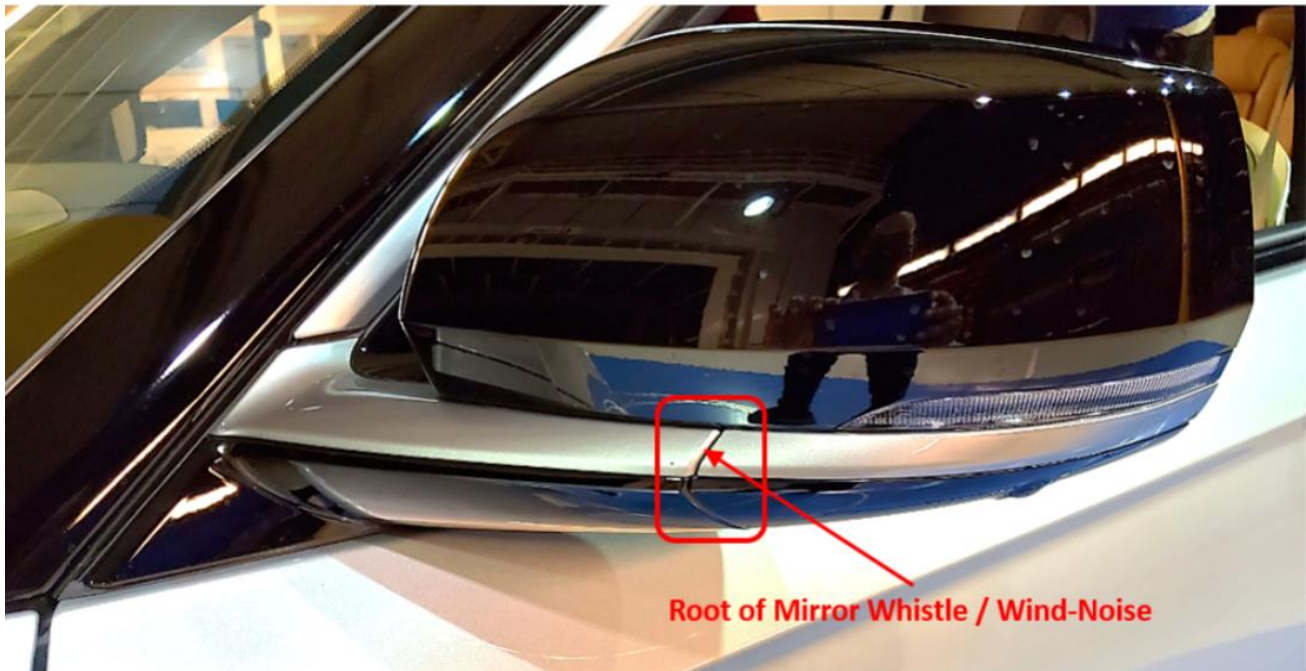
Inspect the side mirror on the side that has the noise complaint. Attempt to duplicate the condition with one window down at a time driving speeds from 30-60mph.

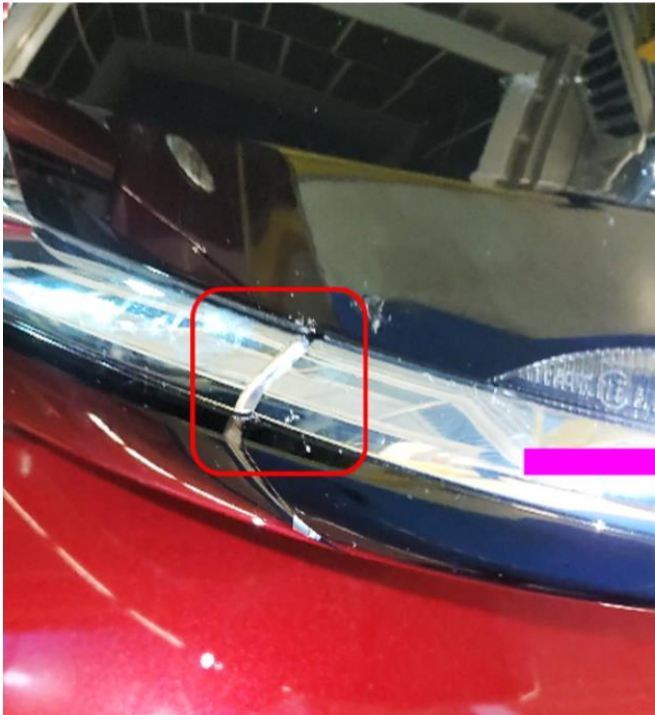
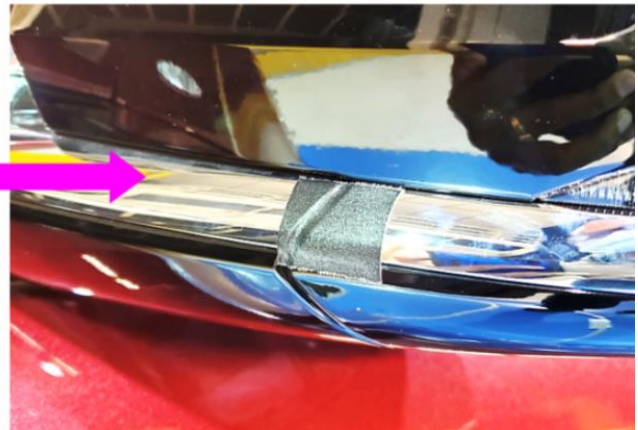
Fig. 1 : Vertical seam

If duplicated, apply a piece of tape over the vertical joint shown in figure 1 and test drive the vehicle again in the same manner.

Tape the vertical gap between both Mirror Base and Mirror Head Accent Pieces as following - Chrome or Painted finish

If the noise is gone with tape applied - perform the repair below.

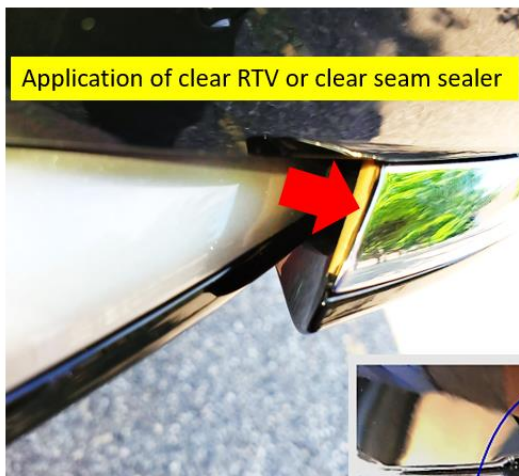
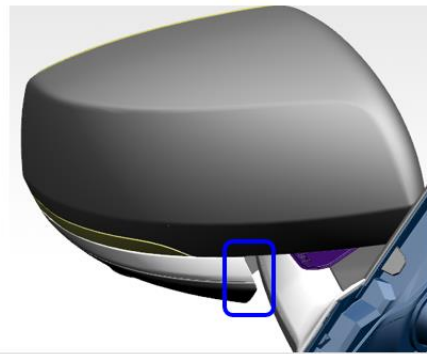
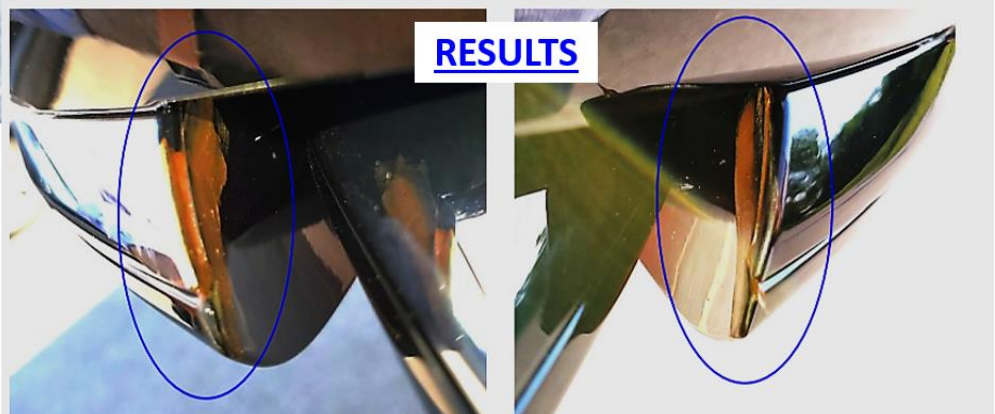
Fig. 2 : Seam with sealer applied.

Obtain a clear RTV or clear seam sealer such as Kent Products p10200 Hi Tech Clear. Following the products application and curing directions carefully apply the sealer in the vertical gap on the mirror head at the molding. It may help application to cut the tip of the applicator on an angle and so the opening size controls the flow of product into the gap. Apply enough to discretely fill the vertical gap shown in figure 2. Be mindful to keep sealer out of the mirror's moving joints and wipe/remove any excess that could be visible. Remove masking tape once the sealer is cured.

Note : Fold mirror head forward before application of the sealer

Perform a test drive in the same manner used to duplicate the condition. One side window down at a time driving up to 60 mph to confirm condition is no longer present.
