July 2022

Dealer Service Instructions for:

Customer Satisfaction Notification Z70 Door Speaker Covers

2022 (WS) Jeep® Wagoneer

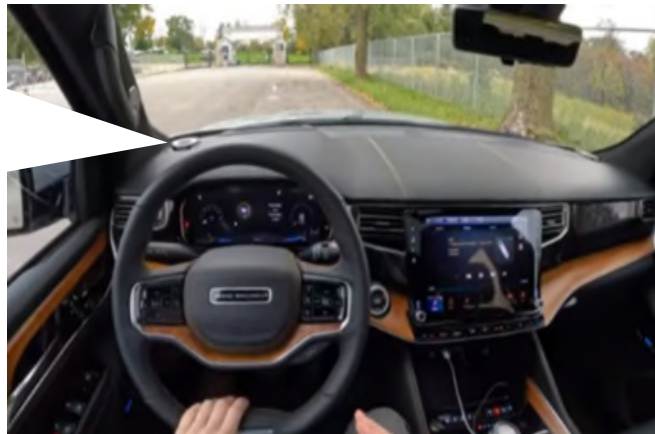
Figure 1 – Instrument Panel Speaker

1. Open the driver's door and visually inspect the speaker cover name plate located on the left side of the instrument panel speaker cover (Alpine or McIntosh) (Figure 1).

2. Open each door and verify the name plate on all 4 door speaker covers is the same as on the instrument panel speaker cover name plate (Alpine or McIntosh).
 - Did any of the door speaker covers not have the same name plate as the instrument panel speaker cover (Figure 1)?
