**NUMBER:** 23-051-22

RamBox Applique Separation/Delamination

This bulletin involves inspecting and possibly replacing both RamBox lids and appliques with updated parts.

2019 - **2022**	(DS)	RAM 1500 Pickup
2019 - **2022**	(DJ)	RAM 2500 Pickup
2019 - **2022**	(D2)	RAM 3500 Pickup

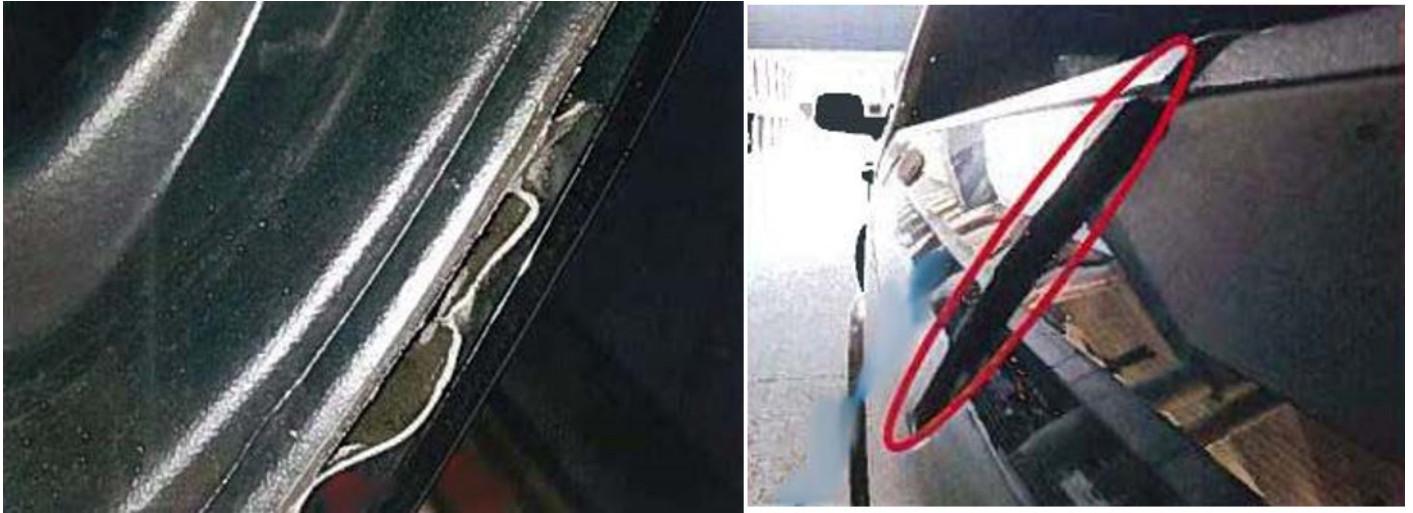
Fig. 1

- One or both of the RamBox appliques are separating/delaminating (Fig. 2) from the RamBox lids.

Examples Of RamBox Separation Or Delamination

**NOTE: If no separation/delamination is found, do not replace the appliques and lids.**

**Appliques and box lids must be replaced as a pair. If one has separation/delamination issues, both must be replaced.**

1. \*\*Remove and discard the RamBox lid with applique. Refer to the detailed service procedures available in DealerCONNECT/Service Library under: Service Info>23 - Body / Exterior / Box, Pickup / Removal.
2. Feather sand the surface area of the new primed applique with P500 sandpaper.
3. Which type of basecoat will be used?
  - Solvent Basecoat >>> Proceed to [Step 1](#) of the Solvent Basecoat Procedure.
  - Waterborne Basecoat >>> Proceed to [Step 1](#) of the Waterborne Basecoat Procedure.
