# RECALL: THIS MODIFICATION HAS TOP PRIORITY AND MUST BE PERFORMED IMMEDIATELY TO ENSURE CUSTOMER SAFETY

## IMPROVEMENTS TO THE MAIN WIRING HARNESS (Inspection and repair if needed)

**2020 1290 SUPER DUKE R**

**2022 1290 SUPER DUKE R EVO**

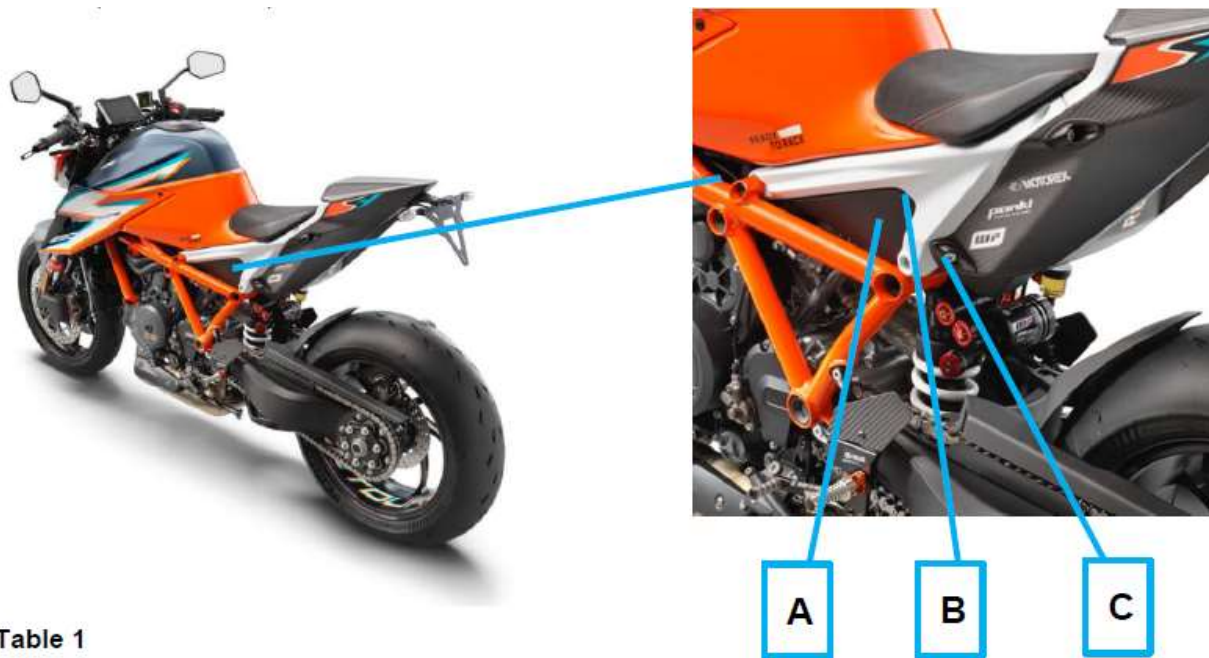
**Table 1**

The wiring harness must be inspected in Area A, Area B and Area C as shown in the photos and Table 1 below. There may be components on this vehicle from this TI already installed at the factory which is why an inspection of Area A, Area B and Area C is required first.

Area	Description	Figures Before/after
A	Battery support	A1 / A2
B	Main wiring harness	B1 / B2
C	Fastener for rear frame	C1 / C2

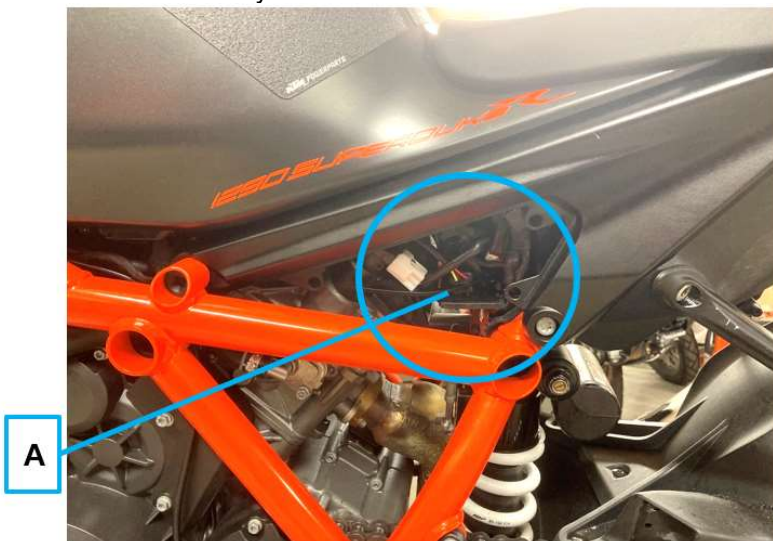
Area A: Remove the Battery support, rear side cover to access Area A.

1. Remove the left side fairing in accordance with the repair manual to access Area A and Area B.
2. During work, take photos according to the attached checklist.

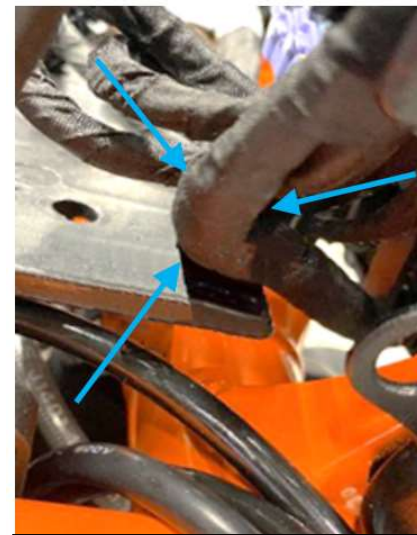
Area A1: Inspect the wiring for damage at the indicated location. Also check if the cable tie with foot section is missing or installed. (Take photo for claim)

4. Inspect wiring harness at position A1 for damage to underside and photograph from same distance and angle as shown in this TI and attach to warranty claim.

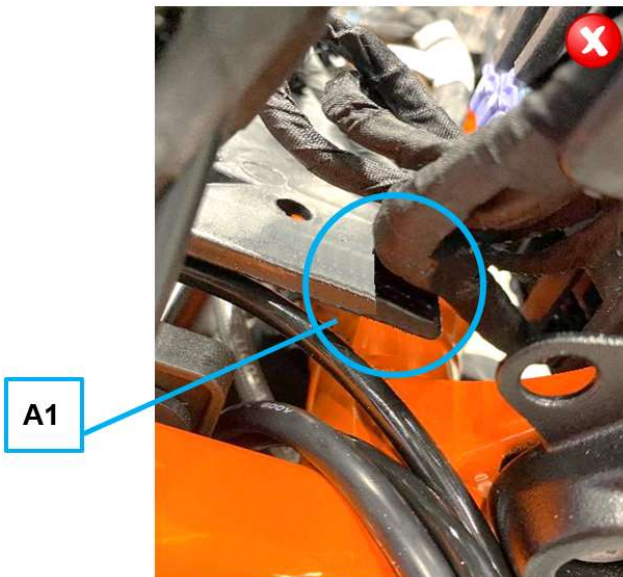
Area A1 (Before): If the Battery support looks like this and is missing the cable tie with foot section it must be updated to look like A2. (Take photo for claim)

8. If the Battery support is missing the cable tie with foot section you must update this area by installing the cable tie with foot section wiring harness protection parts as shown in photo A2. Following is the part number to order and install: (p.n. 0330000520000) - Cable tie with foot section
9. Check the positioning of the wiring harness for contact-free mounting, only the cable tie with foot section, cable tie guide and the frame cover are permissible as contact points.
10. Photograph the final positioning of cable tie with foot section, cable tie guide and frame cover from same distance and angle as shown in this TI, and attach to warranty claim.

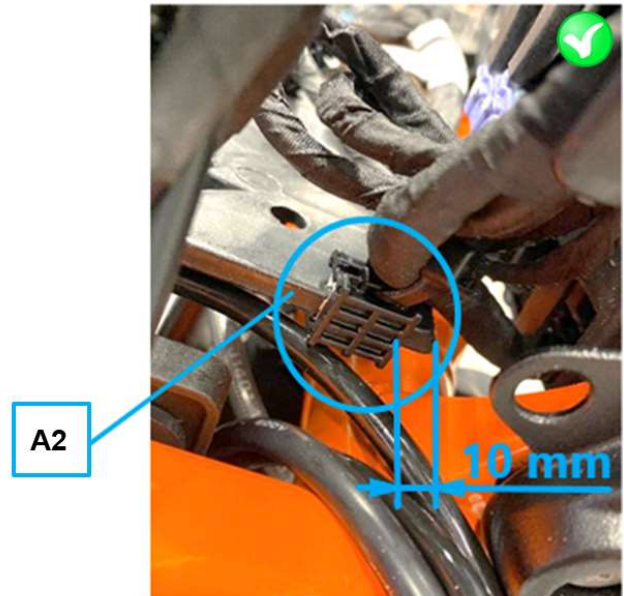
Area A2 (After): If the Battery support is missing the cable tie with foot section you must update this area by installing the cable tie with foot section wiring harness protection parts. Install the cable tie with foot section as shown here in photo A2. If needed order and install (0330000520000) - Cable tie with foot section. (Take photo for claim)

6. Check the correct wiring harness routing to ensure it is routed to the improved wiring harness standards along with being equipped with the wiring harness protection parts as shown in photo A2.

7. If the wiring harness is routed correctly and the wiring harness protection parts are installed as shown in photo A2 then the motorcycle meets the improved wiring harness standards and no further repair is required. Just make sure that you have taken the required photos and have completed the checklist so you can attach them to the claim.

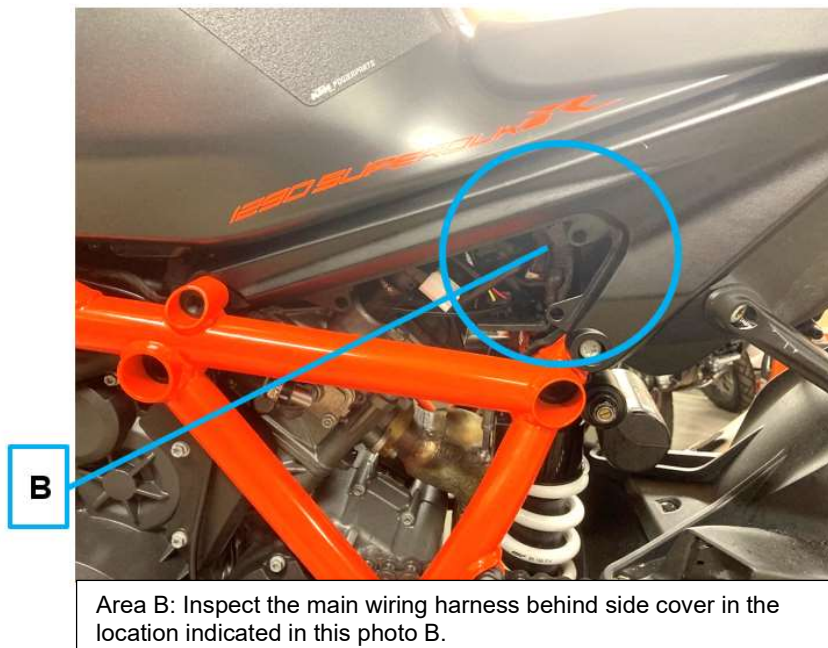
1. With the left side fairing already removed inspect the main wiring harness in Area B.
2. During work, take photos according to the attached checklist.

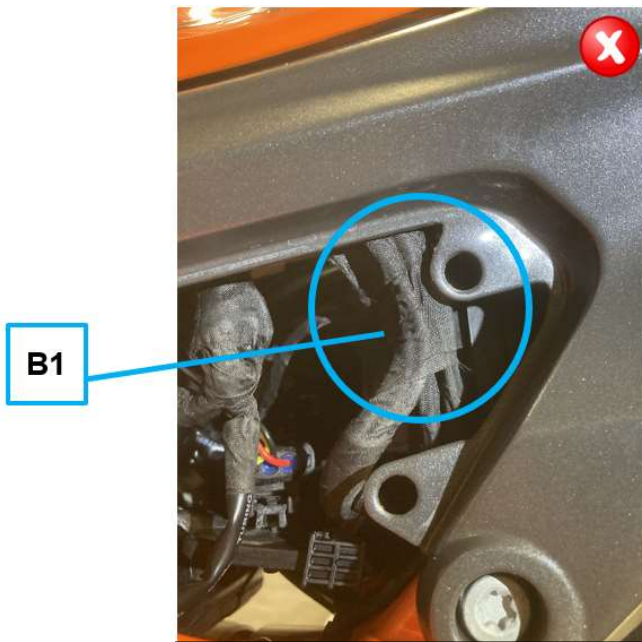
4. Inspect the wiring harness at position B1 for damage to contact point to rear frame and photograph from same distance and angle as shown in this TI and attach to warranty claim.

**Area B1 (Before):** If the main wiring harness looks like this and is missing the cable tie guide with cable tie it must be updated to look like photo B2. (Take photo for claim)

8. If the cable tie guide with cable tie is missing you must update this area by installing the cable tie guide with cable tie protection parts as shown in photo B2. Following are the part numbers to order and install: (p.n. 60311046050) - Cable tie guide and (p.n. 44011076140) - Cable tie 140/2.5 mm black

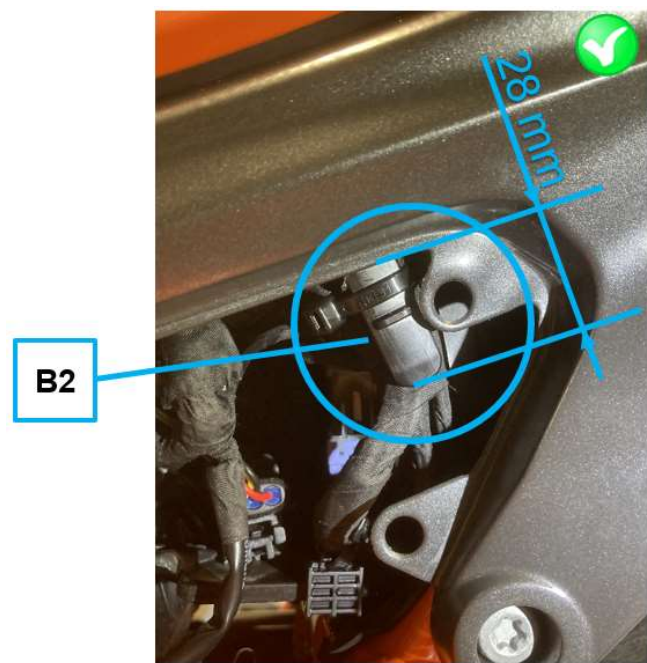
**Area B2 (After):** If the cable tie guide with cable tie is missing you must update this area by installing the cable tie guide with cable tie protection parts. Install the cable tie guide with cable tie as shown here in photo B2. If needed order and install the following parts:  
 (60311046050) - Cable tie guide  
 (44011076140) - Cable tie 140/2.5 mm black  
 (Take photo for claim)

7. If the wiring harness is routed correctly and the wiring harness protection parts are installed as shown in photo B2 then the motorcycle meets the improved wiring harness standards and no further repair is required. Just make sure that you have taken the required photos and have completed the checklist so you can attach them to the claim.

9. Check the positioning of the wiring harness for contact-free mounting, only the cable tie with foot section, cable tie guide and the frame cover are permissible as contact points.

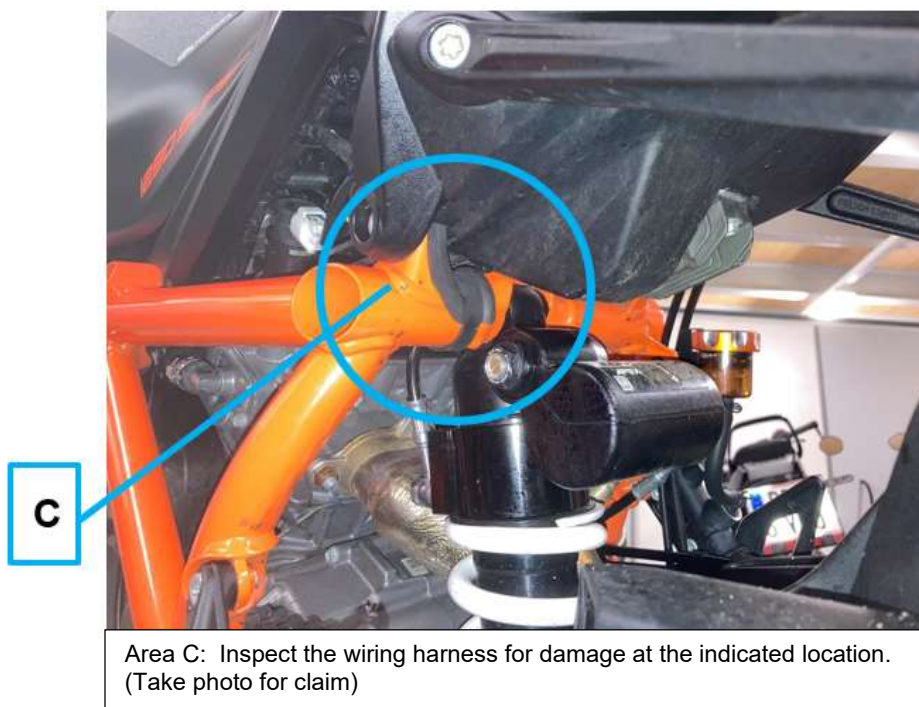
1. With the left side fairing already removed inspect the main wiring harness in Area C.
2. During work, take photos according to the attached checklist.

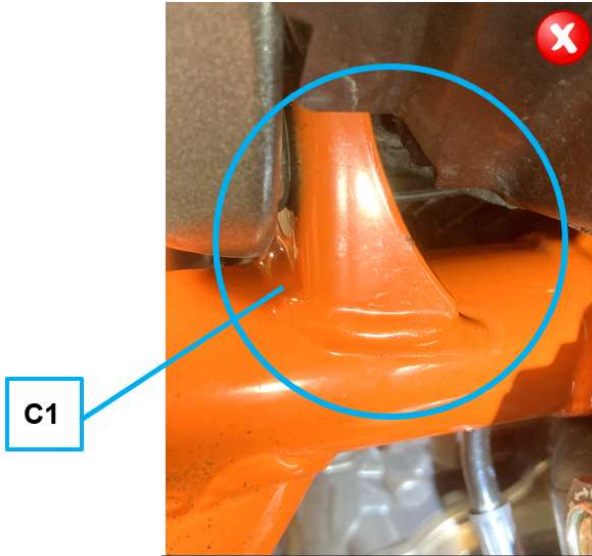
4. Inspect wiring harness at position C1 for damage to frame tab and photograph from same distance and angle as shown in this TI and attach to warranty claim.

Area C1 (Before): If the frame tab looks like this without the frame cover it must be updated to look like C2.  
(Take photo for claim)

6. Check if the frame tab frame cover is missing or installed as shown in photo C1 and C2.
7. If the frame tab cover is missing you must order it and install it as shown in photo C2. The part number for the frame cover is 61703083000

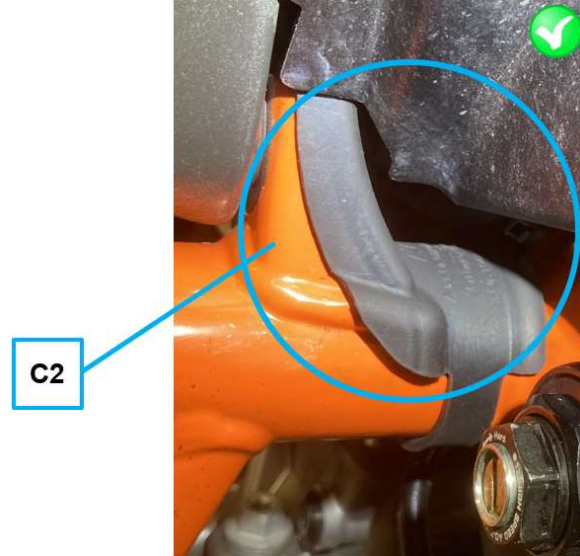
Area C2 (After): If the frame cover is missing you must update this area by installing the frame cover as shown here in photo C2. If needed order and install (p.n. 61703083000) – Frame cover  
(Take photo for claim)

8. Check the positioning of the wiring harness for contact-free mounting, only the cable tie with foot section, cable tie guide and the frame cover are permissible as contact points.
