Service Bulletin

Date: **5th January 2023**

Subject: **Headlight wiring harness**

Product:	Brutale 800 RR \ RC \ SCS \ ROSSO Euro 5	until VIN NV007262
	Dragster 800 RR \ RC \ SCS \ ROSSO Euro 5 fino a	until VIN NV007124
	BRUTALE 1000 RR Euro 4	All VIN
	BRUTALE 1000 RR Euro 5	until VIN NV001427
	BRUTALE 1000 RS Euro 5	until VIN NV001435
	BRUTALE 1000 NURBURGRING Euro 5	until VIN NV001398

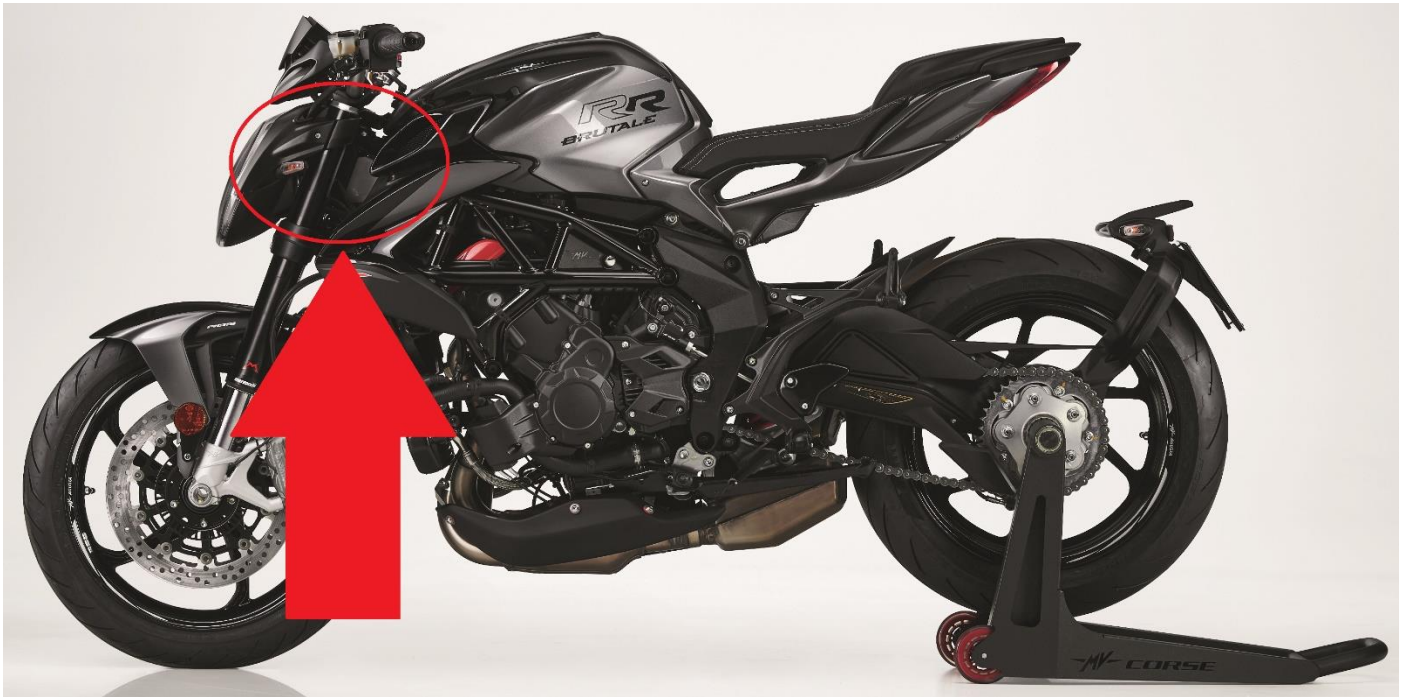
- Locate the final branch of the wiring harness leading to the headlight (left side of the motorbike):

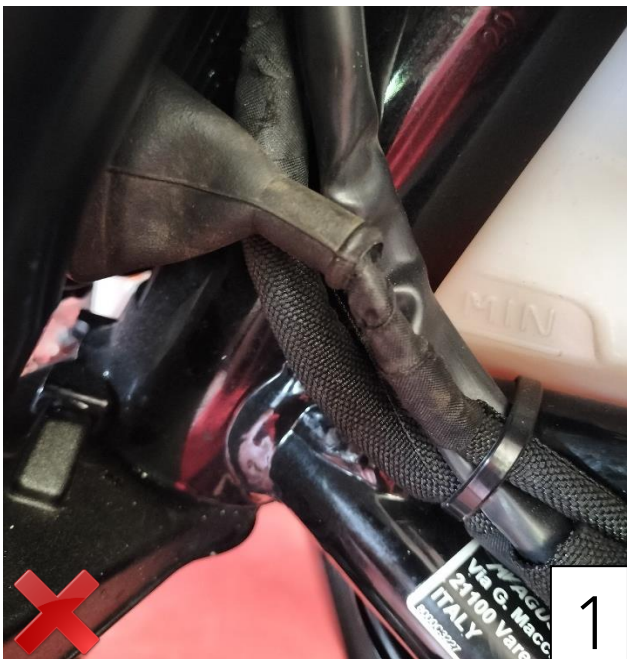
- Remove the protective cap from the headlight connector and check the integrity of the cables in the connector area and up to a distance of 10 cm from the connector by removing the protective sleeve.
If there is damage to the wiring of any kind, proceed directly to part no. 2
- **Check that the layout is the same as in figure 2 below**; if the cable has different positions, modify it by disconnecting the connector and positioning the wiring as in figure 2:

The headlamp wiring must be positioned inside the branch of the harness leading to the handlebar controls.

- If the wiring is already correctly positioned (fig. 2), no intervention will be necessary.
- Perform tests by moving the handlebar in both directions to check that the headlamp harness does not have too pronounced bends and that it maintains sufficiently large bends even under stress.

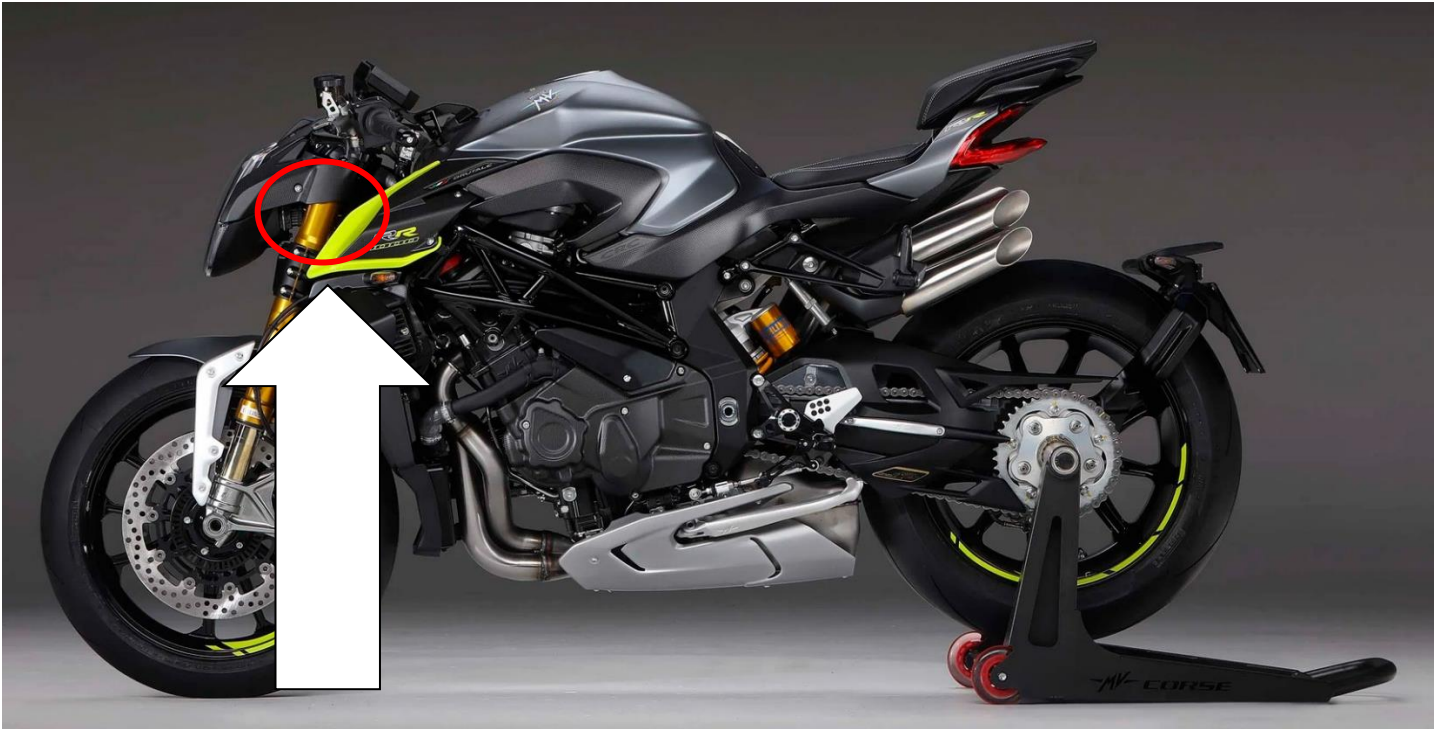
- Locate the final branch of the wiring harness leading to the headlight (left side of the motorbike):

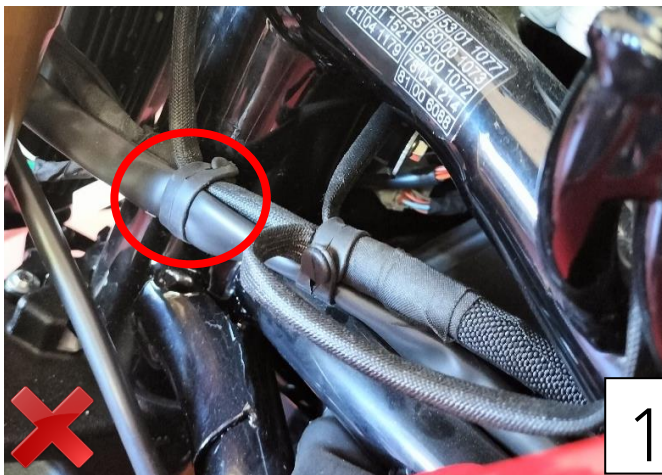
- Remove the protective cap from the headlight connector and check the integrity of the cables in the connector area and up to a distance of 10 cm from the connector by removing the protective sleeve.
If there is a damage to the wiring of any kind, proceed directly to part no. 2
- Locate the front L39 clamp and remove it to free the headlight wiring branch (FIG. 1); then reposition the L39 clamp at the same height, taking care NOT to include the headlight wiring in the fixing (FIG. 2):

- If the wiring is already correctly positioned (fig. 2), no intervention will be necessary.
- Perform tests by moving the handlebar in both directions to check that the headlamp harness does not have too pronounced bends and that it maintains sufficiently large bends even under stress.

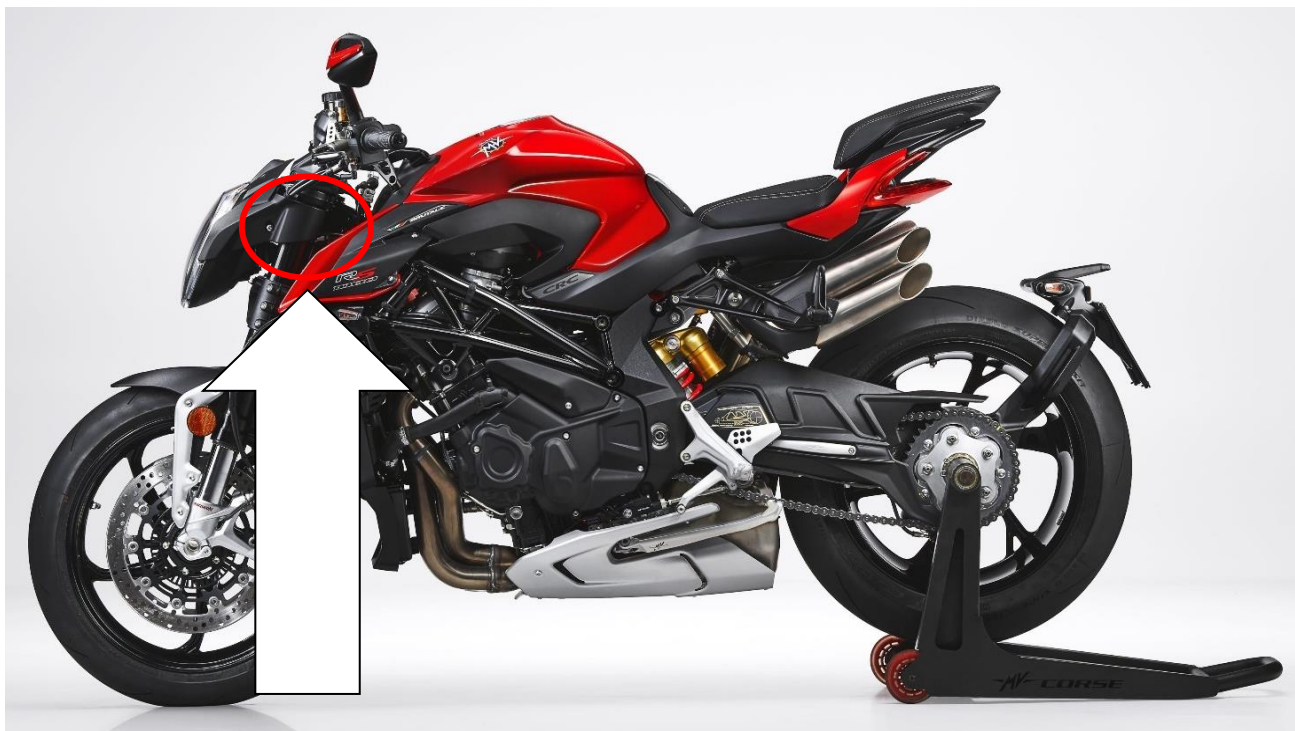
- Locate the final branch of the wiring harness leading to the headlight (left side of the motorbike):
