GROUP	MODEL
ELE	2013-2016MY Optima (TF HEV)
NUMBER	DATE
273	January 2023

TECHNICAL SERVICE BULLETIN

HIGH-VOLTAGE BATTERY SAFETY PLUG FUSE INSPECTION AND REPLACEMENT

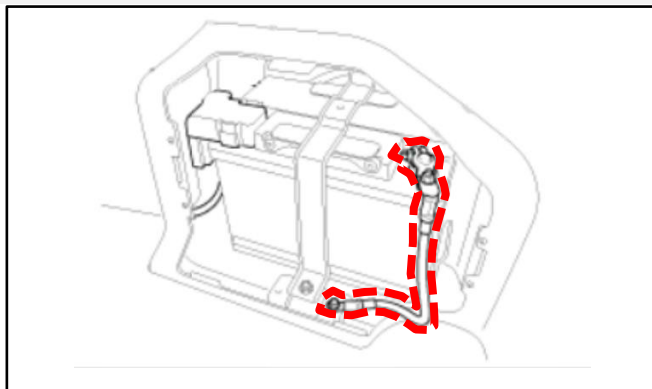
1. Disconnect the auxiliary 12V battery negative (-) cable located in the rear cargo area.

Failure to follow the High Voltage Shut-off Procedure may result in serious electrical injuries.

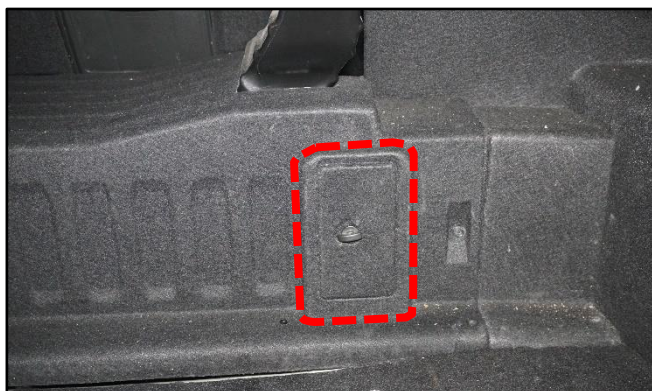
2. Open the High Voltage Battery (HVB) safety plug service cover in the rear cargo area.

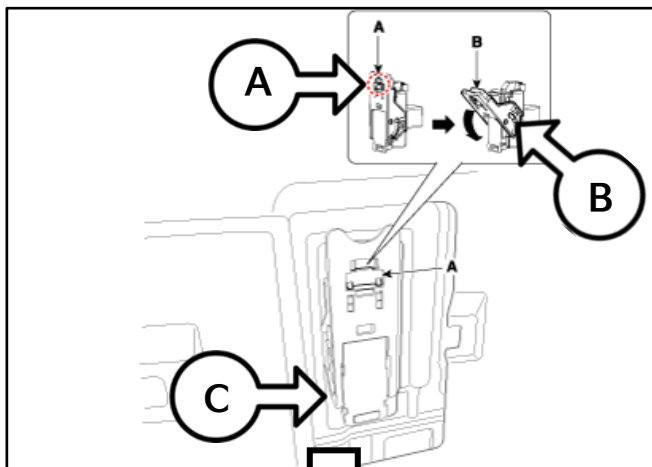
3. Unlock the lever hook (A).
4. Pull down on the lever (B).
5. Remove the safety plug (C).

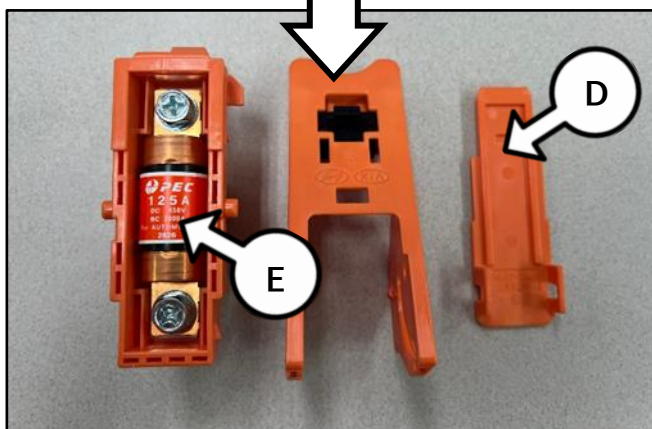
7. Using a flathead screwdriver, remove the safety plug cover (D) to expose the High Voltage (HV) main fuse (E).

Note: OPEC 125A/150A is the Kia genuine fuse.

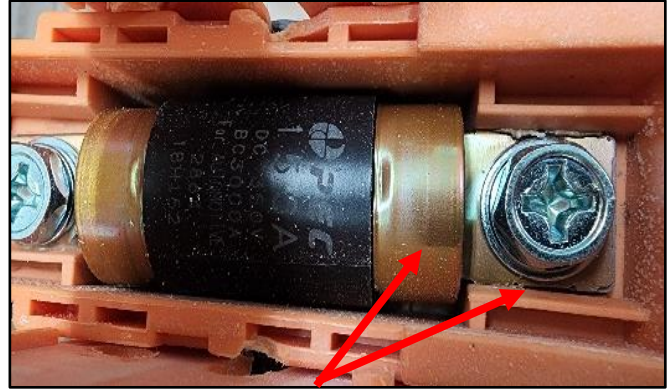
Thermal Deformation / Burnout

6. Inspect the HV main fuse for any trace of 'thermal deformation/burnout' and if the HV main fuse has been replaced with an aftermarket (non-genuine Kia) fuse.

- Thermal deformation or burnout is present, replace Safety Plug Fuse Assembly (150A) and skip to step 8.
- A 'non-genuine Kia' HV main fuse is present, replace Safety Plug Fuse Assembly (150A) and skip to step 8.
- No thermal deformation/burnout is present and the main fuse is a genuine Kia fuse, proceed to step 7.

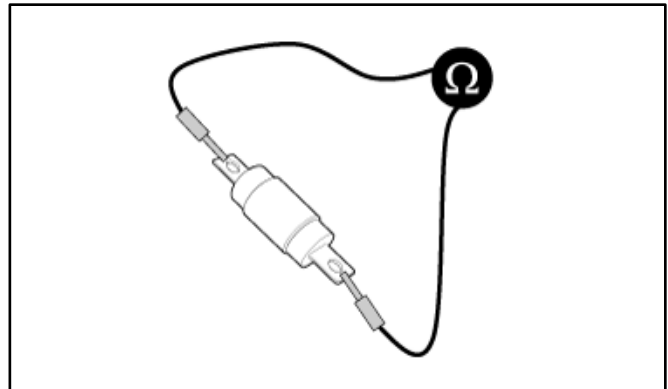
7. Using a multimeter, measure the HV main fuse resistance.

- Resistance is 1Ω or less (OK), refer to the applicable Shop Manual on KGIS for DTCs P1B77 and P1B25 to diagnose.
- Resistance is over 1Ω (NG), replace the HV Main Fuse only.
