GROUP	MODEL
Service Campaign	2022-2023MY Multiple Models Listed
NUMBER	DATE
SC252 (Rev 1, 01/04/2023)	December 2022

VOLUNTARY SERVICE CAMPAIGN

HECU INSPECTION /REPLACEMENT (SC252A/B/C)

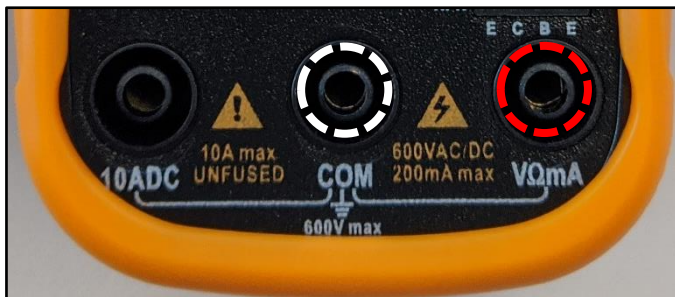
1. Connect two (2) lead wires (red and black) to the SST.

Black Ground (-) lead wire; connect to COM

Positive (+) lead wire; connect to VΩmA.

DO NOT USE THIS 10A PORT CONNECTION

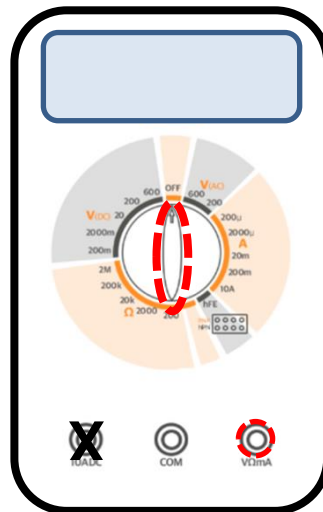
2. Turn the selection knob to the right and set it to **200uA**.

Select 200μ setting (Microamps)
