Incorrect fuses on Power Distribution Module (PDM) on Standard Rear Discharge Mixer

Date: January 12, 2023
Bulletin Name: MXR-TSB-031
Model: Standard Rear Discharge Mixer
Model Year: 2022

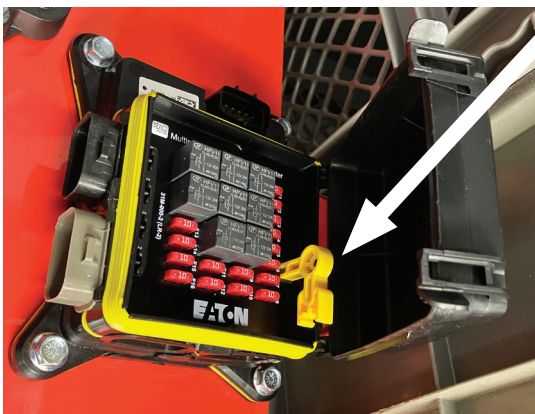
NOTE: A fuse removal tool (yellow tool shown below) is included with the PDM.

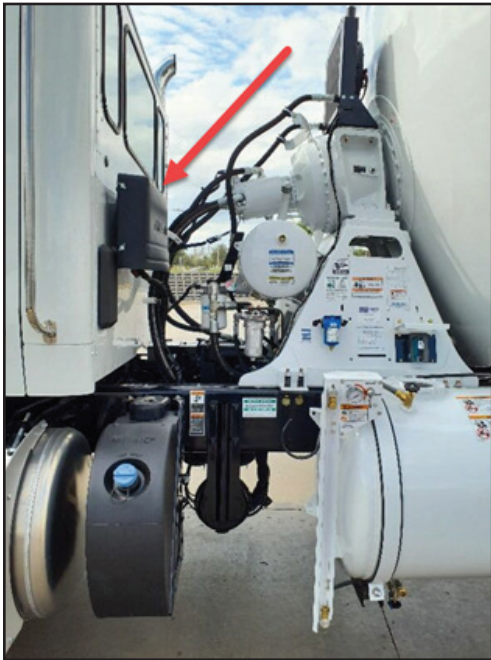
Figure 1

1. Perform your company's Lockout/Tagout procedure. If your company does not have a Lockout/Tagout procedure, follow OSHA 1910.147 and 1910.146 Confined Space as appropriate. Chock wheels and engage the service brake.
2. The PDM is installed as part of the FLEX module assembly and is located on the Standard Mixer truck on the back of the cab on the driver's side (as shown in Figure 1).

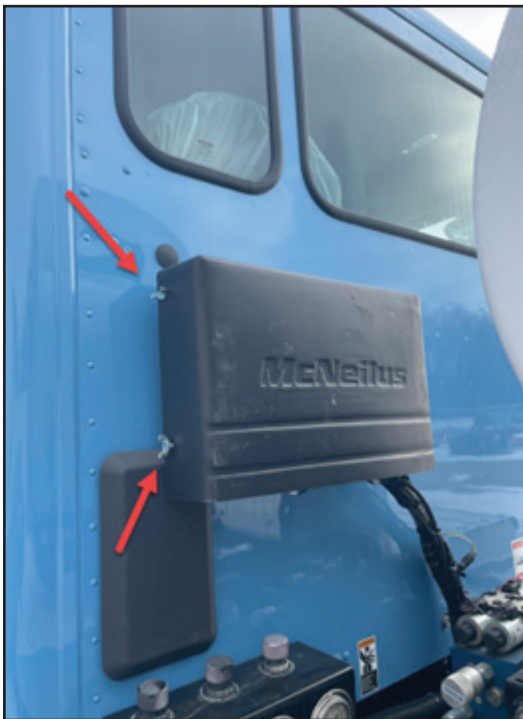
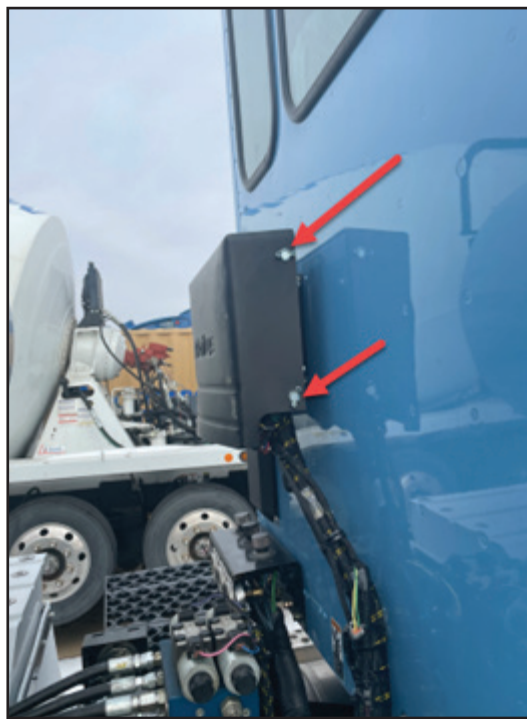
Figure 2

3. Remove the cover on the module assembly. Remove and retain the wing nuts that secure the cover on the assembly. See Figure 2.

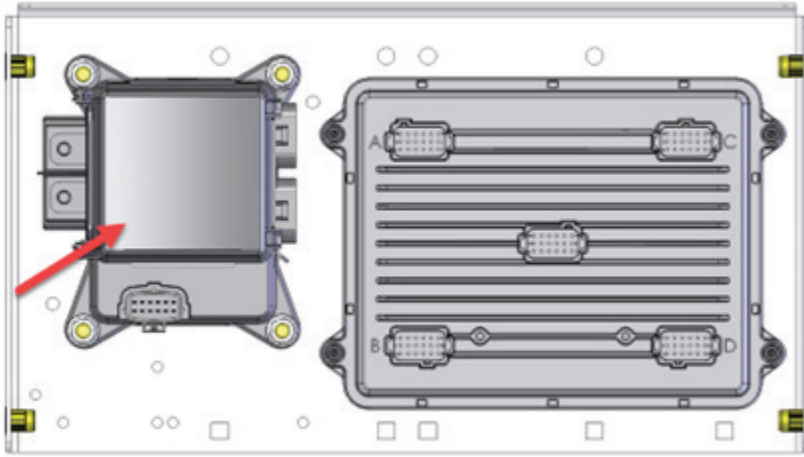
Figure 3 shows the PDM location in the assembly after the assembly cover is removed.

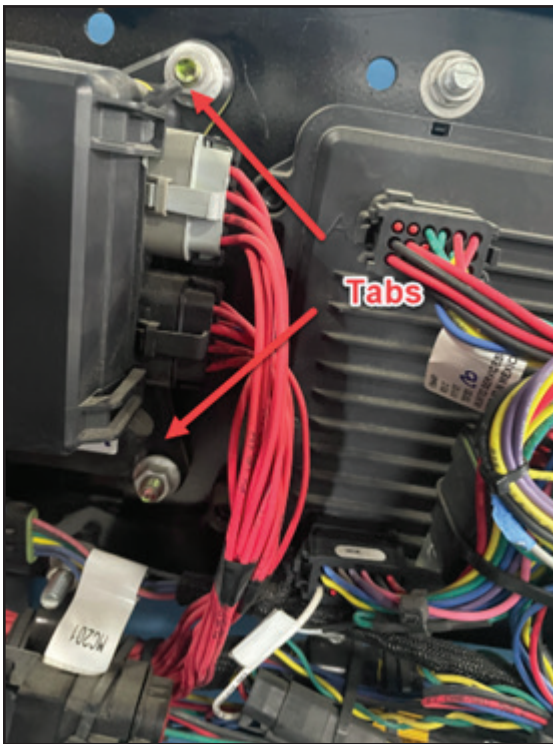
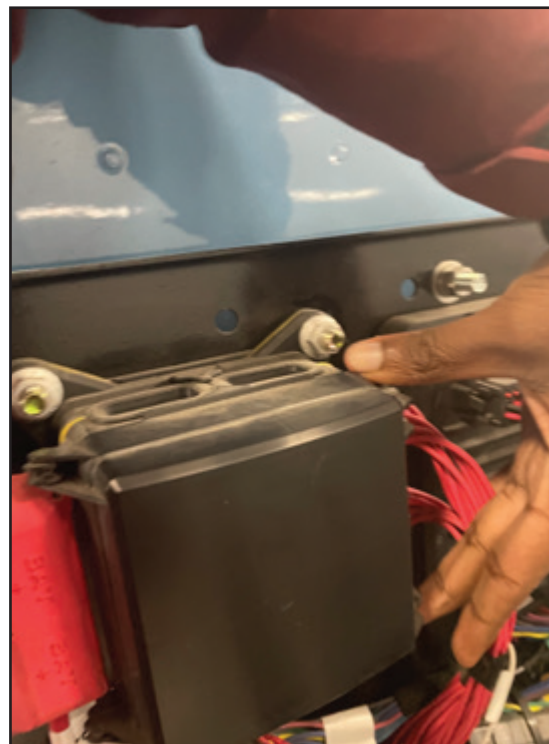
Figure 4

4. Open the PDM cover by pressing the tabs on the PDM cover as shown in Figure 4.
