Airstream Service Bulletin

Bulletin Number: 195

Product Line: Model Year 2020-2021 19' Caravel and 19' Bambi

Subject: Refrigerator Cabinet Securement Repair

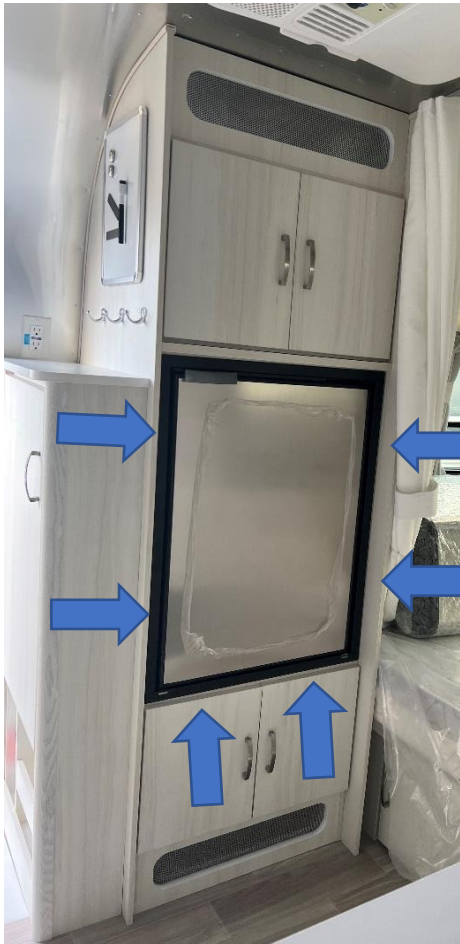
To add additional brackets, the refrigerator will need to be removed. There are six screws in the refrigerators faceframe that need to be removed to extract the refrigerator. Use a rug, or another protectant, to protect the flooring before setting the refrigerator down.

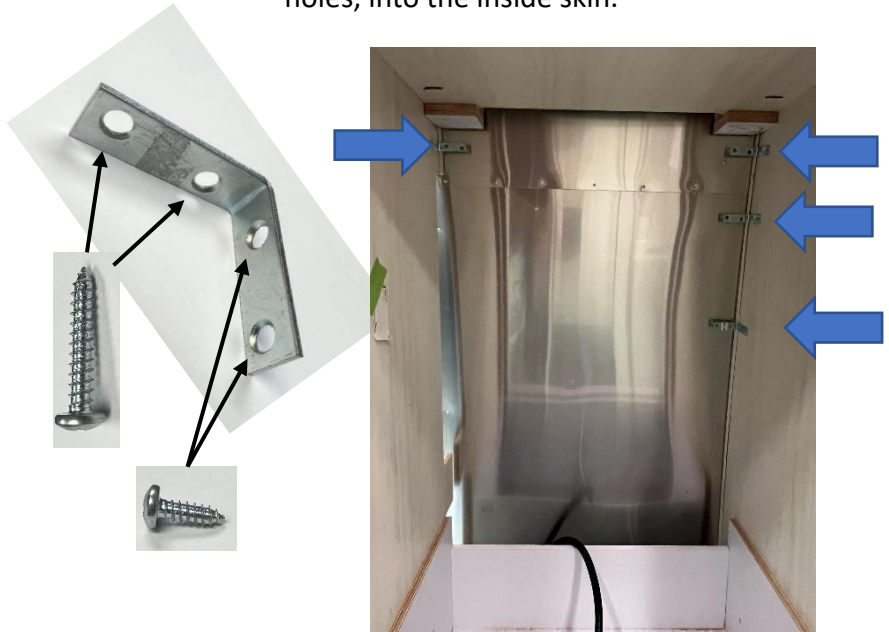
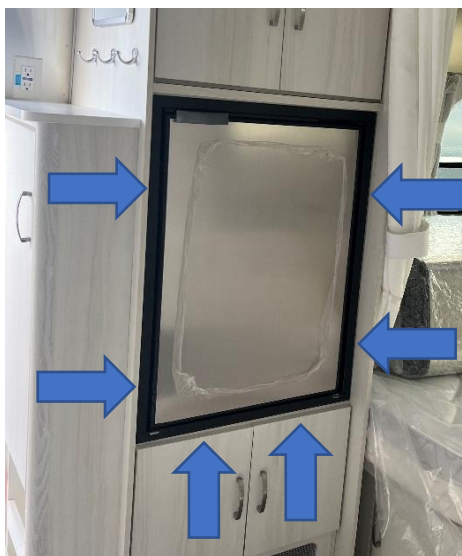
There should be a total of 4 brackets in the back of the cabinet. If there is less than 4, you will need to add additional 2" brackets (380264) to the areas indicated. Use #8, 1/2" screws (320035), through both holes of the bracket, into the wood panel. Use #8, 1" screws (320005), through both holes, into the inside skin.

If there is already 4 brackets installed, or after the additional brackets have been installed, place the refrigerator back into the cabinet and resecure the 6 faceframe screws.

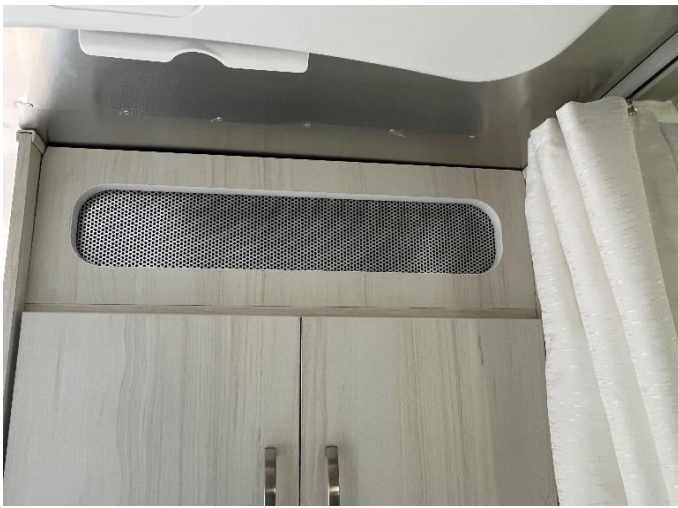
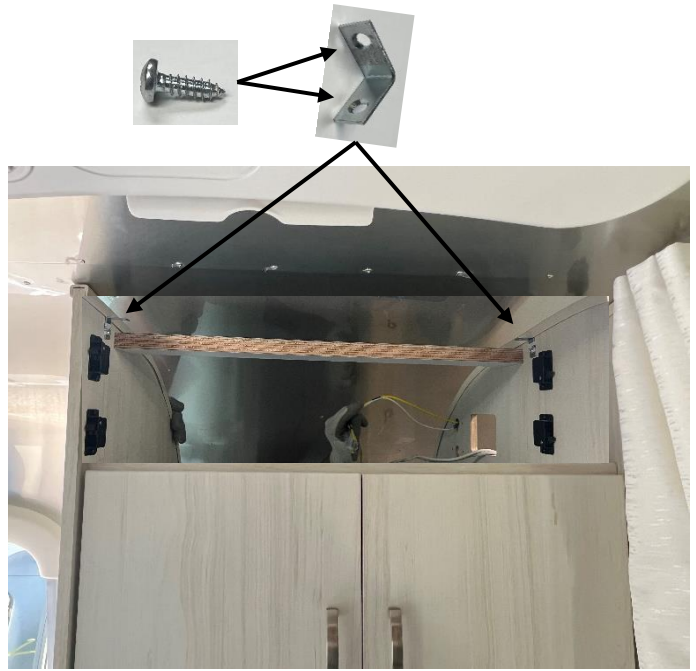
Two 1" brackets should be installed behind the refrigerators vent. This panel has 4 latches holding it in place. To access, pull the top vent board off by grabbing the bottom of the vent screen and pulling straight out.

The two, 1" brackets (380041), will need to be installed, if they are not already. Use a 1/2" screw (320035), in the bracket hole to the wood panel, and a 1" screw (#320005), in the bracket hole to the interior skin.

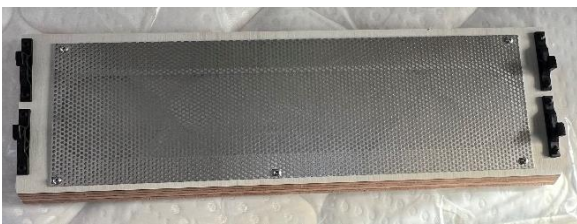
Reinstall the vent panel, by lining up the latches and pressing it back into position, above the refrigerator.
