Technical Service Bulletin

66 Exterior black optic trim is discolored

66 23 95 2060333/3 January 26, 2023. Supersedes Technical Service Bulletin Group 66 number 20-67 dated October 16, 2020, for reasons listed below.

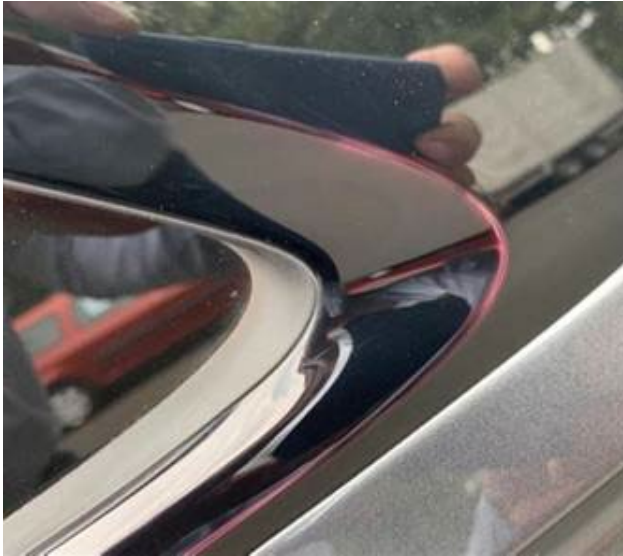
- The exterior trim on a vehicle with black optic package is discolored. It appears to take on a red or purple hue and, in some cases, may take on a grey or metallic appearance.

The ultraviolet radiation resistance in the trim coating was found to be insufficient.

Figure 1. The black optic trim takes on a red, purple, grey, or metallic hue.

- Should the symptom described in this TSB present as described, then replace the affected trim. Any other symptoms on a black optic trim piece or an issue with a non-black optic trim piece may require AASM authorization as specified in the Warranty Policies and Procedures.

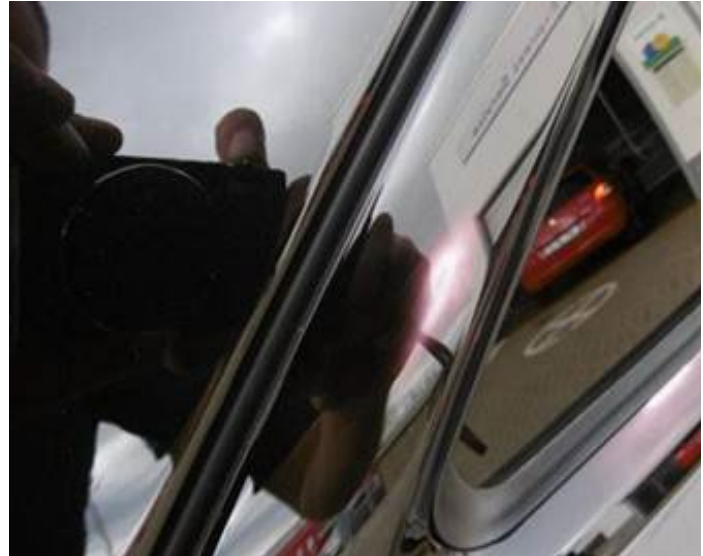
Figure 2. An additional example of the trim discoloration.

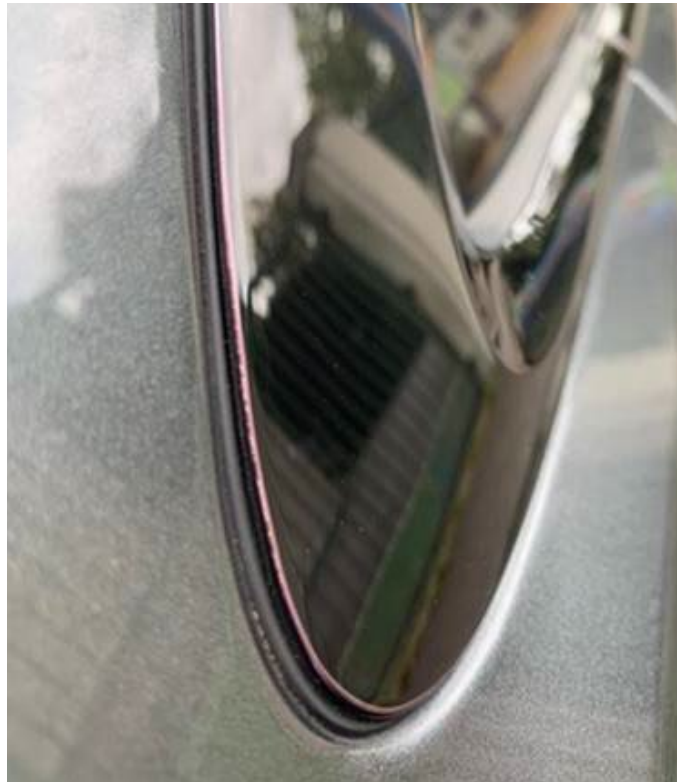
Figure 3. Discolored black optic trim around the rear side window.
