Technical Service Bulletin

92 Rear view camera washer operates with difficulty

92 23 32 2059228/3 January 19, 2023. Supersedes Technical Service Bulletin Group 92 number 22-27 dated February 7, 2022, for reasons listed below.

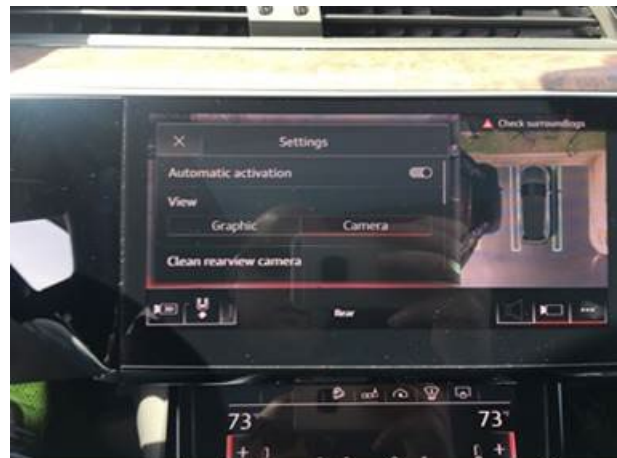
- When the 'clean rearview camera' function is activated, the washer fails to spray solvent (Figure 1).
- The function must be activated several times before the solvent is sprayed.

Figure 1. Clean rearview camera function being displayed.

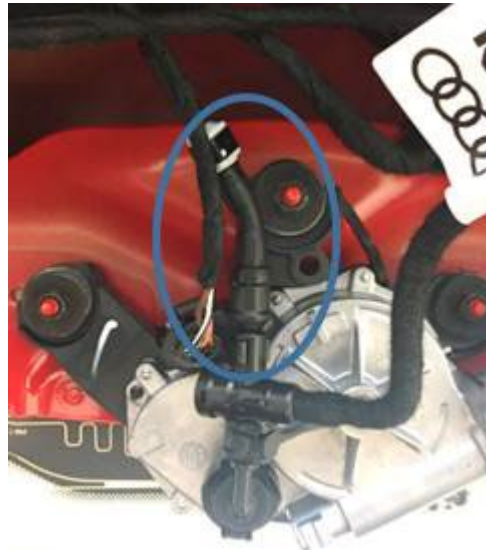
Figure 3. Check valve assembly installed on the e-tron model.

2. Fit the 4N0 955 481 A valve end of the assembly to the 'T' section of the manifold and the 5M0 955 875 coupling piece end to the removed washer line as shown in the illustration. It should now be installed in line with the original assembly (Figure 3).

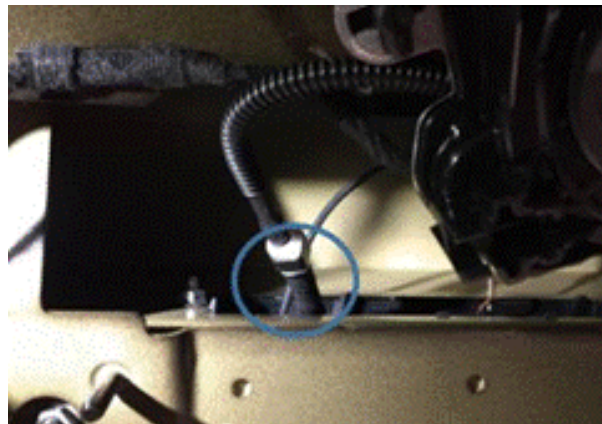
Figure 4. Check valve assembly installed on the e-tron Sportback model.

3. Fit the 4N0 955 481 A valve end of the assembly to the male fitting at the inside of the rear lid handle and the 5M0 955 875 coupling piece end to the removed washer line as shown in the illustration. It should now be installed in line with the original assembly (Figure 4).
