SERVICE BULLETIN

APPLICABILITY: All Models

NUMBER: 02-191-22R

SUBJECT: Genuine Subaru Alternative Engine Oil Filter Replacement

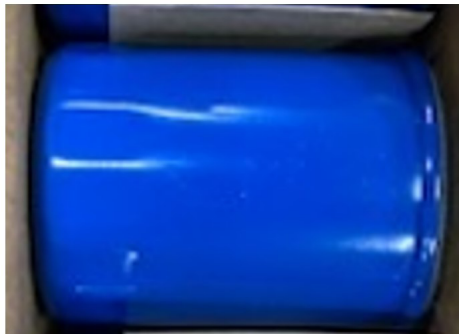
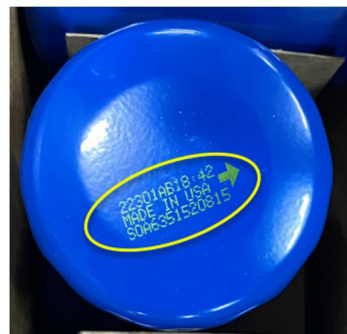
The genuine Subaru alternative filters have a square cut seal, are blue in color, and have the part number printed on the top.

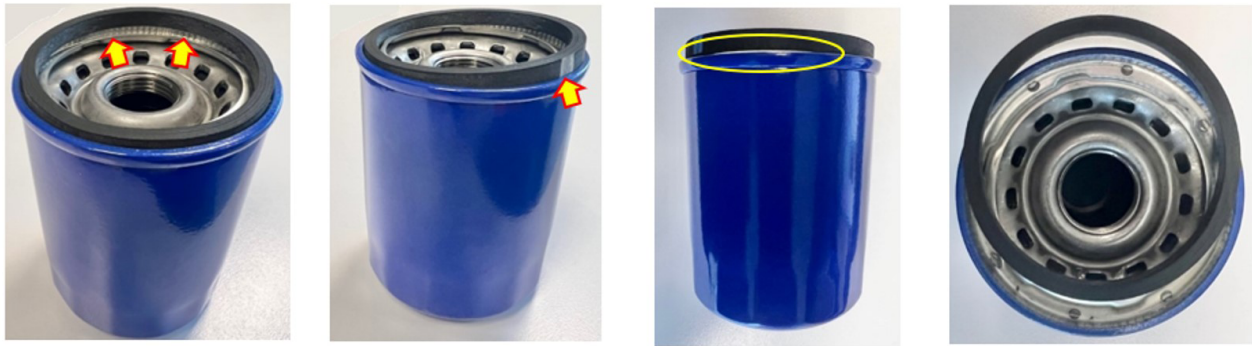
IMPORTANT NOTE: It is possible for the oil filter seal to become dislodged or misaligned during shipping and handling (see example images below). If this situation occurs, inspect the seal and mating surface for any visible damage.

If any damage is found, replace the filter. If no damage is found, the seal may be refitted to the filter and installed on the vehicle.

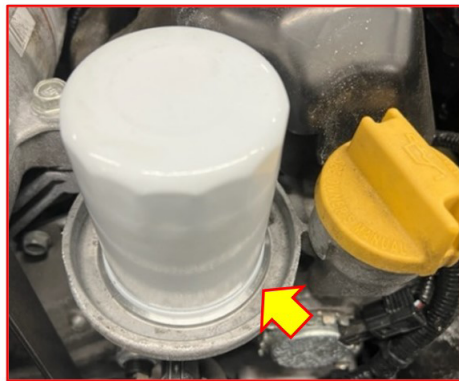
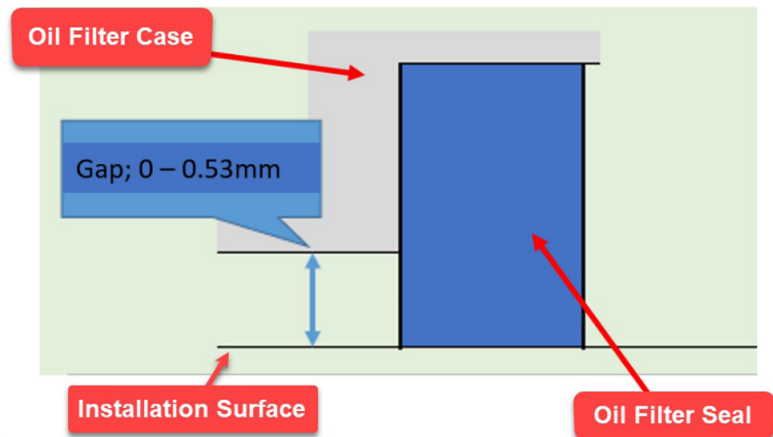
IMPORTANT NOTE: It is possible there may be a gap between the filter case and the installation surface (0-0.0209 inch / 0-0.53mm). This is a normal condition. Further verification can be achieved with the use of a 0.022 inch (0.56mm) sized feeler/thickness gauge. This sized gauge should be unable to be inserted in this gap.
