Service Bulletin

Bulletin No.: 22-NA-017

Subject: Liftgate Paint Peeling or Chipping at Applique

Brand:	Model:	Model Year:		VIN:		Engine:	Transmission:
		from	to	from	to		
Chevrolet	Suburban	2021	2022			All	All
	Tahoe

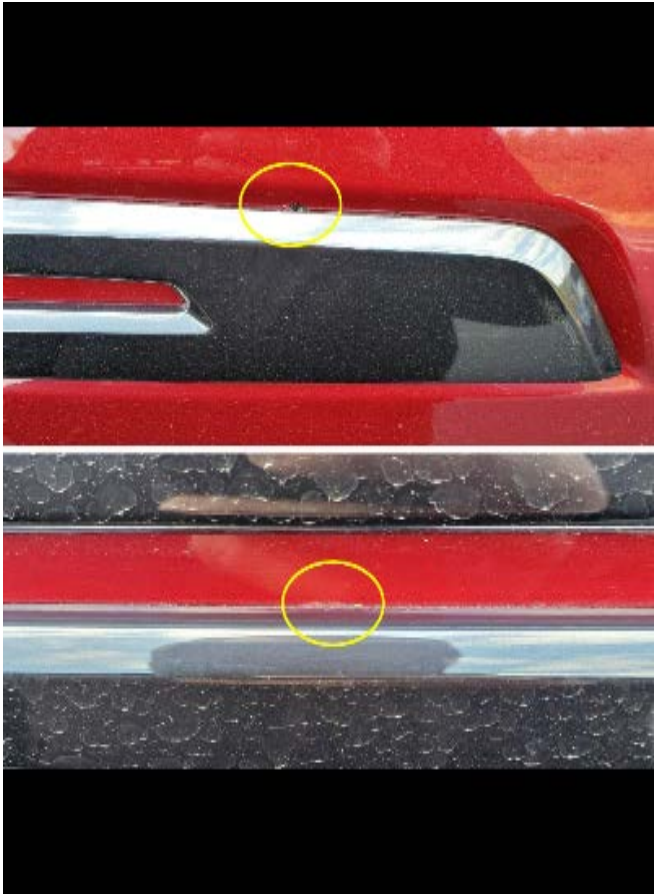
<p style="text-align: right; font-size: small;">5969025</p> <p>Some customers may comment on seeing paint peeling, or chipping on the liftgate, where the black/chrome applique attaches.</p>
Cause	The cause of the condition may be interference contact between the applique and the painted surface.
Correction	Replace the rear closure center applique, the emblem applique (gray and green parts) and refinish liftgate as necessary.

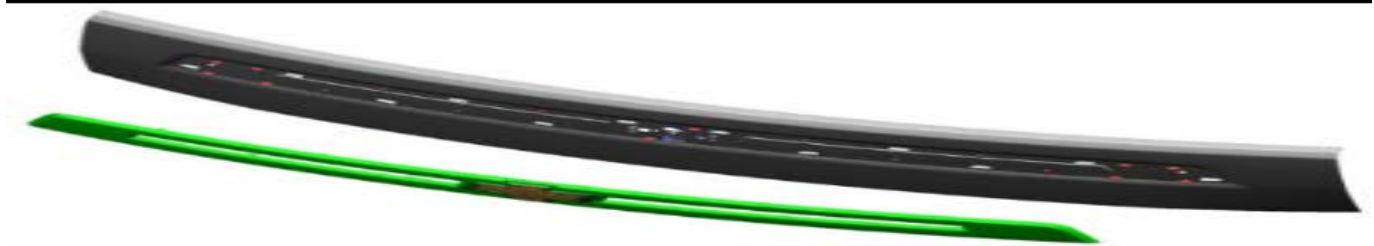
5985319

Tip: The applique kit will **replace both the grey and green part shown below**, as an assembly.

Causal Part	Description	Part Number	Qty
N/A	APPLIQUE KIT-RR CLSR CTR	86823363	1
