# QUALITY ACTION

## CAMPAIGN BULLETIN

### Wheel Center Cap Dealer Inventory

Reference: PC942

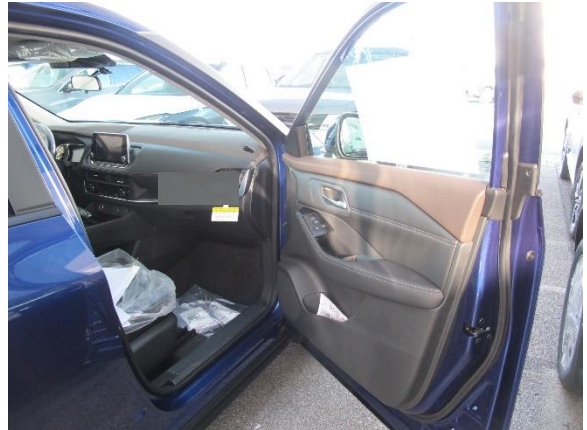
Figure 1

1. Open the front passenger door.

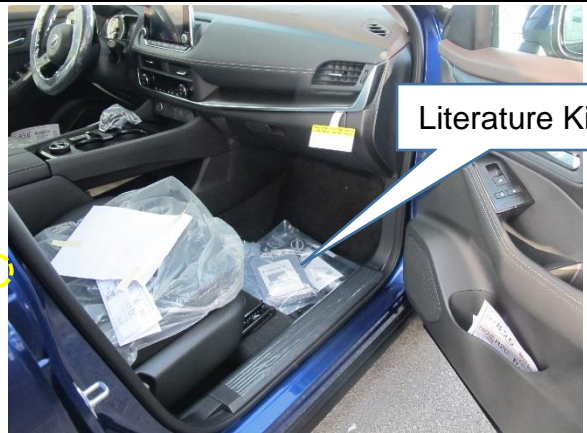
Figure 2

2. Locate the Literature Kit (Lit Kit).

- Usually found on the passenger floor or passenger seat

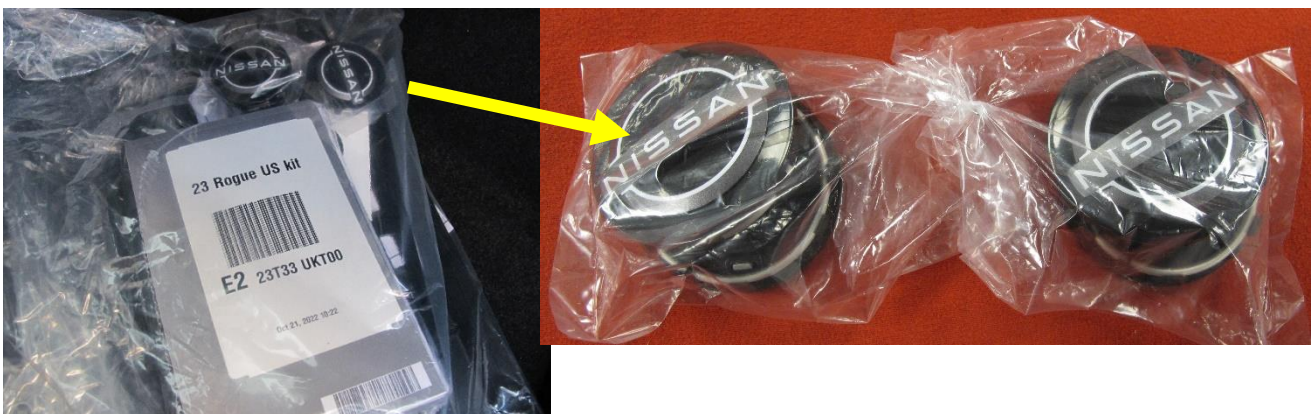
Figure 3

3. Open the Lit kit and pull out the wheel caps.

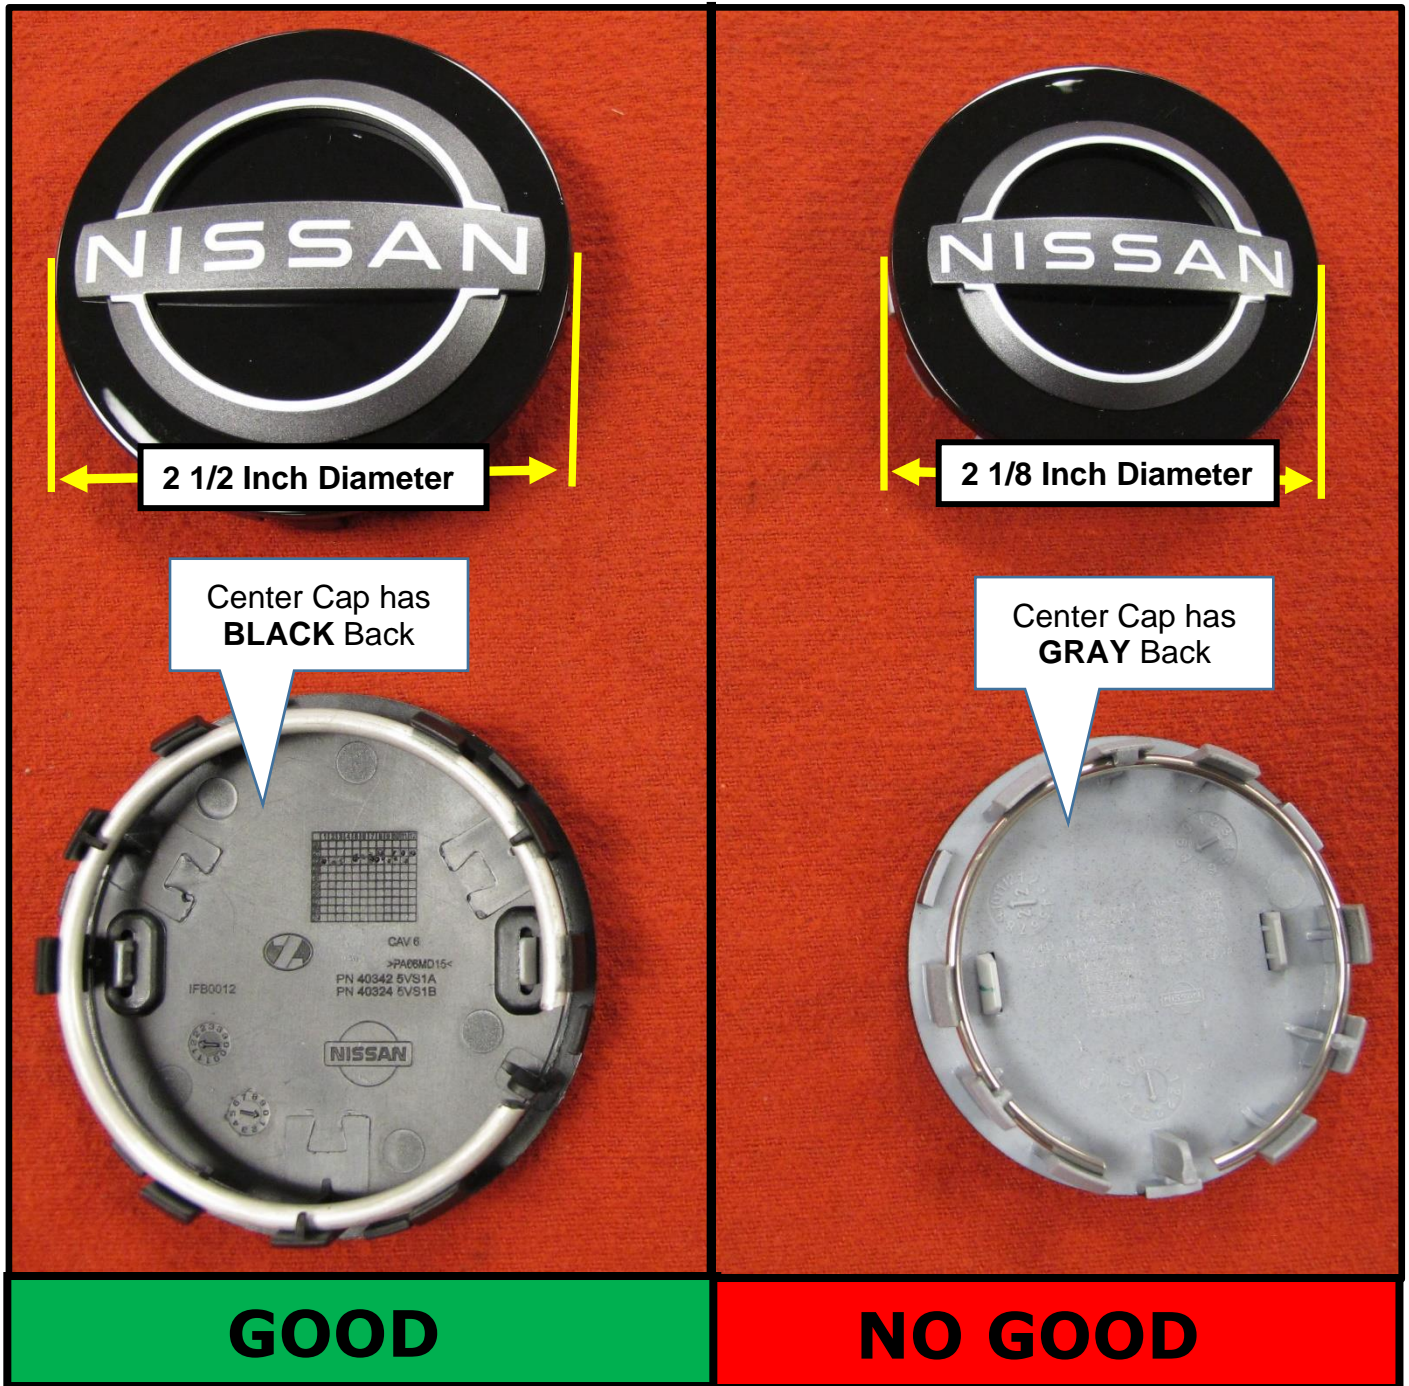
4. Inspect all (4) wheel caps to verify they are correct for the Rogue.

- Refer to Figure 4 below for inspection criteria

5. Are the wheel caps GOOD as shown in Figure 4?

- **YES** => No Further action is required. Submit claim per Claims Information
- **NO** => Scrap the wheel caps from the Literature Kit and order (4) new wheel caps using the part number listed in Claims Information

**NOTE: Only order replacement wheel caps if inspection result in Step 5 is NO GOOD.**
