# Technical Service Bulletin

## 46 Brake noise analysis and handling

46 23 41 2034181/23 February 7, 2023. Supersedes Technical Service Bulletin Group 46 number 22-34 dated August 11, 2022, for reasons listed below.

Model(s)	Year	VIN Range	Vehicle-Specific Equipment
All Audi Vehicles	2012 – 2023	All	Not Applicable

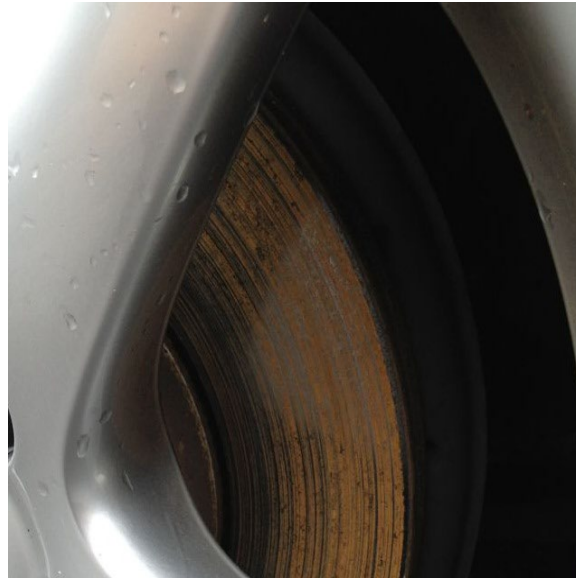
5. Discs are covered with rust. Rust can form when the vehicle has not been driven for a long period of time (Figure 1).

**Figure 1.** Disc covered with rust.

1. **Check the overall condition of the brakes** to determine if the brake noise is caused by one of the causes listed in the *Technical Background* section of this bulletin. If the noise is not a result of one of these causes, proceed with the following steps 2-4.
2. **Determine the location of the brake noise** (e.g., left front, front axle, rear axle, etc.):
  - Knowing the location of the noise on the vehicle is critical to properly addressing the concern.
  - It may be necessary to have an assistant listening from inside or outside of the vehicle to accurately determine the location.
3. **Obtain a sound or video recording and fill out the questionnaire:**

A) With careful consideration of the traffic situation, perform up to 5 ABS stops from speeds above 50 mph. Between each ABS stop, allow the brake components to cool by driving the vehicle for more than one minute at speeds greater than 50 mph.

B) Let the vehicle sit for two hours to cool down.

C) Manually clean all the brake components. Remove all brake dust from components (springs, retaining clips, pistons, caliper, pins, etc.).

Clean all contact points between pads/clips/caliper and add the correct lubrication paste to the contact areas (review ELSA for the correct paste for each application).

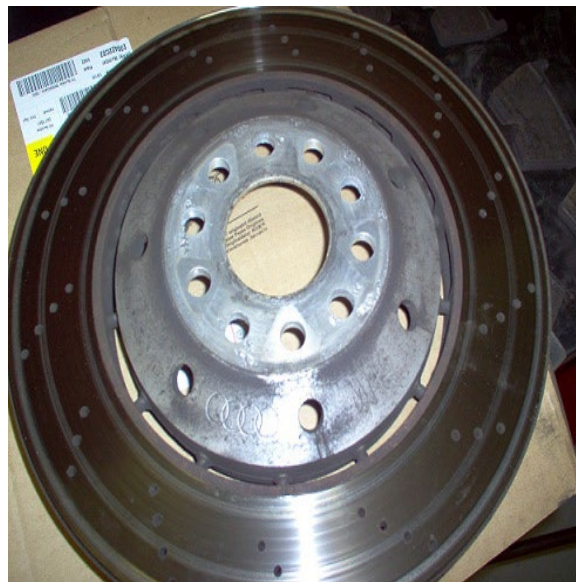
6. Discs are grooved (Figure 2).

**Figure 2.** Grooved disc.

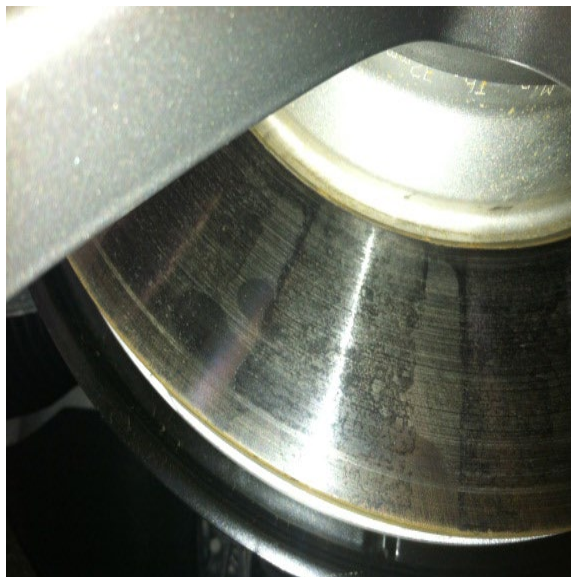
7. There is chemical contamination on the braking surface of the brake disc due to wheel or tire cleaner being sprayed directly onto the brake disc (Figure 3 and Figure 4).

**Figure 3.** *Discoloration on the brake disc due to chemical contamination from the cleaner that was sprayed directly onto the disc.*

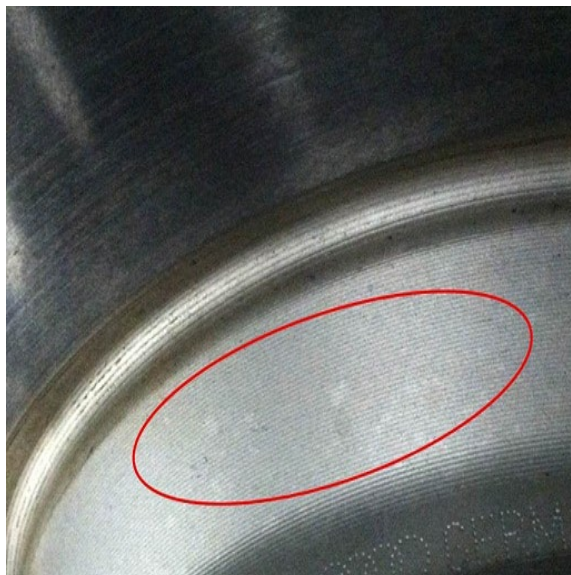
**Figure 4.** *Small spots and discoloration due to chemical contamination from the cleaner that was sprayed directly onto the disc.*

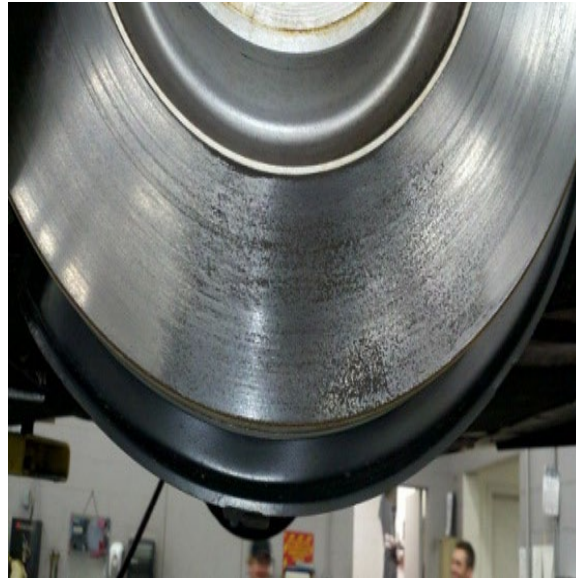
8. There are “pad marks” on the brake disc as a result of brake pad material transferring to the discs (Figure 5). Pad marks can occur when a vehicle has been parked for long periods of time in a wet or snowy environment.

*Figure 5. Brake pad material has transferred to the discs.*

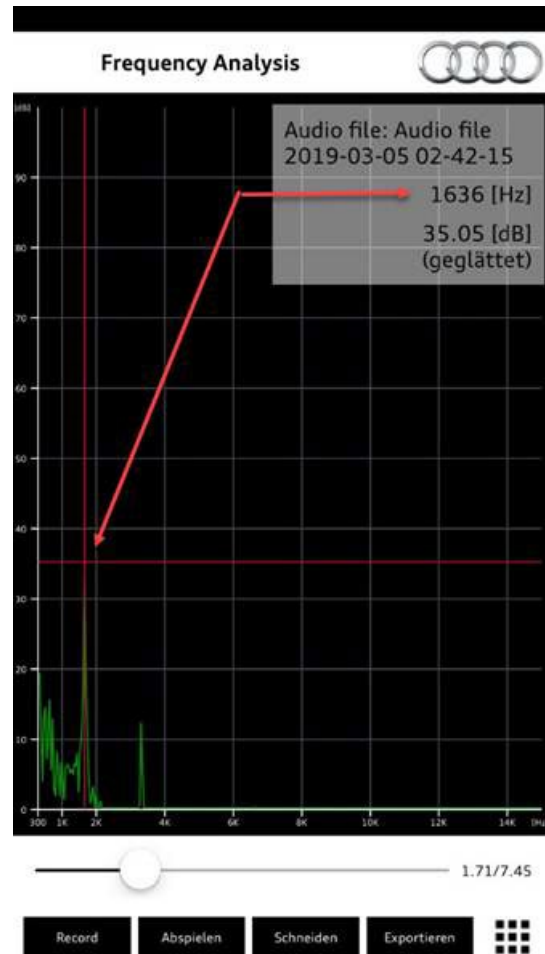
- Completed Brakes Acoustic Questionnaire.
- Sound or video recording (sound recording preferred from Audi frequency app, see TSB 2051095: *Audi frequency analysis*).
- Frequency analysis (screenshot preferred showing peak frequency, see figure 6).

Figure 6. Example of a frequency analysis screenshot.

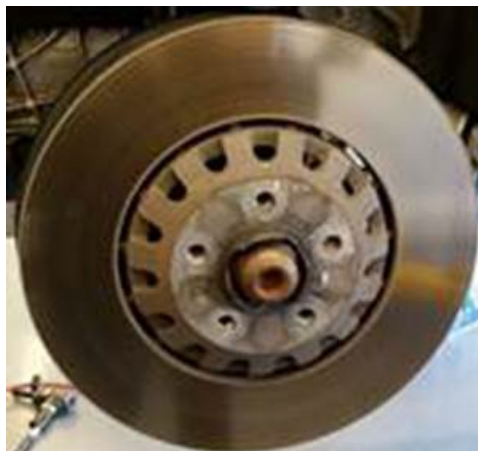
- Photos of the affected brake discs and pads that clearly show the condition of the braking surface (see Figures 7 through 11).
-

**Figure 7.** Example of the whole disc.

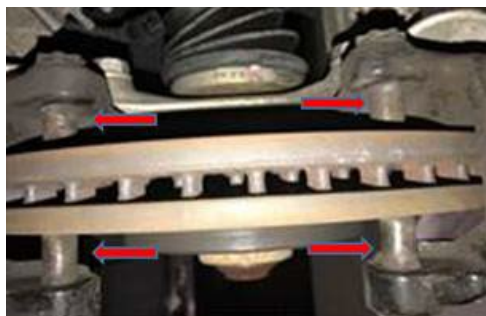
**Figure 8.** Example of brake system equipped guide pins (showing all 4 guide pins).

- A) 1.6 KHZ to 1.7 KHZ from front brakes. Inspect front discs.
- B) 3.2 KHZ from front brakes. Inspect and if needed, suggest to clean and lube the guide pins in the caliper carrier using anti-seize paste G052560A2.
- C) 7.8 KHZ from front brakes. Inspect front pads.

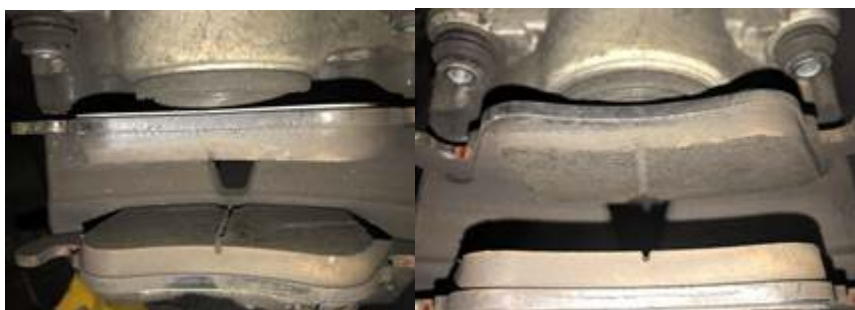
**Figure 9 and 10.** Example of Inner and outer with an adhesive pad.

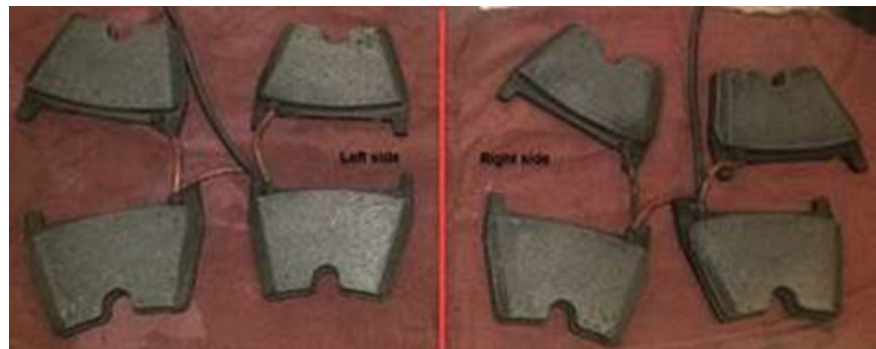
**Figure 11.** Example of pads without adhesive (mark position for reinstallation if not replaced).
