Preliminary Information

PIP5889A Diagnostic Tip: DTC P0299 Set As Current Or In History Models

Involved Region or Country:	North America
Condition:	DTC P0299 set as current or in history
Cause:	Possible Charge Air Bypass Valve sticking open intermittently.

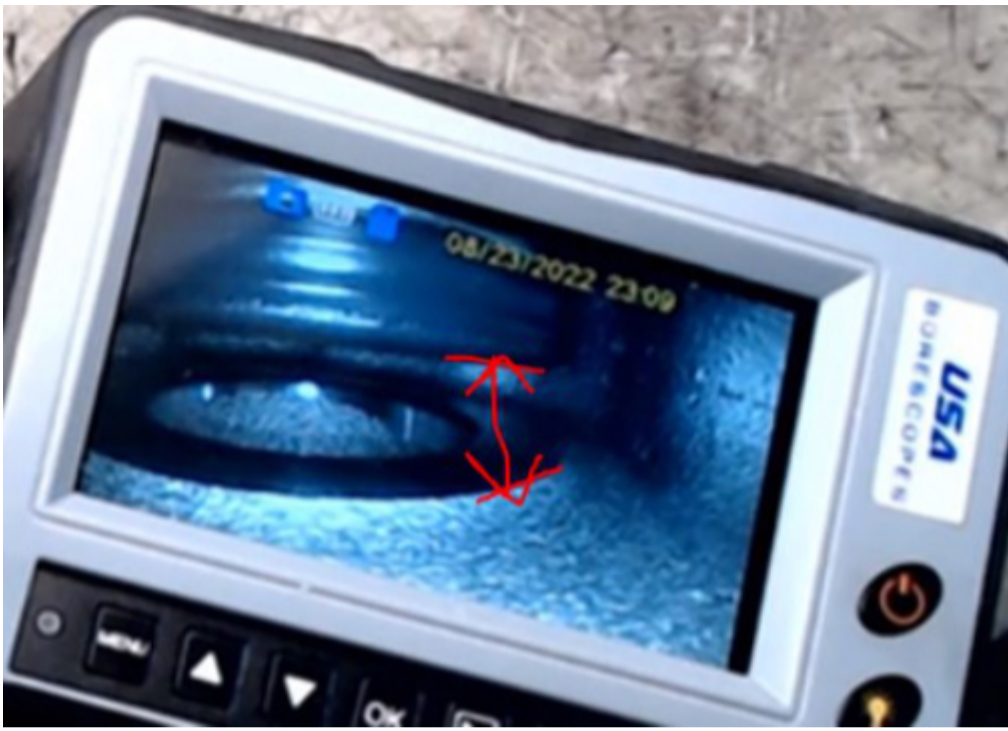
The bore scope picture below is showing the Charge Air Bypass Valve in a stuck open position.

If no damage has been identified with the compressor wheel use the bore scope and inspect the Charge Air Bypass Valve for possibly being in the stuck open position.

Note: The Charge Air Bypass can stick open intermittently so it's recommended to use the bore scope for the inspection as attempting removal could unstick the valve causing it to return to a normally closed position.

If the Charge Air Bypass Valve is found to be stuck open or is causing an intermittent DTC p0299 replace the Charge Air Bypass Valve using current service parts listed in EPC.

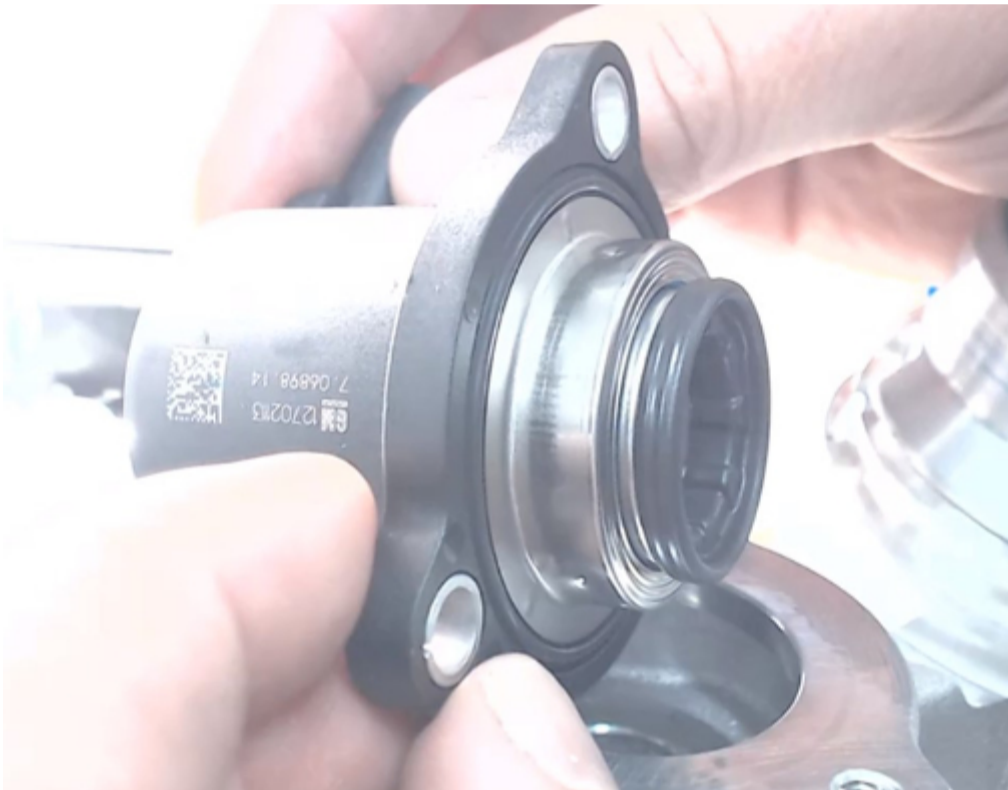
Picture below shows Charge Air Bypass Valve in stuck open position (plunger fully retracted)

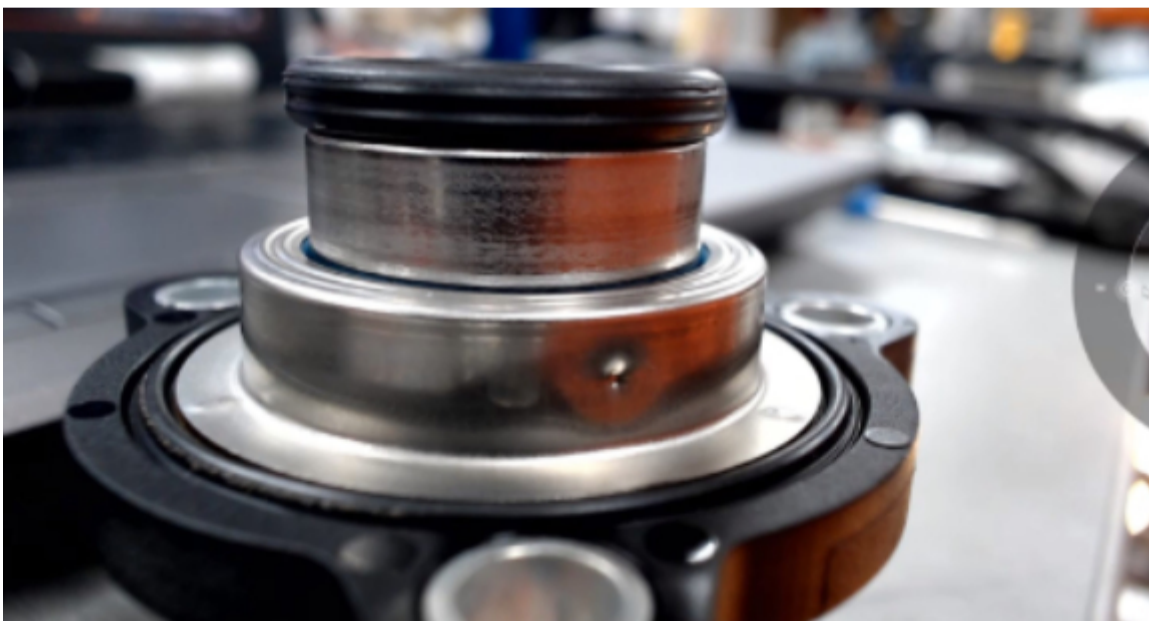
Picture below shows Charge Air Bypass valve fully extended or closed position
