Preliminary Information

**PIT5966A OTA Download 0 Percent Complete / No Crank / Dead Battery / N222379480
N22236683 N222386380 N22236410 N22236365 N222382220**

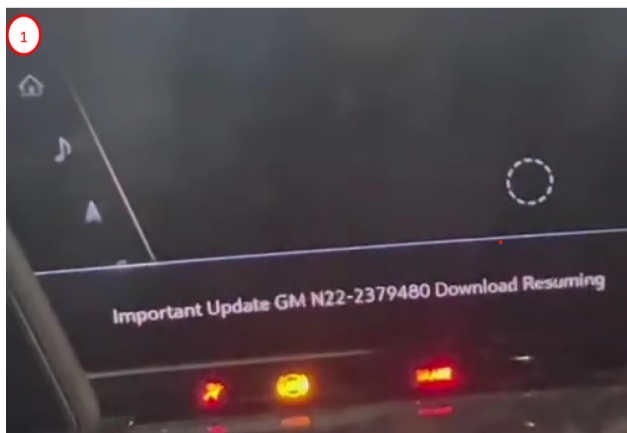
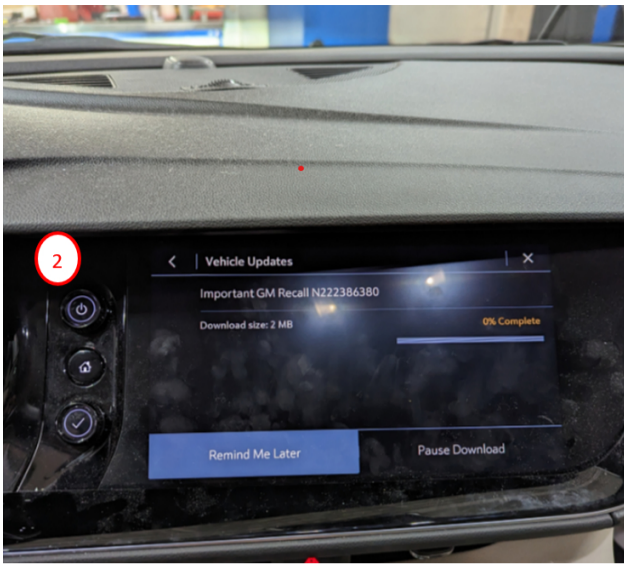
Involved Region or Country	North America
Condition	<p>Some customers may comment on any of the following complaints after an Over The Air (OTA) update:</p> <ul style="list-style-type: none"> - No Crank due to a dead battery. Vehicle will start and run after the battery is charged. - Intermittently at start up the radio display may momentarily display "Important Update Download Resuming", example shown below (1). - When checking the Vehicle Update screen it will show an OTA available and at 0% Complete, examples shown below (2 and 3). <p>NOTE: These messages will indicate which OTA is being downloaded examples: N222379480, N22236683, N222386380, N22236410, N22236365, N222382220. Not all OTA campaign numbers will show up in Global Warranty under Required Field Actions.</p>
Cause	The cause of these concerns could be the OTA is stuck in a download.

This condition only applies to a specific list of vehicles. If you have a vehicle, that has these symptoms, please perform the following to reset the OTA and clear the messages:

1. Charge the vehicle battery and test for a good battery. Then confirm the vehicle will start and run.
NOTE: When connecting the negative battery charger lead, use a solid engine ground or the ground stud in the engine compartment that is connected directly to the battery negative cable/terminal/post. Do NOT connect the battery charger lead directly to the negative battery post.

2. Go into vehicle settings and verify under "Vehicle Updates" that it shows an OTA available and 0% Complete. Record the campaign number that is shown.
NOTE: If the vehicle does not power up or start once the battery is charged, then this procedure does not apply and perform normal SI Diagnostics.

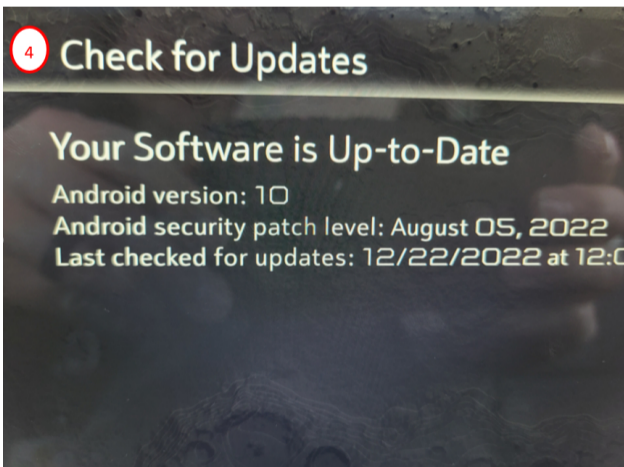
6. Once the confirmation message has been received back from TAC, allow the vehicle to remain undisturbed for 2 hours.
7. After 2 hours, start the vehicle and verify no update messages are shown on the radio display, but more importantly, go back into vehicle settings and check the "Vehicle Update" screen to make sure there are no OTA's available, examples shown below (4).
NOTE: This is only an example showing your software is up to date and the version or dates will vary.
