NUMBER: 23-001-23

Easy Entry and Fold Flat Seats Inoperative

This bulletin involves inspection and adjusting the cables for the easy entry/exit and fold flat 2nd row seats. If the cables can not be properly adjusted, then they will need to be replaced.

2022 - 2023 (WS) Grand Wagoneer/Wagoneer

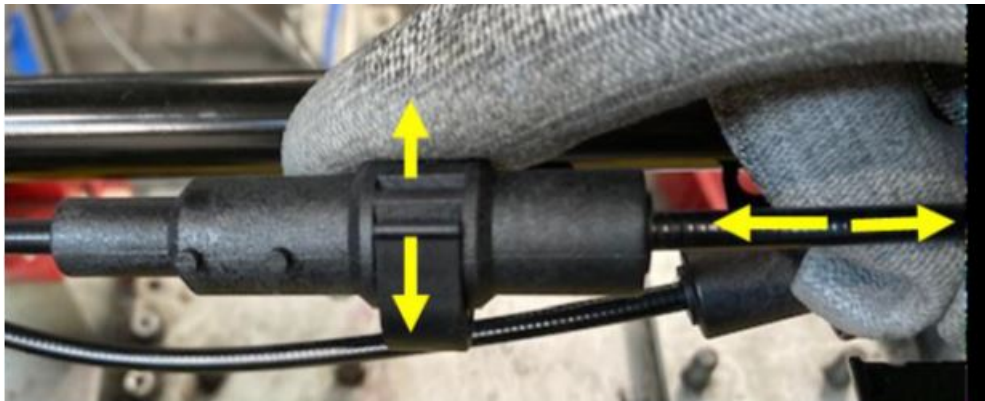
Fig. 1
Easy Entry Cable Adjusters

7. Remove the seats' lower side shields of the 2nd row seat that doesn't operate properly. Refer to the detailed service procedures available in DealerCONNECT> Service Library under: Service Info> 23 - Body / Seats, Second Row / Side Shields / Removal.
8. Check if the cable **adjusters** are fully locked in place. Lock tab must be pushed up completely ([Fig. 1](#)) .

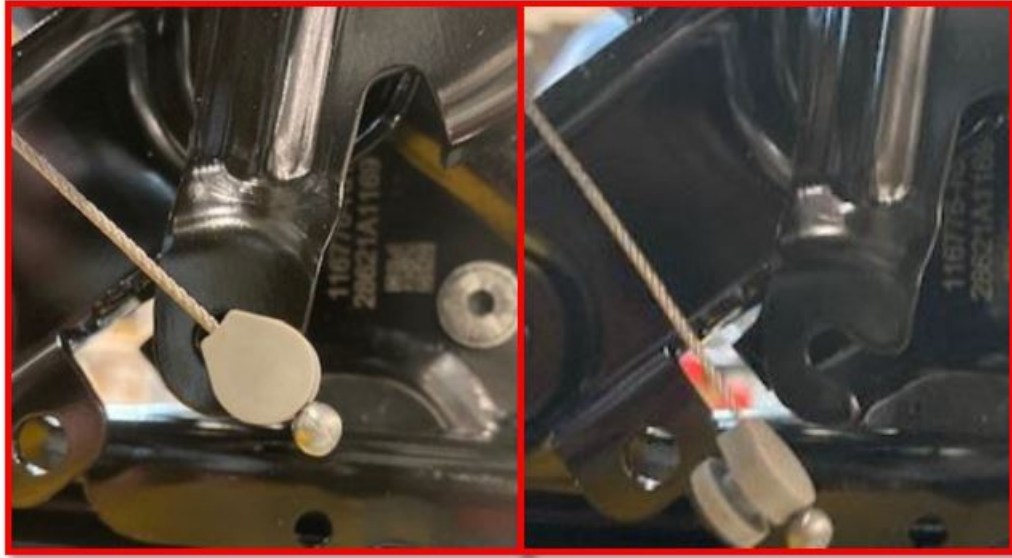
Fig. 2
Cable Ends Not Installed Properly

9. Check if the cable **ends** are completed locked in place. If the cable end is properly locked in place, it should be able to be turned. If cable ends are loose or not fully seated use pliers to lock cable end into the bracket (Fig. 2) .

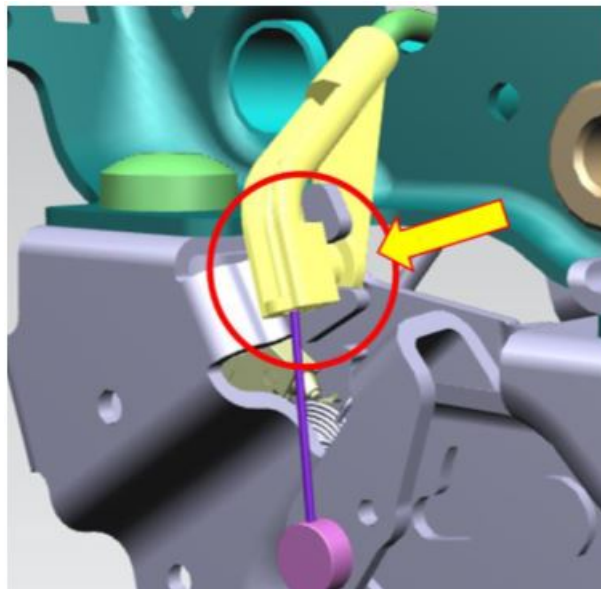
Fig. 3
Plastic End Fitting

10. Check if the plastic cable end fitting is completely locked into the mounting bracket (Fig. 3) .

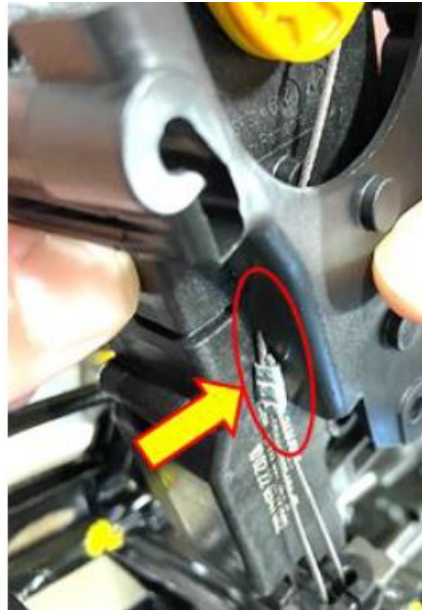
Fig. 4
Cable Routing Through Guide

11. Check if the cable is routed properly through the guide (Fig. 4) .

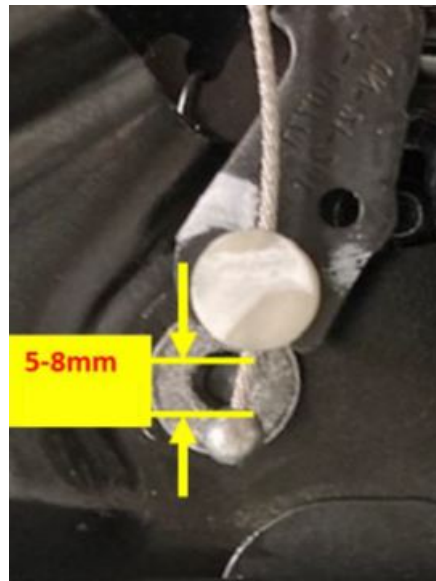
Fig. 5
Proper Cable Stick Out From The Fitting

12. Check if the cables are adjusted properly. The cable end should be 5 to 8 mm past the fitting (Fig. 5) .

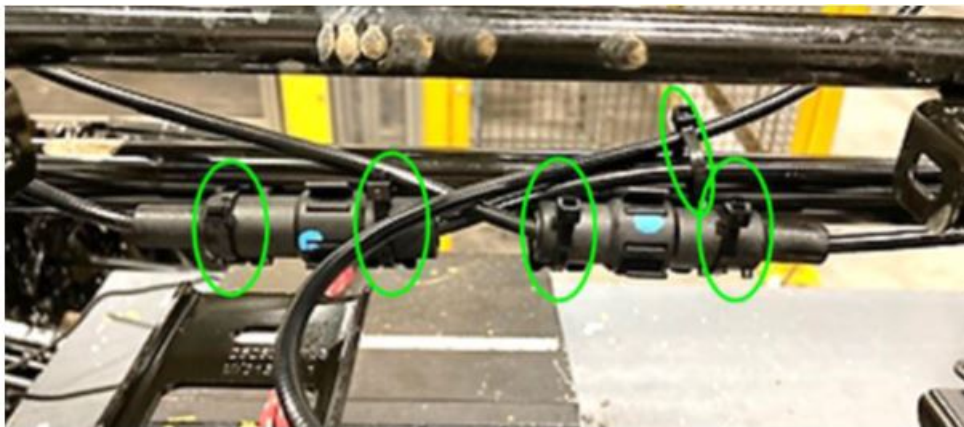
Fig. 6
Cut Off Zip Ties

13. If the cable(s) need to be adjusted, cut off zip ties (Fig. 6) .

17. Use new zip ties to attach the adjusters back to the seat frame. Leave the zip tie around the cable loose, so the cables move reword: as the seat back lies flat (**Fig. 6**) .
18. Install the seats lower side shields of the 2nd row seat that doesn't operate properly. Refer to the detailed service procedures available in DealerCONNECT> Service Library under: Service Info> 23 - Body / Seats, Second Row / Side Shields / Installation.
19. Confirm that the easy entry feature is now working properly. This bulletin has been completed.
20. Remove the seats lower side shields of the 2nd row seat that doesn't operate properly. Refer to the detailed service procedures available in DealerCONNECT> Service Library under: Service Info> 23 - Body / Seats, Second Row / Side Shields / Removal.

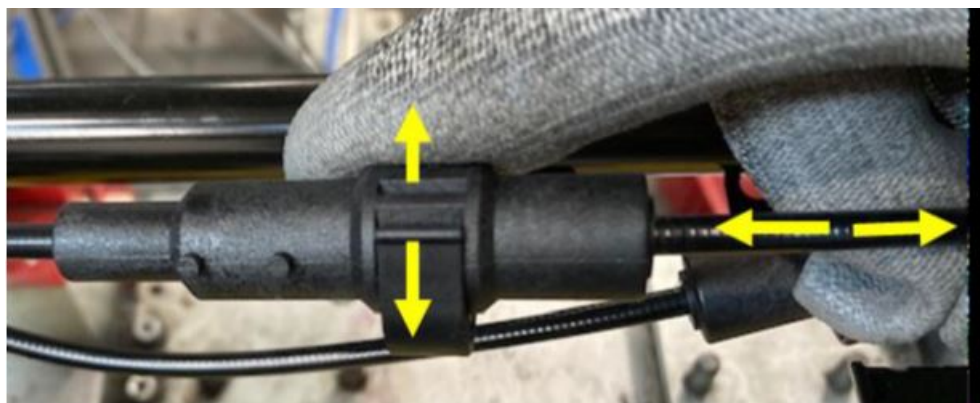
Fig. 7
Easy Entry Cable Adjusters

14. Unlock the cable adjuster and push/pull on the cable to adjust the cable stick out (5 to 8 mm). Make sure once the adjustment is completed, **make sure the adjuster is fully locked** (Fig. 7) .

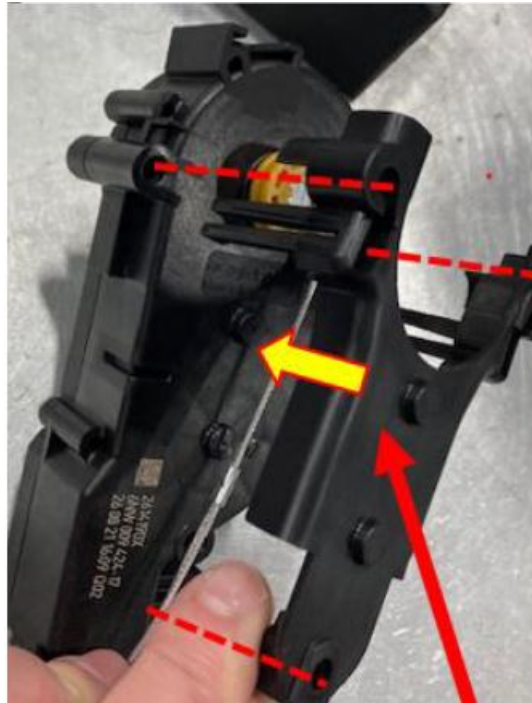
Fig. 8
Reusable Spacer

NOTE: Make sure the cables are routed properly and all faster, plastic fitting and cable ends are locked in place. There is a reusable spacer that needs to go onto the new actuator before installing it on the seat (**Fig. 8**) .

15. Does both 2nd row easy entry feature work properly?
- YES>>> Proceed to [Step 17](#).
 - NO>>> Replace the easy entry actuator cable assembly. Proceed to [Step 16](#).
16. Replace the actuator assembly only on the seat that doesn't work properly. Refer to the detailed service procedures available in DealerCONNECT> Service Library under: Service Info> 08 - Electrical / 8N - Power Systems / Power Seats / Actuator / Removal and Installation.

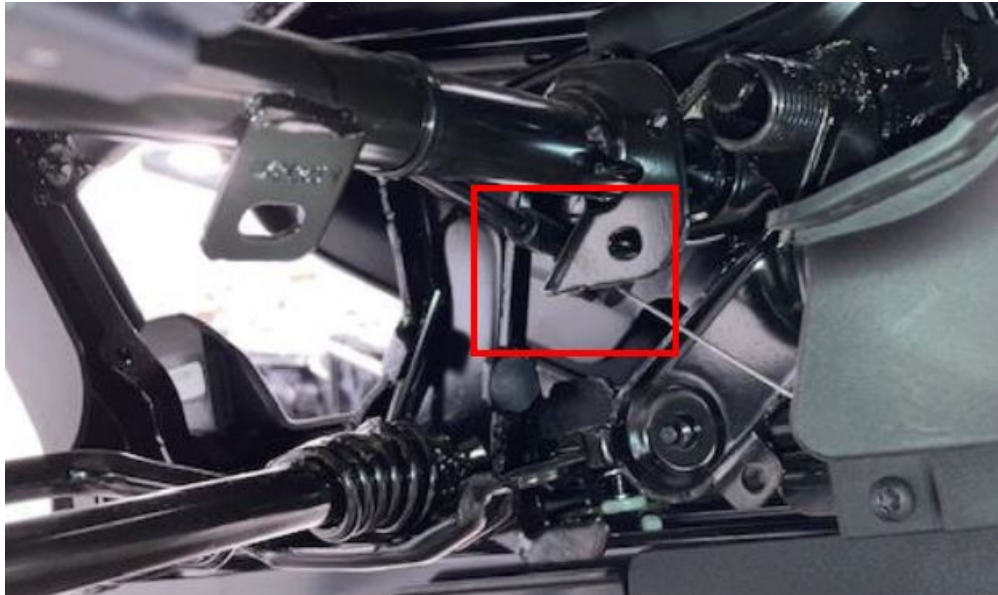
Fig. 9
Cable Bracket Location

21. Visually inspect if the plastic cable fitting is properly attached to the seat bracket (Fig. 9) .

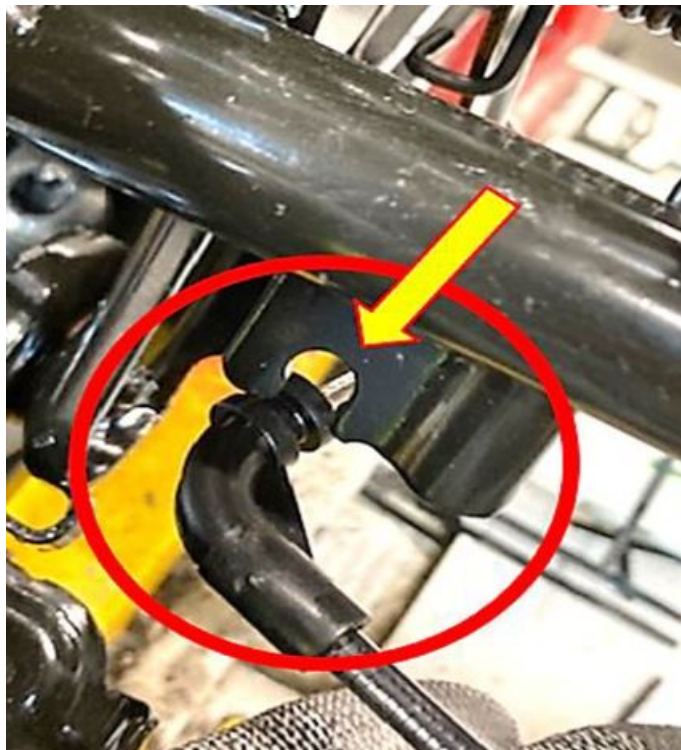
Fig. 10
Cable Out Of The Seat Bracket

22. If the cable fitting is not properly installed into the bracket, use a plier to snap back in place (Fig. 10) .

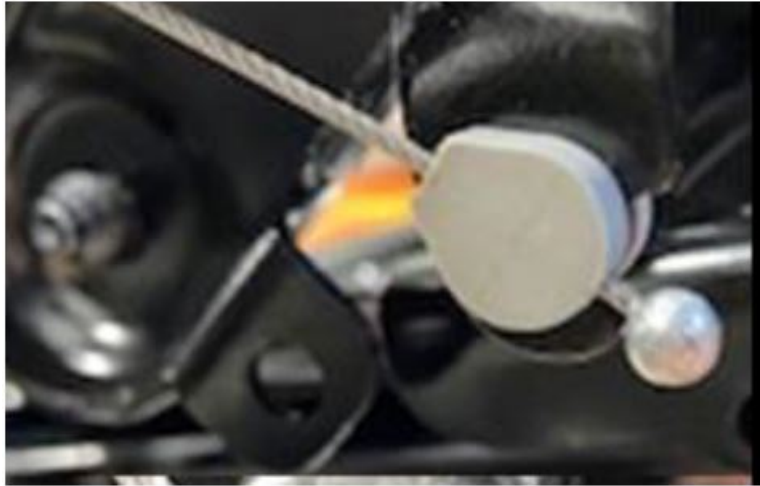
Fig. 11
Cable End Fitting

23. Check if the cable end fitting is properly attached to the release lever (Fig. 11) .

25. Replace the fold flat actuator cable assembly. Refer to the detailed service procedures available in DealerCONNECT> Service Library under: Service Info> 08 - Electrical / 8N - Power Systems / Power Seats / Actuator / Removal and Installation (Second Row Fold Flat).
