CAMPAIGN BULLETIN

Manual Transmission 5th Gear Shift Lever Plate Dealer Inventory

Reference: PC950

PC950 - 2023 Z SHIFT SELECTOR ADJUSTMENT

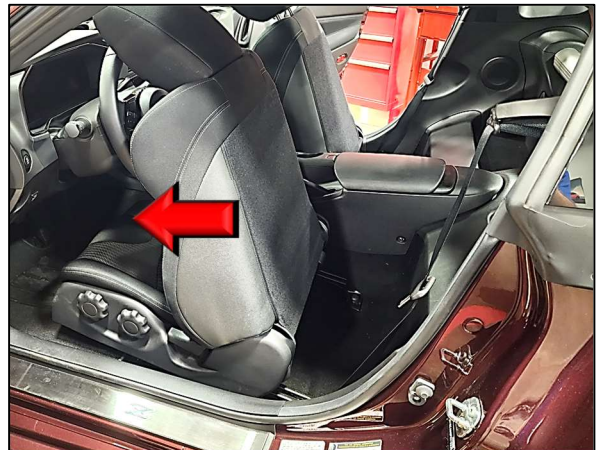
Figure 1

2. Position the Driver's seat. (Figure 1)

- Open the LH front door
- Move the LH seat forward fully
- Move the seat back to the fully forward position

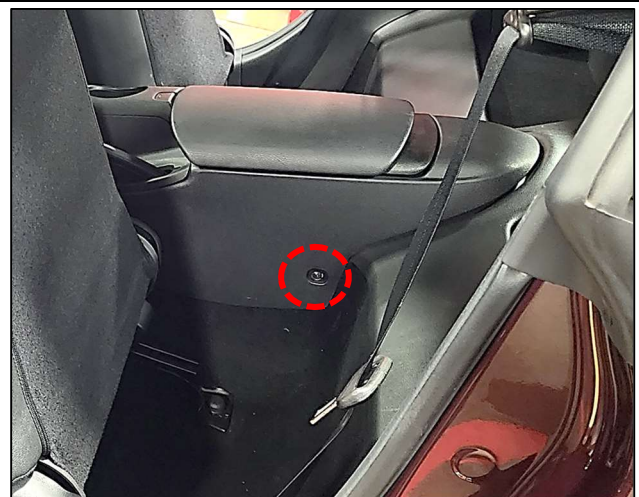
Figure 2

3. Remove the (1) screw from the LH side of the center console. (Figure 2)

- Move the LH seat back to the original position

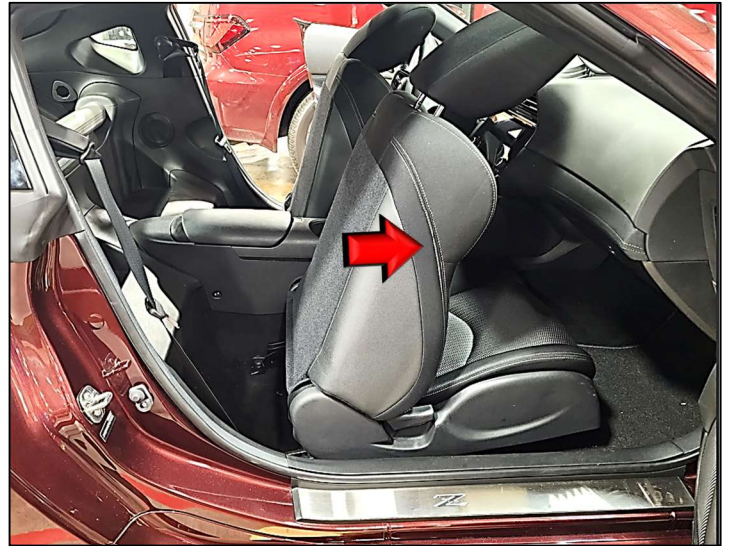
Figure 3

4. Position the passenger seat.
(Figure 18)

- Open the RH front door
- Move the RH seat forward fully
- Move the seat back to the fully forward position

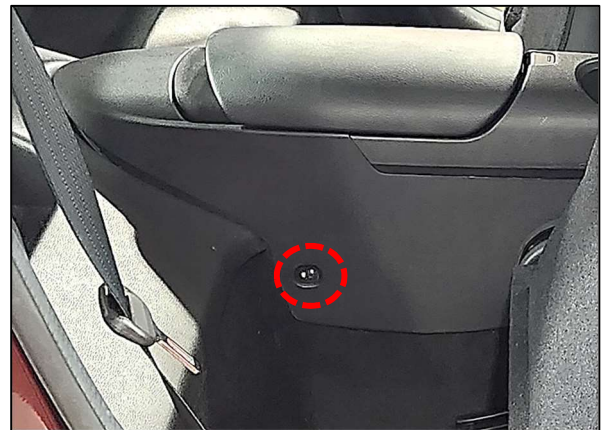
Figure 4

5. Remove the (1) screw from the RH side of the center console. (Figure 4)

- Move the RH seat back to the original position

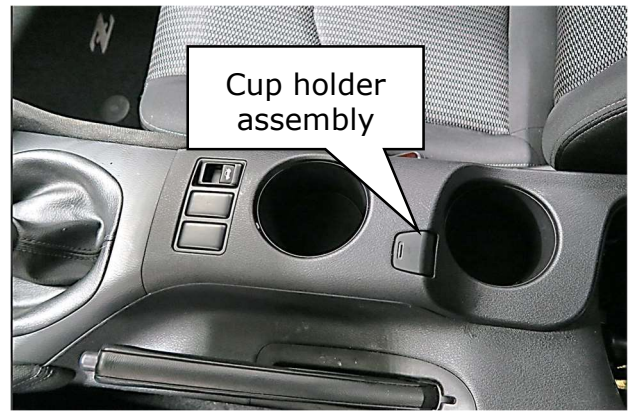
Figure 6

7. Remove the cup holder assembly.
(Figure 6)

- Carefully pull upward on the cup holder assembly to disengage the retainers
- Disconnect the electrical connector(s) from the cup holder assembly
- Depress the tangs on the harness retainer to disengage the harness from the cup holder assembly (Figure 7)
- Place the cup holder assembly in a safe area to avoid damage

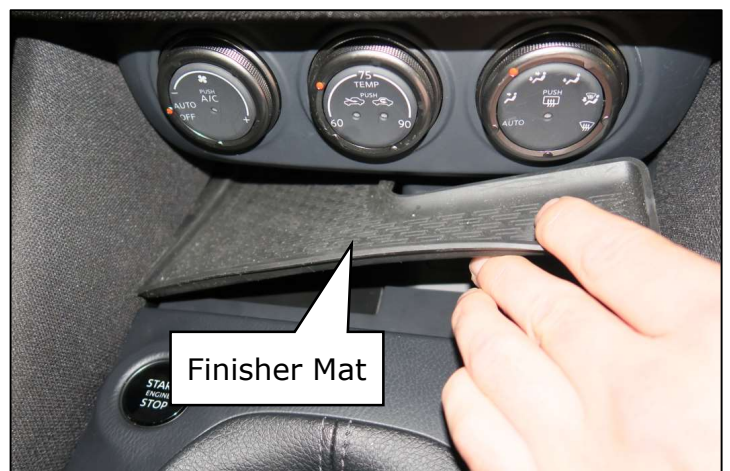
Figure 8

8. Remove the front tray finisher mat.
(Figure 8)

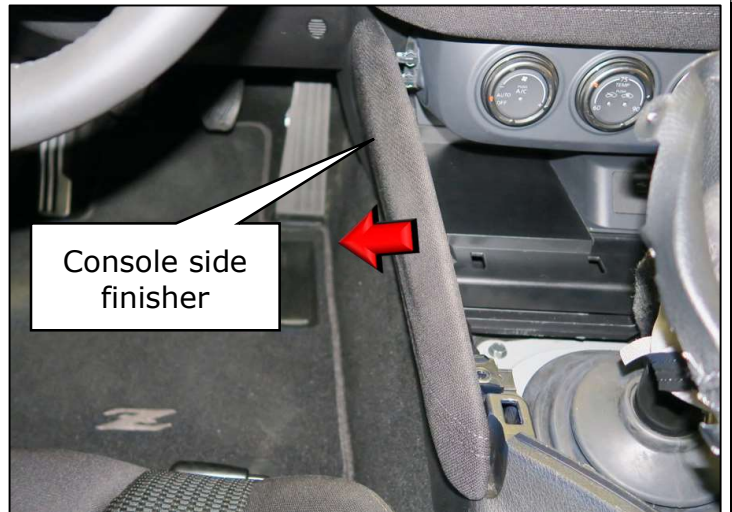
Figure 14

13. Remove both LH and RH console side finishers using a finesse stick. (Figure 14)

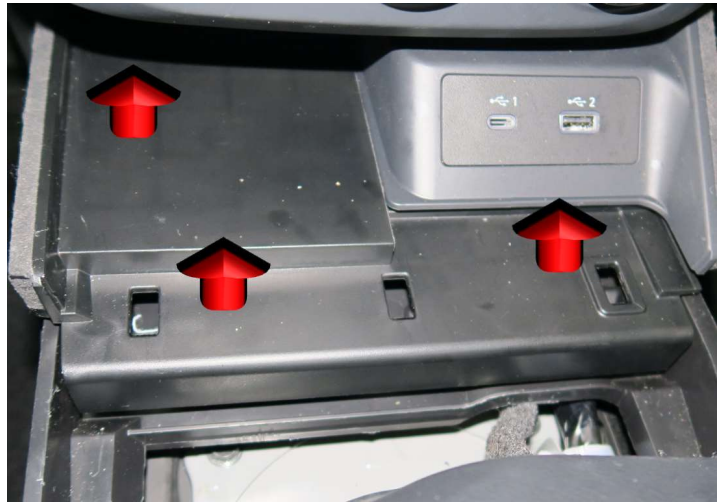
Figure 16

15. Remove the front tray finisher.
(Figure 16)

- Using a finesse stick, carefully pry upward to disengage the front tray finisher clips
- Remove the front tray finisher

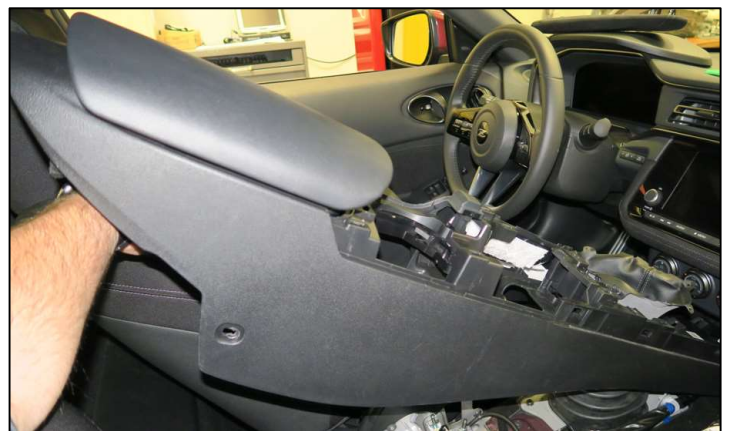
Figure 21

20. Remove the center console.
- Lift upward on the rear of the center console (Figure 21)
 - Move the console toward the rear of the vehicle
 - Carefully remove the center console from the vehicle out of the passenger door making sure to not scratch any of the interior trim

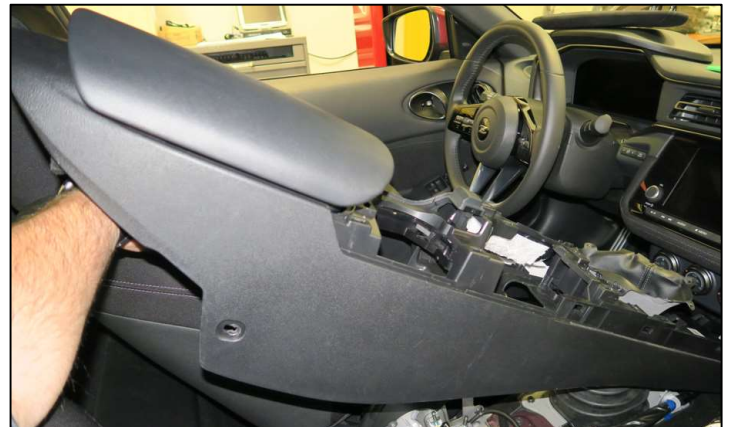
Figure 32

30. Carefully install the center console assembly.
- Route the console rear first through the RH door and toward the rear of the vehicle (Figure 32)
 - Align the front of the center console with the instrument panel
 - Align the parking brake handle with the slot in the center console

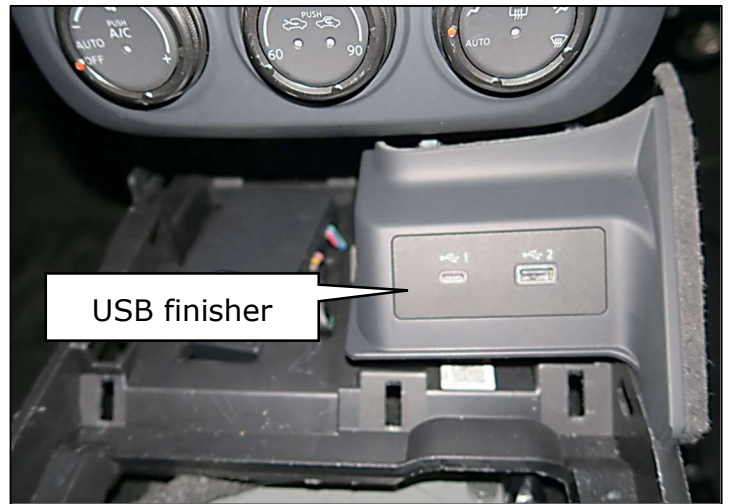
Figure 37

33. Install the USB port finisher.

- Connect the (2) harness connectors to the USB ports
- Place the USB finisher in the position shown in Figure 37, but do **NOT** seat the retaining clips at this time

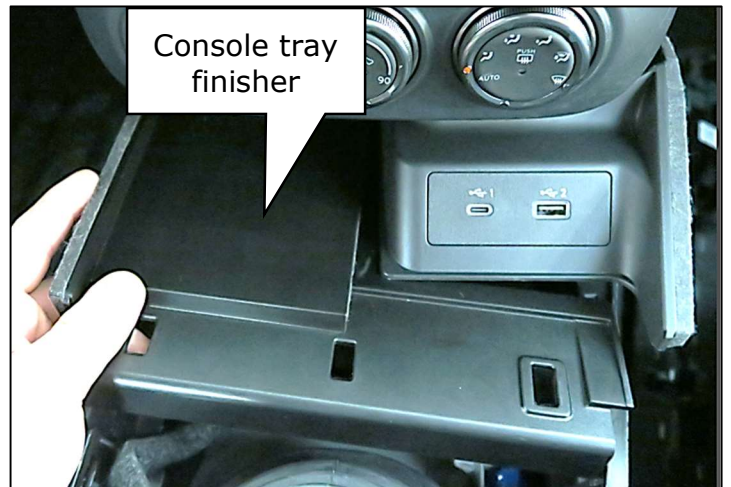
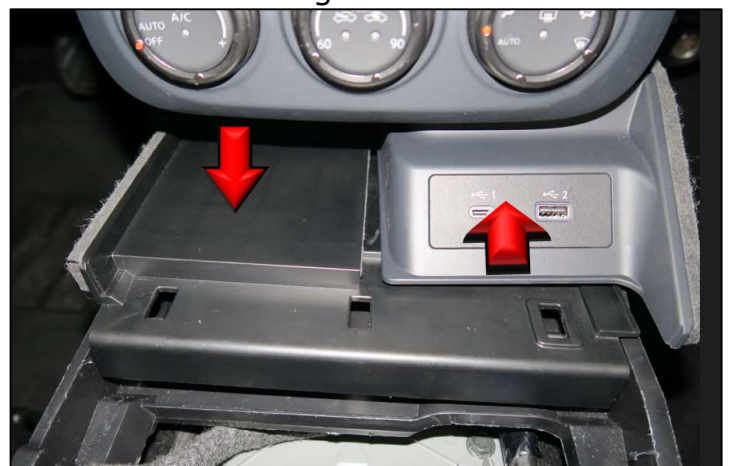
Figure 38

34. Install the Console tray finisher.

- Carefully install the tray finisher under the USB finisher (Figure 38)
- Starting with the rear of the console tray finisher, seat the retainer clips by pushing downward (Figure 39)
- Align the the USB finisher assembly retaining clips and push toward the front of the vehicle to seat the retainer clips

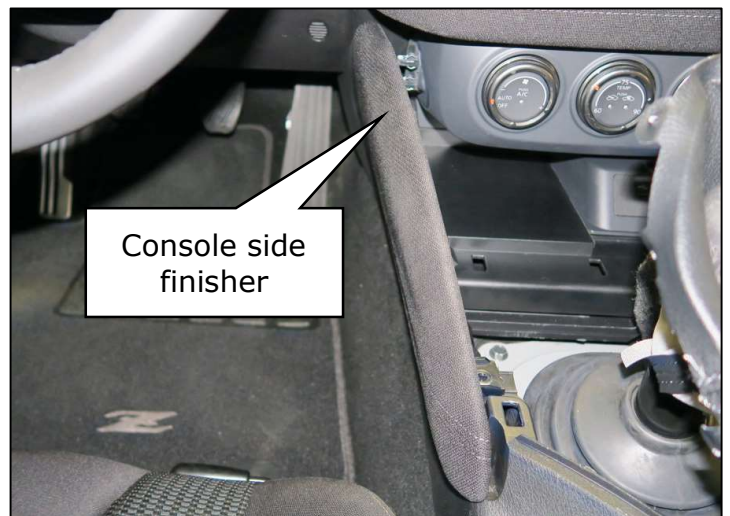
Figure 41

36. Install both LH and RH console side finishers.
(Figure 41)

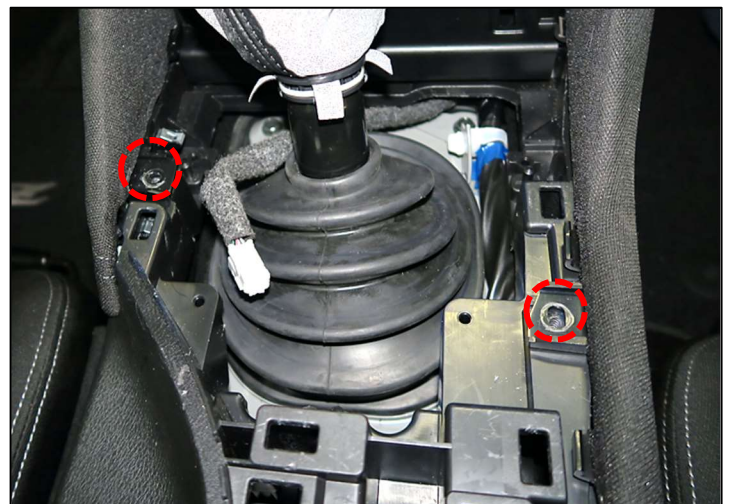
Figure 42

37. Install the (2) screws that secure
the console side finishers.
(Figure 42)

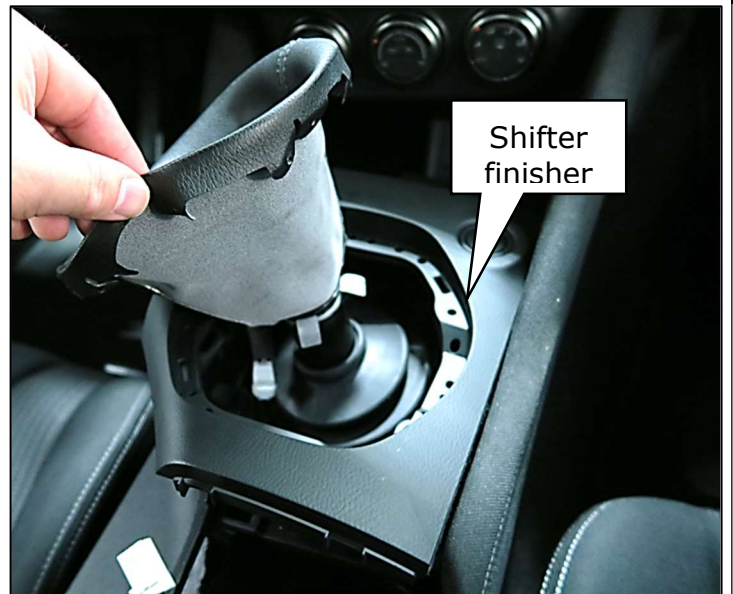
Figure 43

38. Place the shifter finisher over the shifter assembly as shown in Figure 43.

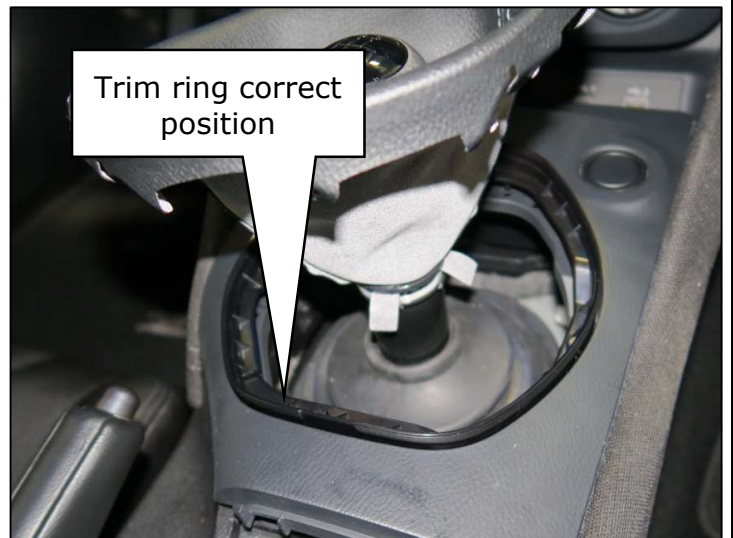
Figure 44

39. Place the shifter trim ring over the shifter assembly. (Figure 44)

- Locate the front of the trim ring by placing it into the shifter finisher and checking fitment
- If the trim ring does not fit, rotate the trim ring 180° and verify trim ring fitment

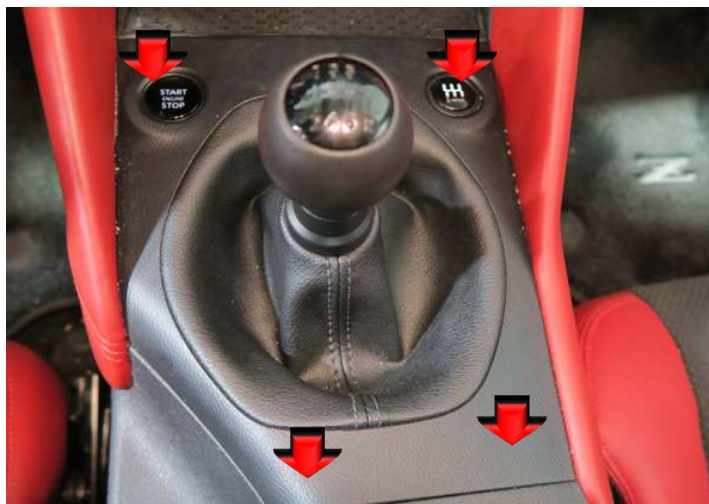
Figure 50

45. Install the shifter finisher. (Figure 50)
- Align the shifter finisher retaining clips with the center console holes
 - Push the shifter finisher downward to seat the finisher
 - Reinstall the console tray finisher mat

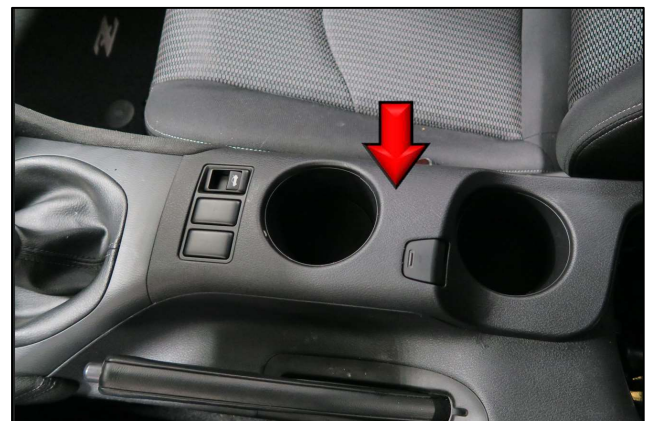
Figure 54

51. Install the cup holder assembly.
- Connect the harness connector(s) for the trunk release and heated seat (if equipped) switches (Figure 54)
 - Insert the harness retainer into the mounting point located on the cup holder
 - Position the cupholder assembly into the center console
 - Push the cupholder downward to seat the retainers into the center console (Figure 55)

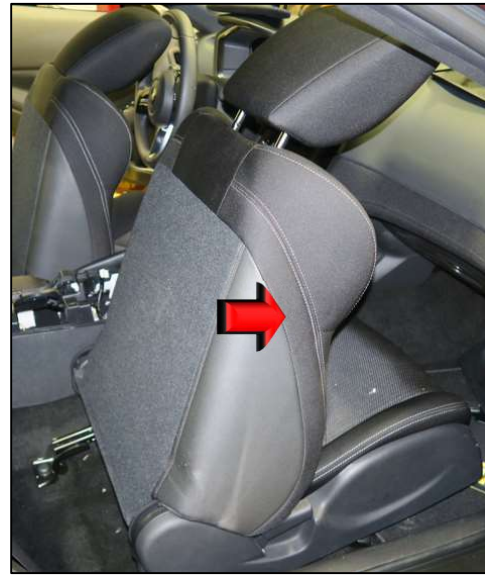
Figure 56

52. Move both seatbacks and seat bottoms fully forward. (Figure 56)

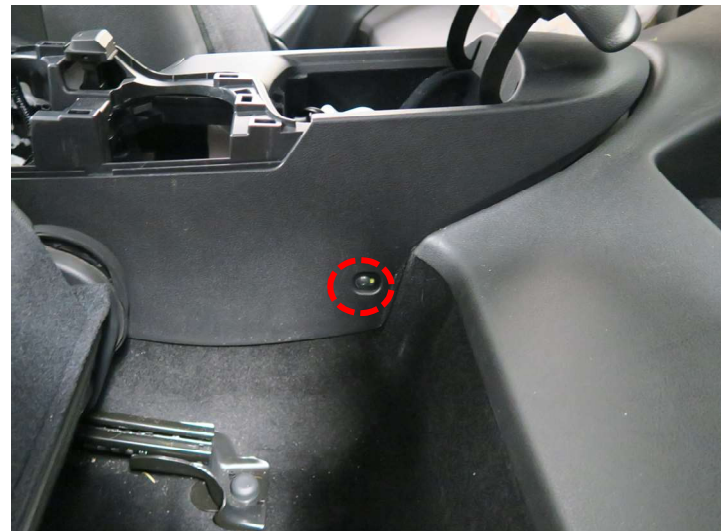
Figure 57

53. Install the (2) rear center console screws. (Figure 57)

- Move both seatbacks to the original position
