Service Bulletin

Bulletin No.: 23-NA-028

Subject: Front Lower Skid Plate Detached

Brand:	Model:	Model Year:		Vehicle Build Date:		Engine:	Transmission:
		from	to	from	to		
Cadillac	XT5	2021	2023	SOP	February 10, 2023	All	All

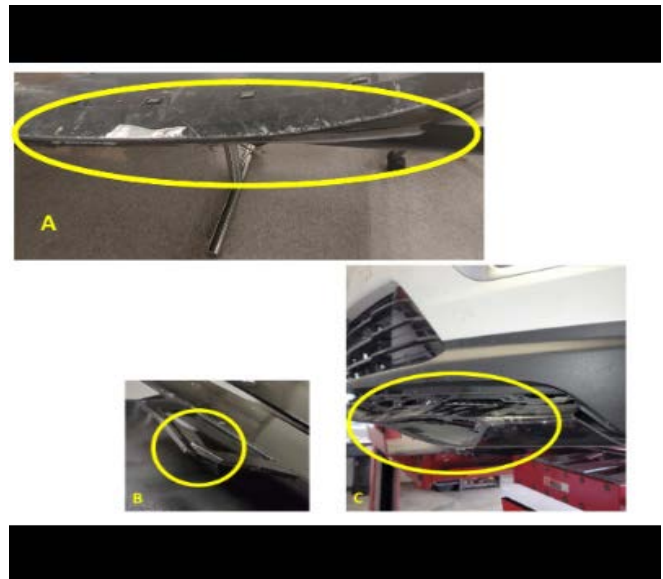
6281445

- If the Skid Plate has partially or completely fallen off the vehicle, and is visibly damaged replace with new skid plate and attach zip ties as shown in steps below. Example of damaged Skid Plates to be replaced are shown above.

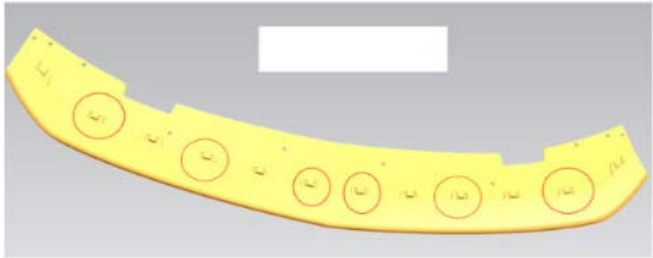
6281447

- 3. Install skid plate by additionally adding 6 zip ties in the locations shown.

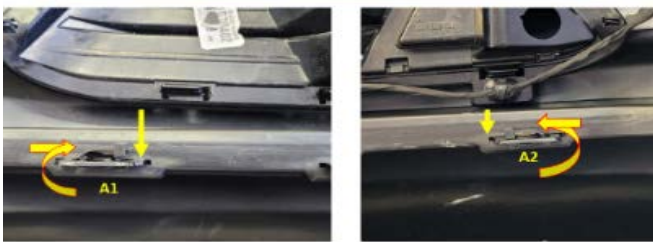
6281449

For locations A1 and A2 the zip tie knot needs to be facing up as shown in picture above.
