INSTRUCTION TO SERVICE

ITS60634		02/10/2023
SECTION:	490-Entrance Door	
WRITTEN BY:	Mark Reitz	
SUBJECT:	D45CRT Single Leaf Masats Entrance Door	
ISSUE:	Entrance Door Adjustment	
SUMMARY:	Performing this procedure will ensure the entrance door is adjusted and operating properly.

ITS-60634

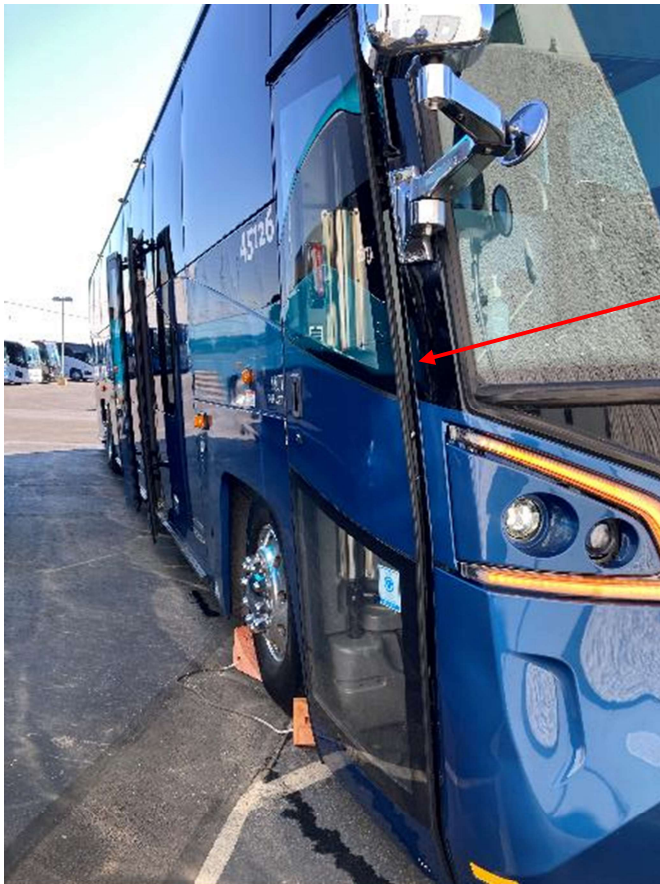
1. Set park brake and chock wheels.
2. Start the coach and turn on the HVAC system. From outside the coach operate the door switch to open and close the door. Observe if the door is closing properly. Note if the door bounces off of the door frame as it attempts to close. Note if the door is not fully seated with the door frame when in the closed position.

Door not fully seated

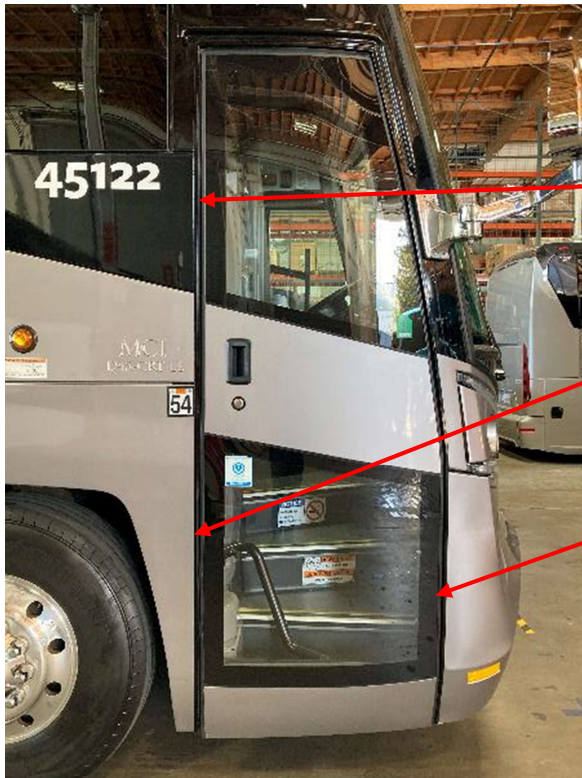
3. With the door closed note the gaps on the rear edge and the front edge of the door at the locations indicated in the photo below. The door gaps must be within 3mm forward side and rear side.

Gap check rear side these 2 places

Gap check forward side here

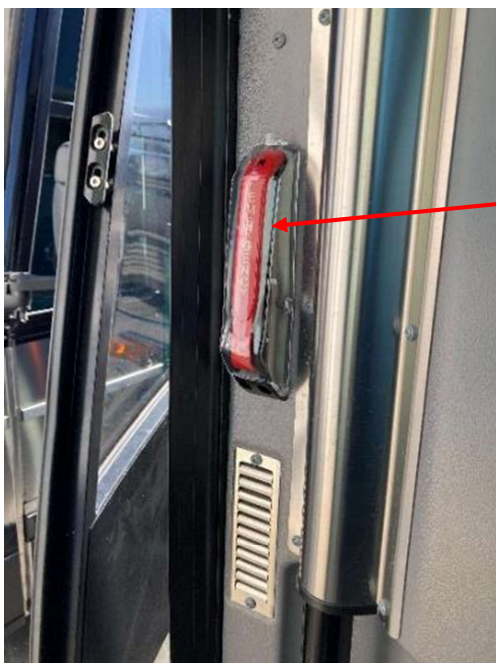
4. If the gap needs adjustment open the door then pull the manual door release handle.

Door release handle

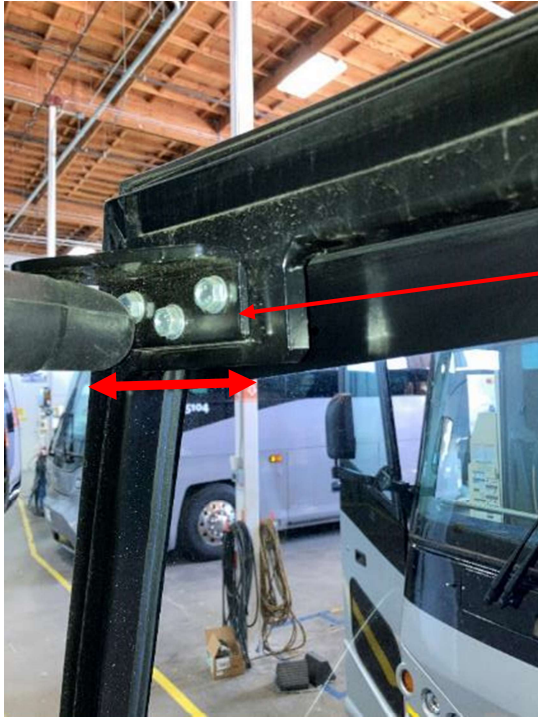
5. Locate the 6 fasteners on the inside of the door leaf that attach the door leaf to the upper and lower linkage arms. Completely loosen, but do not remove, 2 of the three bolts on the upper and lower mounting bracket. Slightly loosen the remaining screws just enough to be able to slide the door fore or aft in the door mtg slots. Have someone from the outside of the coach push the door closed and adjust the gaps evenly. Once the gaps are set, tighten all six bolts to 14-16 ft-lbs.

3 top bolts

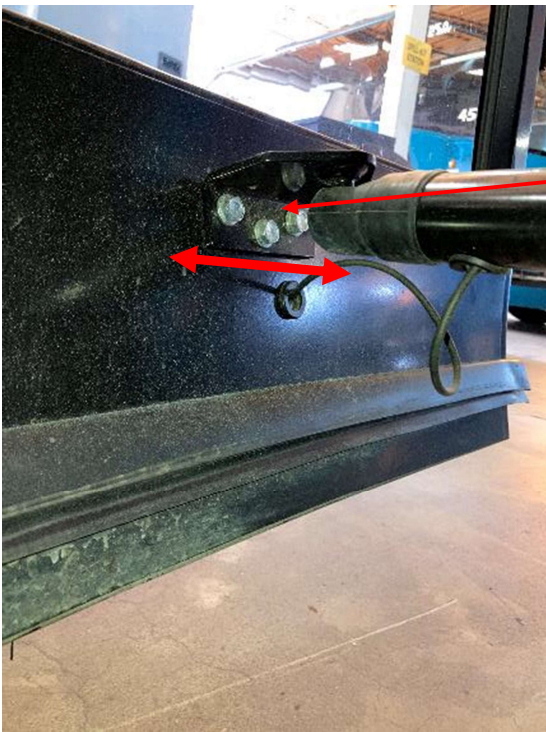
3 bottom bolts

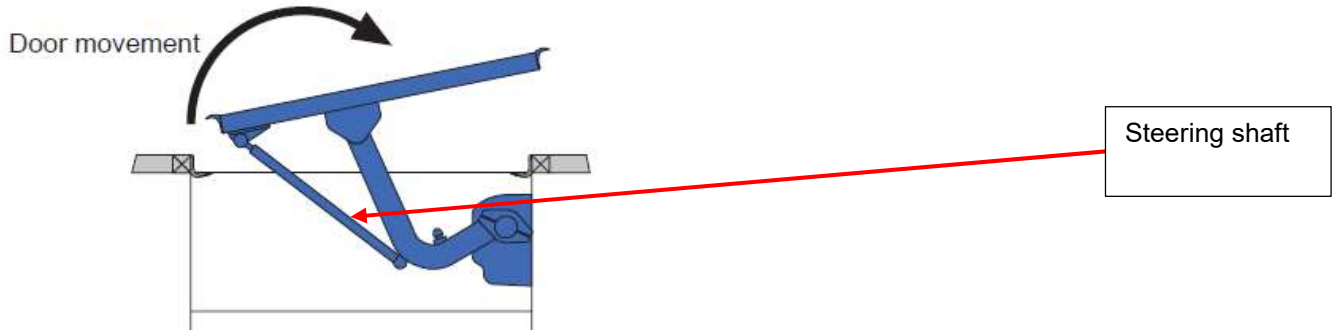
6. While closing the door note if the front side of the door closes before the rear side. The front side of the door must engage the door frame first.

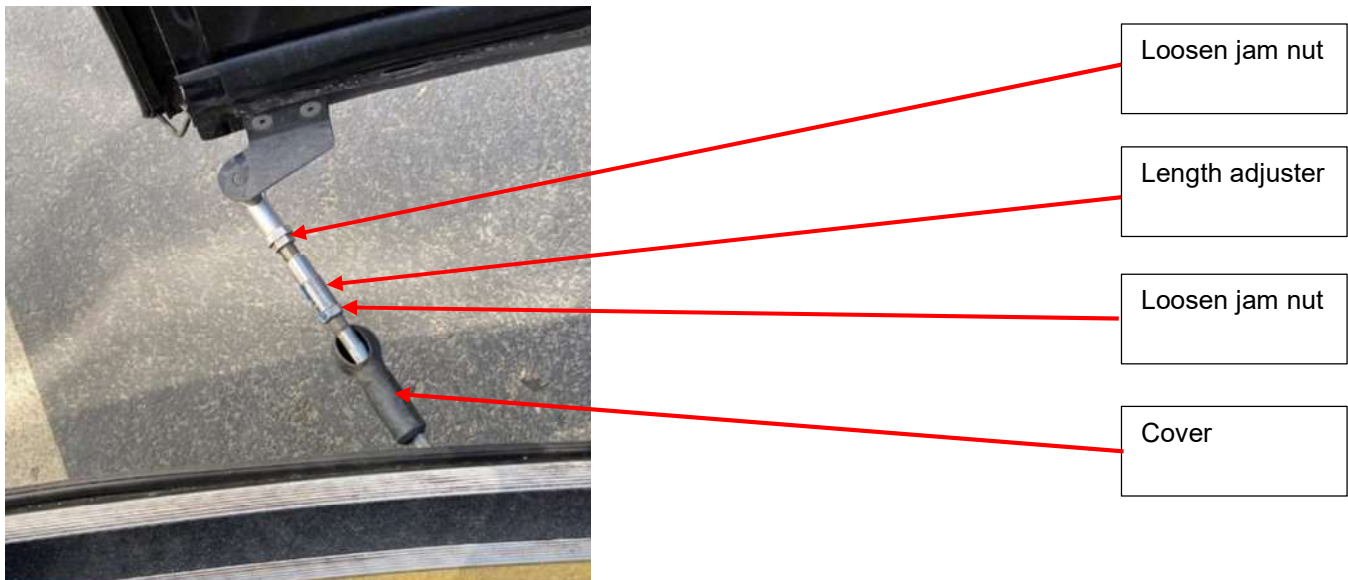
7. If adjustment is needed slide the cover from the steering arm rod-end and loosen the two jam nuts on the steering arm shaft.

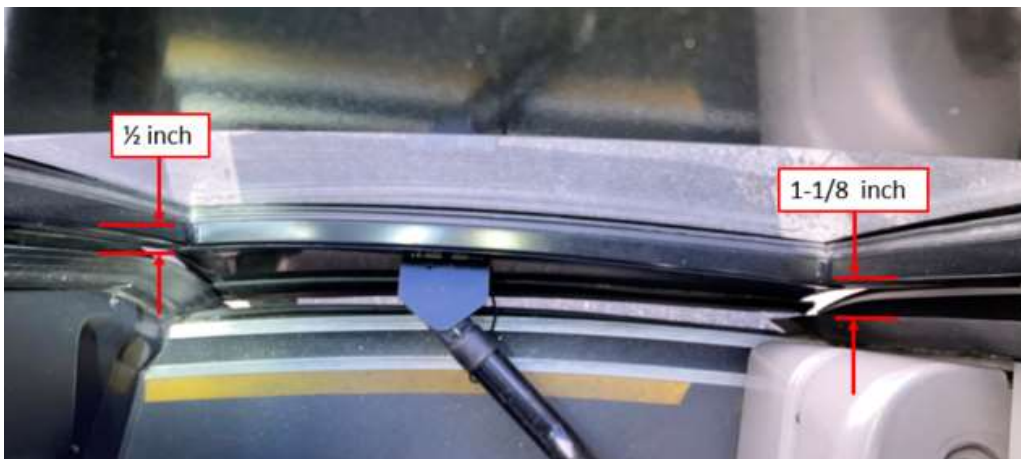
8. Turn the adjuster in 1/2 turn increments until the front of the door frame is 1/2" from the seal and the rear door frame is 1-1/8" from the seal. Once the gaps are achieved do not yet tighten the jam nuts.

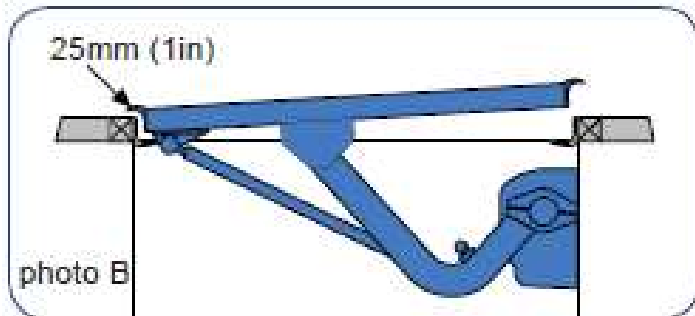
9. Manually close the door slowly and observe the stepwell light going off and note how close the front edge of the door is to the door frame. The door should be 1" from the door frame when the step light goes out. If not, proceed to the next step.

12. Mark the adjustment starting point with a piece of tape and cut around the shaft as shown. Only make slight rotations to the cam (approx. 1deg) then check where the stepwell light goes out. Continue adjusting the cam until the door is about 1" from the frame when the stepwell light goes out (ref. Step 9 diagram). When complete tighten the set screw to 30-32 in-lbs.

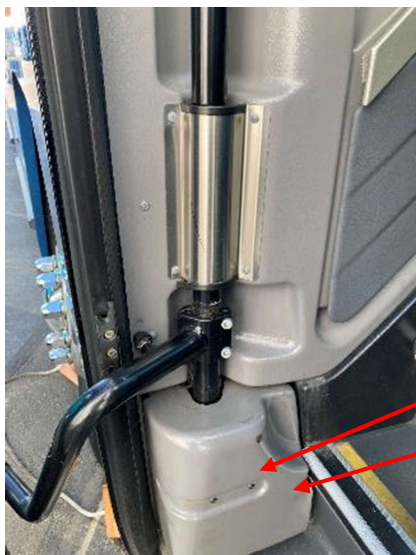
10. To adjust the switch, open the door, remove the two screws holding the motor cover and locate the switch adjustment cam.

Cover screws

Motor cover

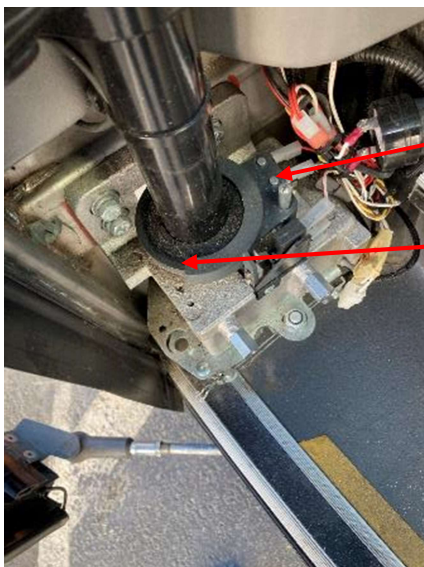
Microswitch

Switch cam

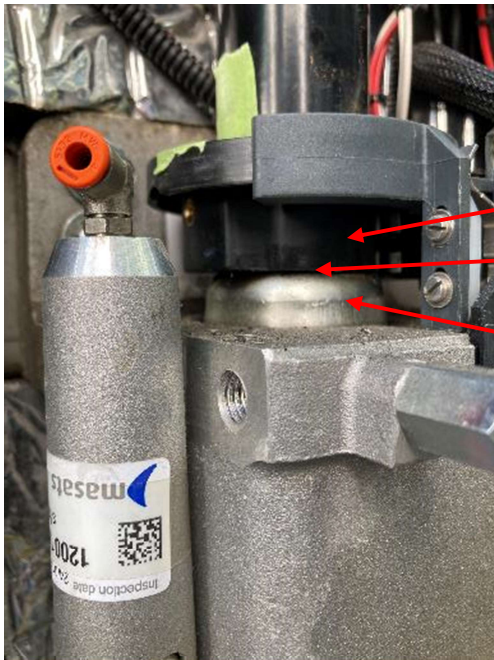
11. Check that there is 1mm of gap between the bottom of the door shaft and the adjustment cam. If not, raise or lower the cam to the desired gap after slightly loosening the 3mm set screw only enough to rotate the cam.

Cam

1mm Gap

Bottom of shaft

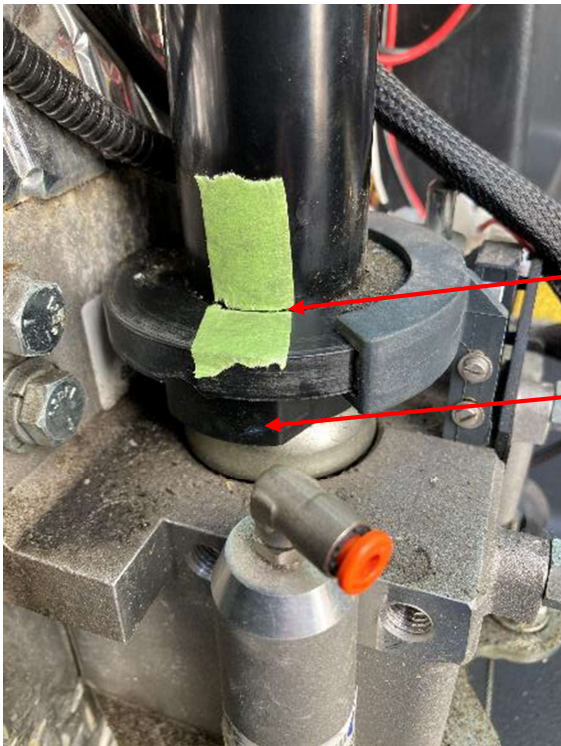
Reference tape

Cam set screw

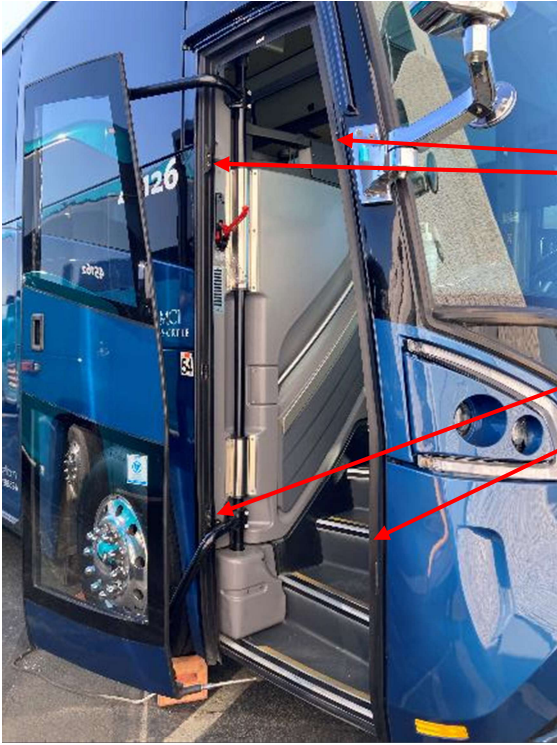
13. From outside the coach manually close the door slowly and observe the gap between all 4 lock wedge pairs. Lock wedge gap should be even at all 4 pair locations. Ideal gap should be between 2-4mm. First attempt to adjust the gap by loosening the bolts on the door side wedge and sliding the wedge. If more adjustment is needed, then loosening the frame side wedge bolt and continue adjusting the gap. Be careful not to remove the frame side bolt letting the T-nut slide down. Tighten wedge bolts to 5 ft-lbs and go to the next step.

Lock wedge locations door frame side

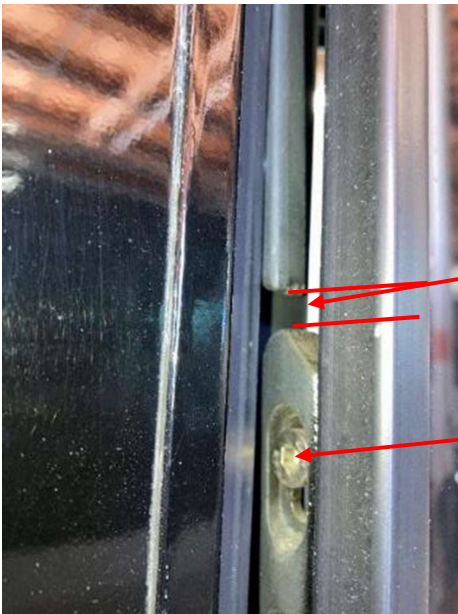
Note gap at all four wedge lock pair locations

Wedge bolt

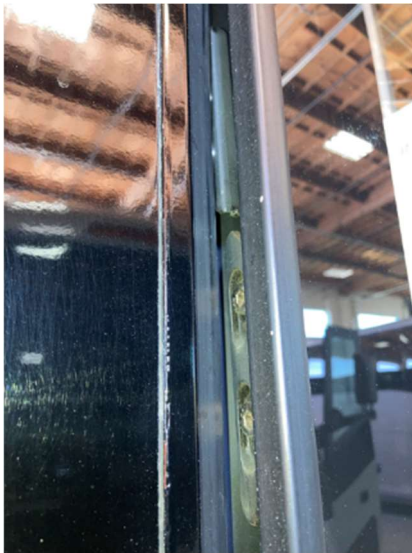
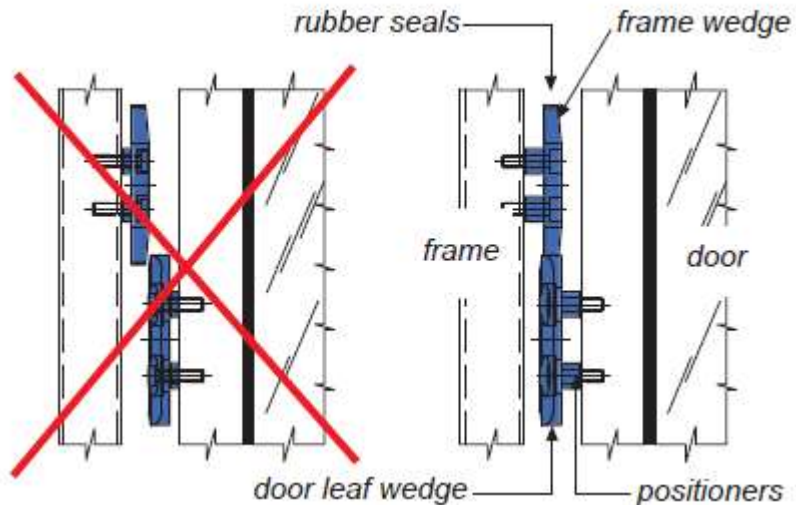
14. Check the wedge pair alignment and note if any of the lock wedge pairs do not overlap fully. See figure.

15. If wedge pair alignment needs to be adjusted then add washers under the door side wedge or subtract washers under the frame side wedge as needed for proper overlap. On the frame side wedge be careful not to let the T-nut slide down the track. Tighten all the wedge bolts to 17-19 ft-lbs.

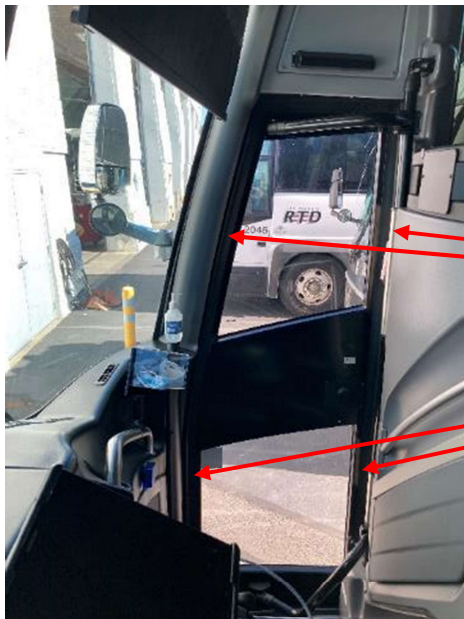
17. From inside the coach push on the door at the wedge lock pair locations. If one of the wedges has not engaged properly, you will hear a rattle of the wedges contacting each other. Reduce the wedge gap slightly at that location.

Push at these locations and listen for any rattle

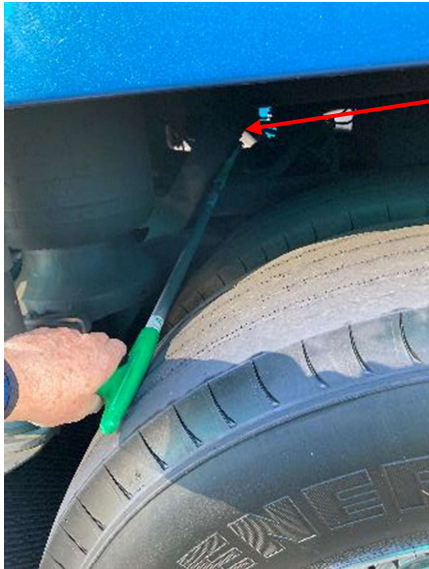
18. Put the coach into "High Ride". Then using the air dump valves remove the air in the front and rear suspension on the RH side of the coach so the coach is leaning to curbside.

Rear dump valve

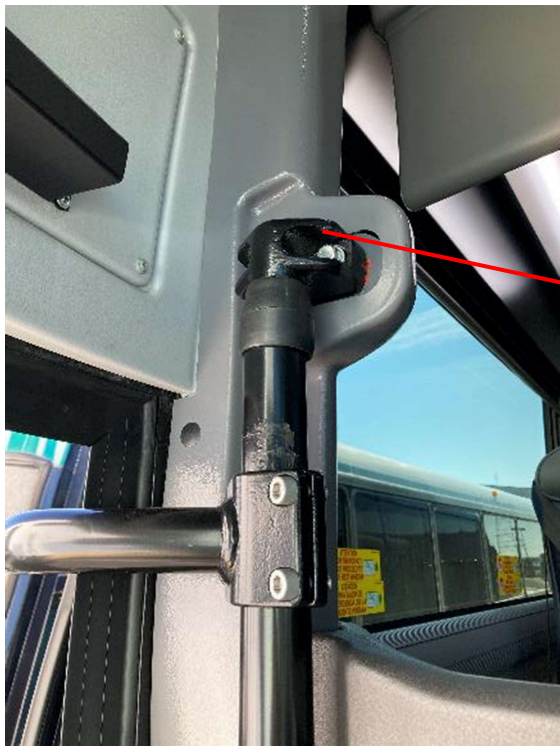
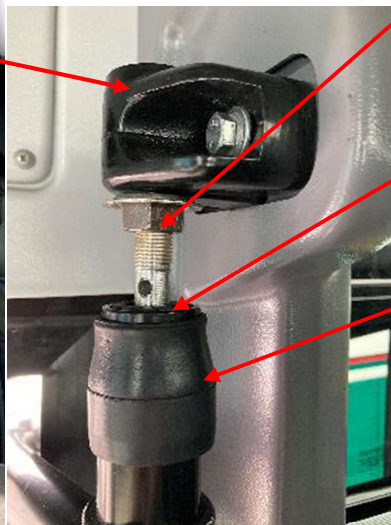
19. Open and close the door with the door switch 3-4 times. Observe function. If the door closes properly no further adjustment is needed. If the door bounces off the frame or does not engage the lock wedge pairs then adjustment of the door tension spring is necessary.
20. Fully open the door by using the manual release lever. Locate the top adjustment rod. Remove the rubber boot and note the location of the spline bushing above or below the tube edge.

Adjustment rod

Spline bushing

Rubber boot

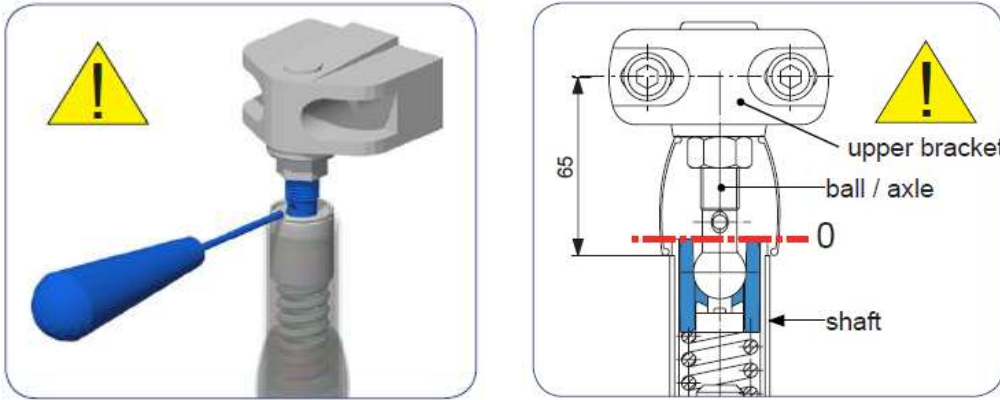
21. If the spline bushing is below the top of the tube edge, loosen the jam nut and turn the adjustment rod until the spline bushing is at the tube edge. See figure. Tighten jam nut to 92 ft-lbs. Re-engage manual door release lever and test door open-close operation 3-4 times for proper closing. If more adjustment is necessary, repeat this step by raising the spline bushing above the tube edge 1mm at a time and repeating the open-close test until the door closes on the lean. Replace the rubber boot.

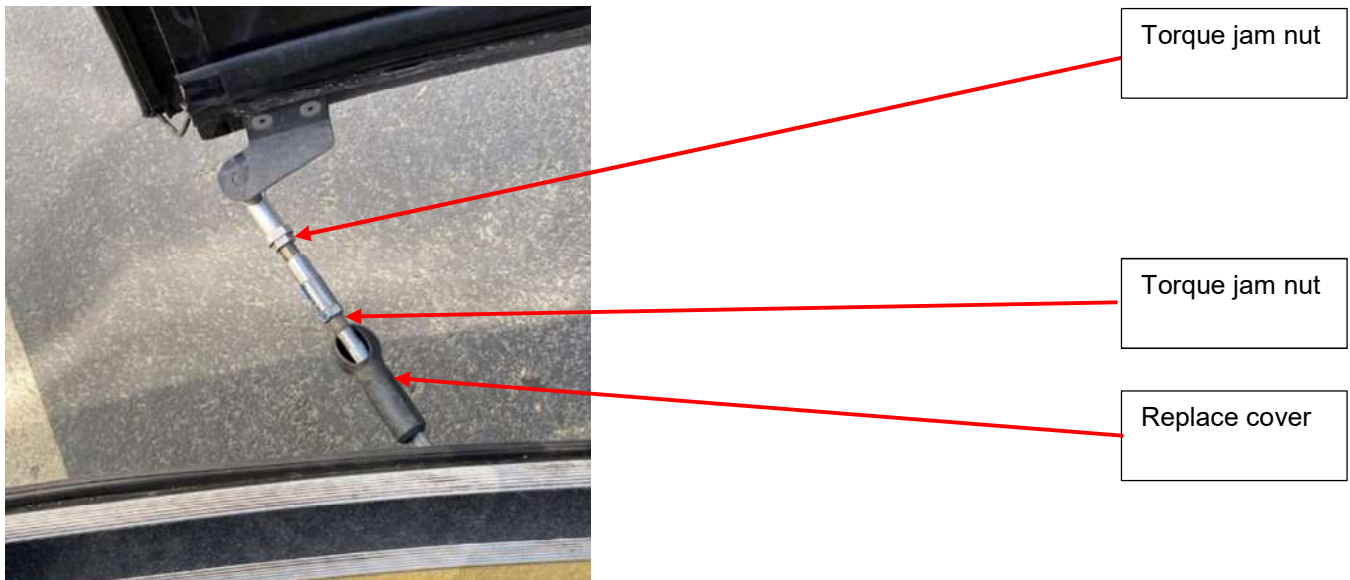
22. Once the door closes and locks well, carefully tighten the steering arm jam nuts 37 ft-lbs. During tightening it is possible to change the adjustment. Replace the cover on the rod-end.
