TECHNICAL SERVICE BULLETIN

| Classification: EC23-002 | Reference: NTB23-015 | Date: February 23, 2023 |

MIL ON AND DTC P0401 STORED IN THE ECM

APPLIED VEHICLES: 2023 Rogue (T33)
APPLIED ENGINES: KR15DDT

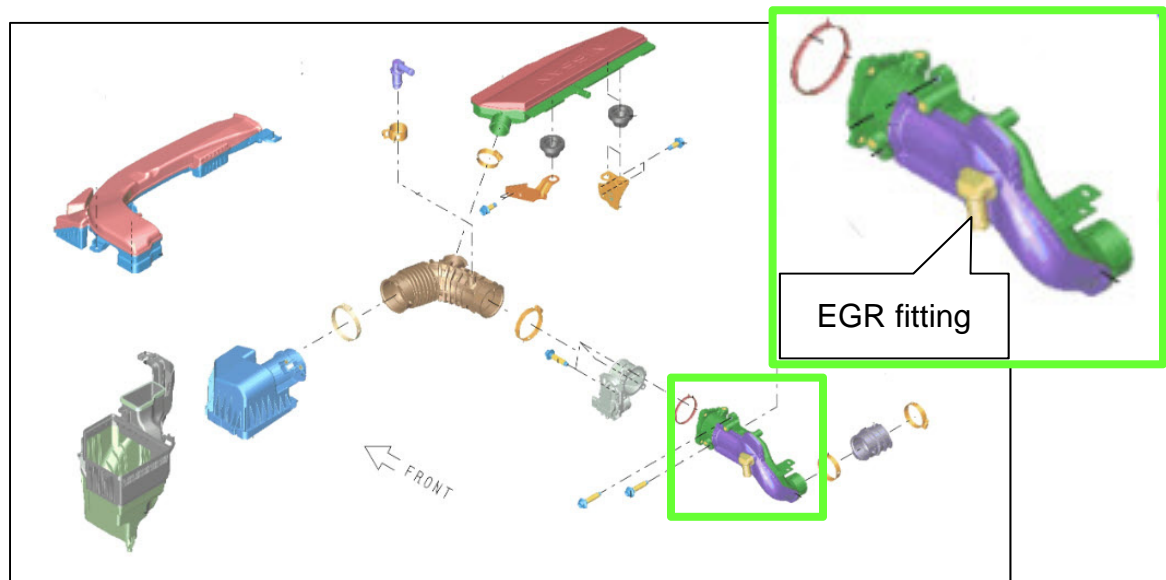
Figure 1

1. Inspect the EGR fitting on the intake air duct (Figure 1) for a restriction.

2. Replace the intake air duct if a restriction is present in the EGR fitting.

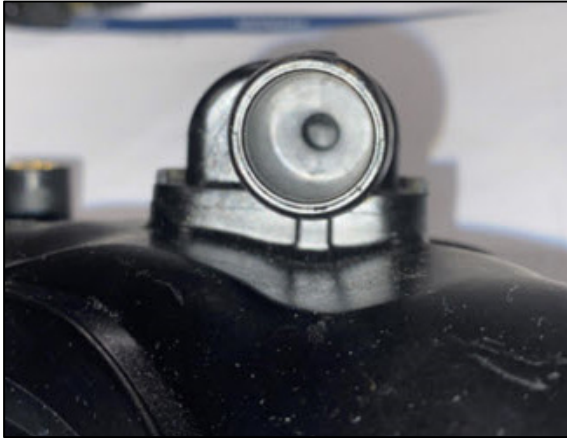
Figure 2

1. Inspect the EGR fitting on the intake air duct for a restriction.
 - If a restriction is present (Figure 2), proceed to step 2 to replace the intake air duct.
 - If a restriction is not present (Figure 3), this bulletin does not apply. Refer to ASIST for further diagnostic assistance.

2. Replace the intake air duct.
 - Refer to the ESM: **ENGINE > ENGINE MECHANICAL > KR15DDT > REMOVAL AND INSTALLATION > ADMISSION VALVE > Removal and Installation**
