## Battery & Solar Connections

| <b>Bulletin Type:</b> | TSB | <b>Publication Date:</b> | March 2023 |
| <b>Bulletin #(s):</b> | 23-093 | <b>Make(s):</b> | Jayco & Entegra Coach |

| <b>Incident:</b> | Battery and solar power connections installed to the secondary battery instead of the primary battery causing blown fuses. |

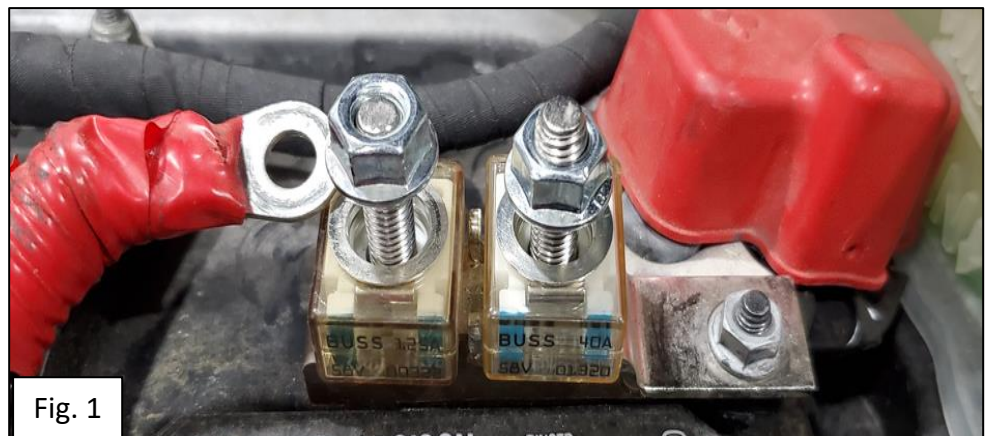
Fig. 1

1. Remove the electrical connections from the passenger side battery using a 1/2" socket. (Figure 1)
2. Remove the nut and fuse blocks, which connects the fuse block to the battery lug using a 10mm socket. (Figure 1)

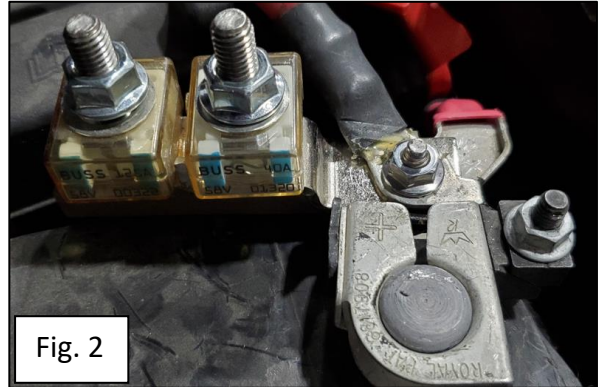
Fig. 2

3. Install the previously removed fuse block on the driver side battery – positive lug with the Ford wiring. (Figure 2)
  - A. **NOTE:** Ford wire connector should be installed between the fuse block and the mounting nut.

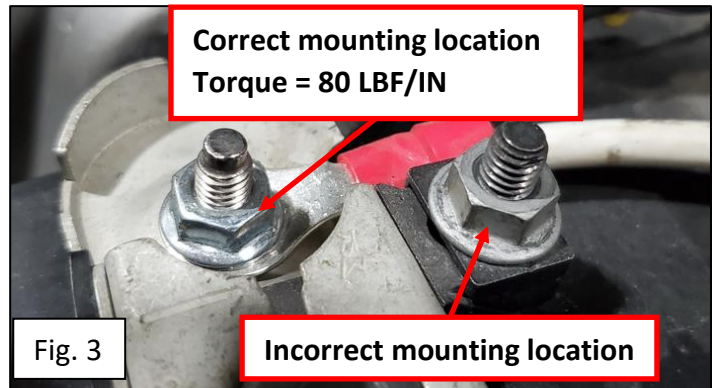
Fig. 3

4. Verify the mounting location of the solar power wire on the negative lug. It should be connected directly to the lug as shown in Figure 3. If it is not, the connection will need to be moved and 6mm nut has been supplied.
  - A. Torque = 80 LBF/IN

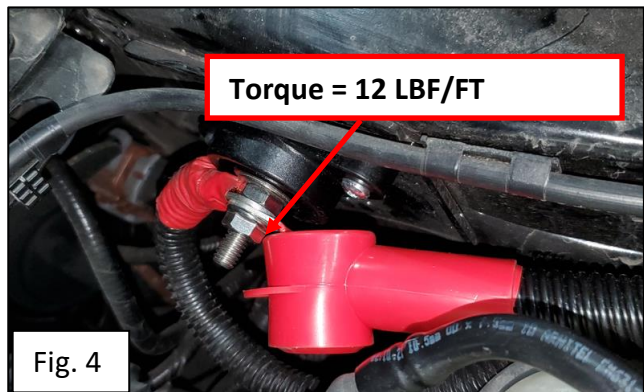
Fig. 4

5. Utilizing a screw gun and square bit, install the isolator stud mount to the driver side interior quarter panel.
6. Attach electrical connections to the isolator stud. (Figure 4)
  - A. Chassis extension wire previously removed in step 1.
  - B. Jumper harness with rubber boot.
7. Cut the ring terminal off of the Black solar power wire removed in step 1 and connect to the heat shrink terminal on the jumper harness. Utilizing a butane torch, heat shrink the terminal.

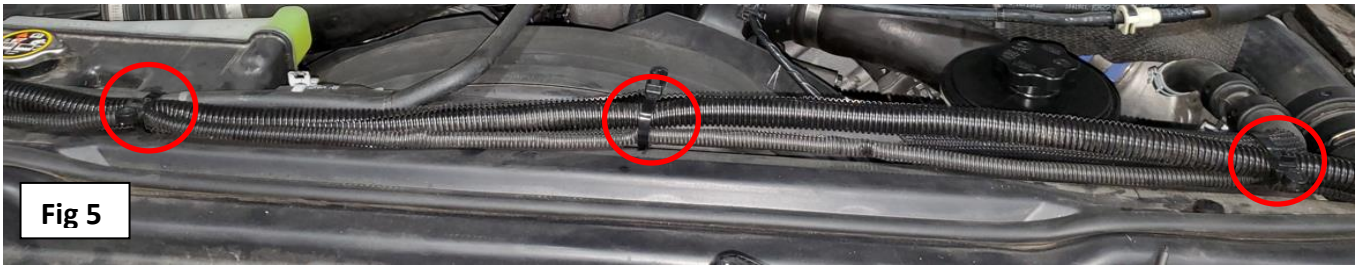
9. Secure the jumper harness with zip ties.
  - A. There should be a minimum of three zip ties securing the harness across the front. (Figure 5)
  - B. Install one zip tie in the passenger front corner. (Figure 6)

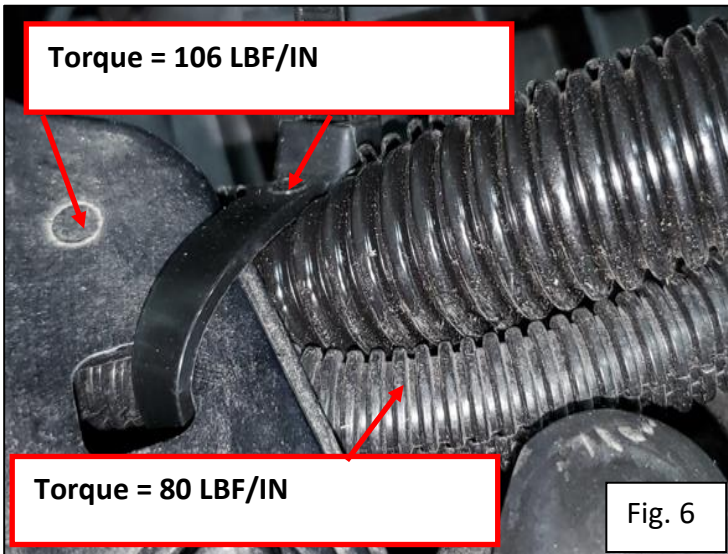
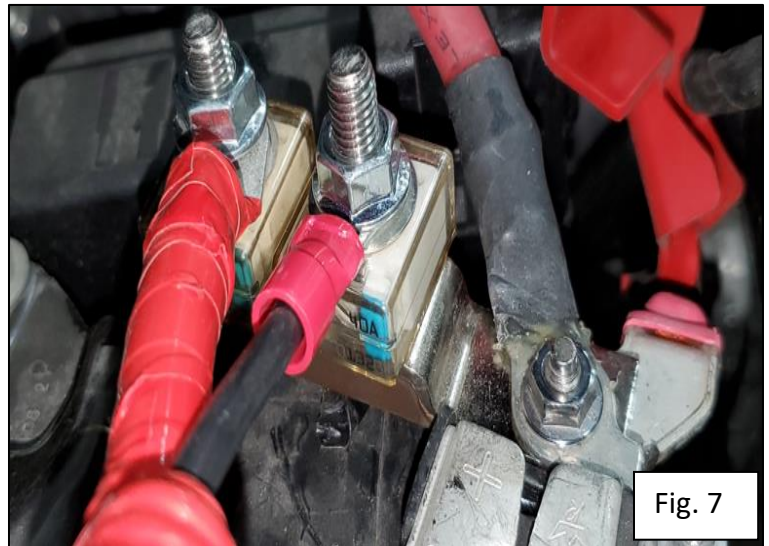
10. Secure jumper harness to the fuse block. (Figure 7)
  - A. Solar Power Wire on top of the 40A fuse. Torque = 106 LBF/IN
  - B. Battery Cable on top of the 125A fuse. Torque = 106 LBF/IN
