Release Date	03/02/2023	Technical Service Bulletin		
74E4 UPDATE

Ski Pass Through Carpet – (NVLW)

This Update has been proactively released to prevent the following condition(s) from occurring in the vehicle:	
Criteria	Technical Background
01	The carpet on the second row seat pass through lid may detach from the lid.

Criteria	Remedy
01	Check the carpet on second row seat pass through lid, and replace if necessary.

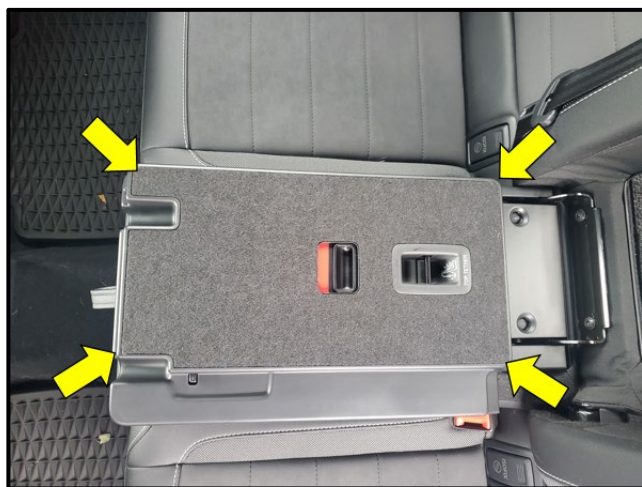
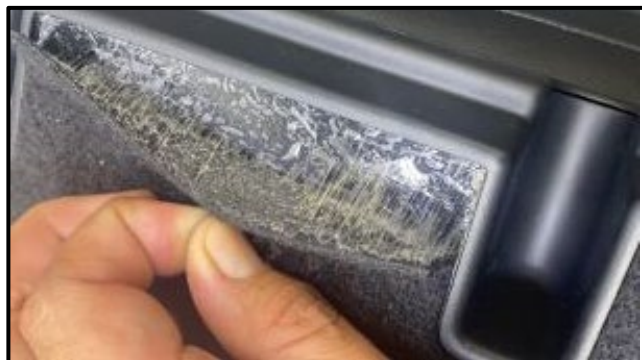
Checking carpet adhesion on pass through lid:

- Recline the pass through lid.
- Pull the carpet slightly away from the lid at multiple locations.
- If the carpet can be easily be pulled away or if considerable threads of adhesive are seen when the carpet is pulled away, the carpet must be replaced.
