Preliminary Information

PIT5990 Hoot Howl Whistle Type Wind Noise From the Front End or Interior While Driving At Highway Speeds Or Squeak Noise From IP Dash

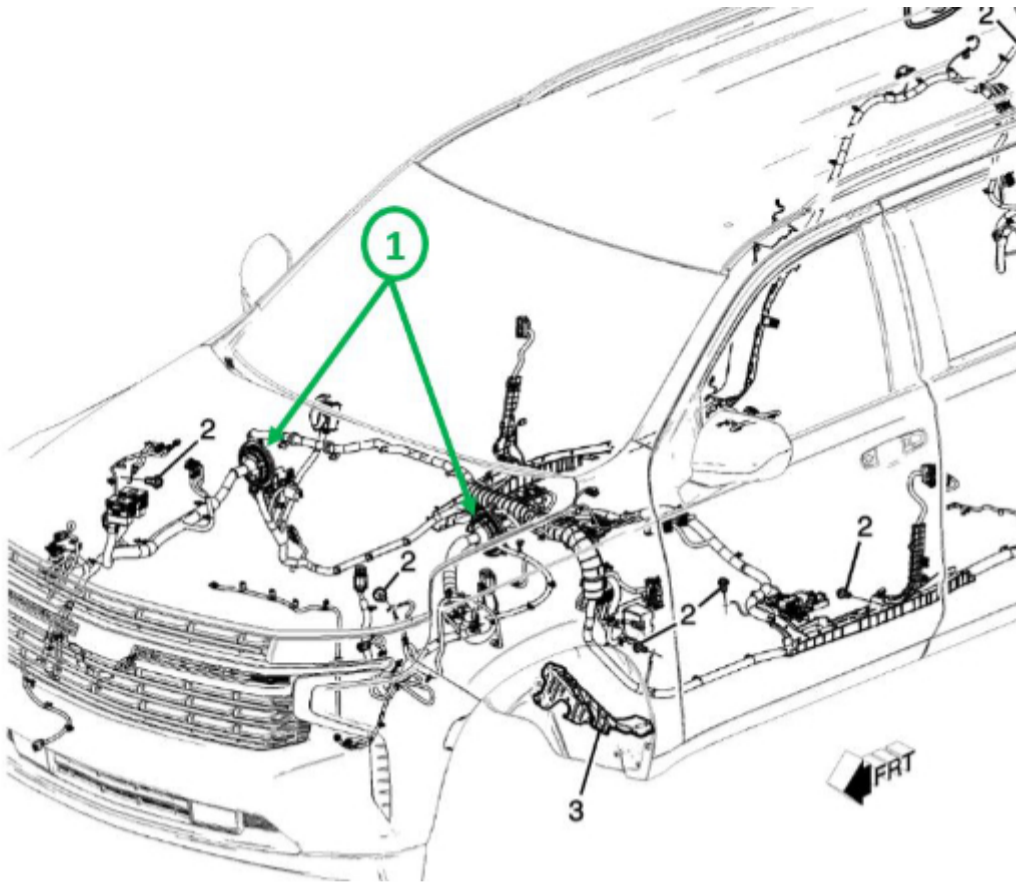
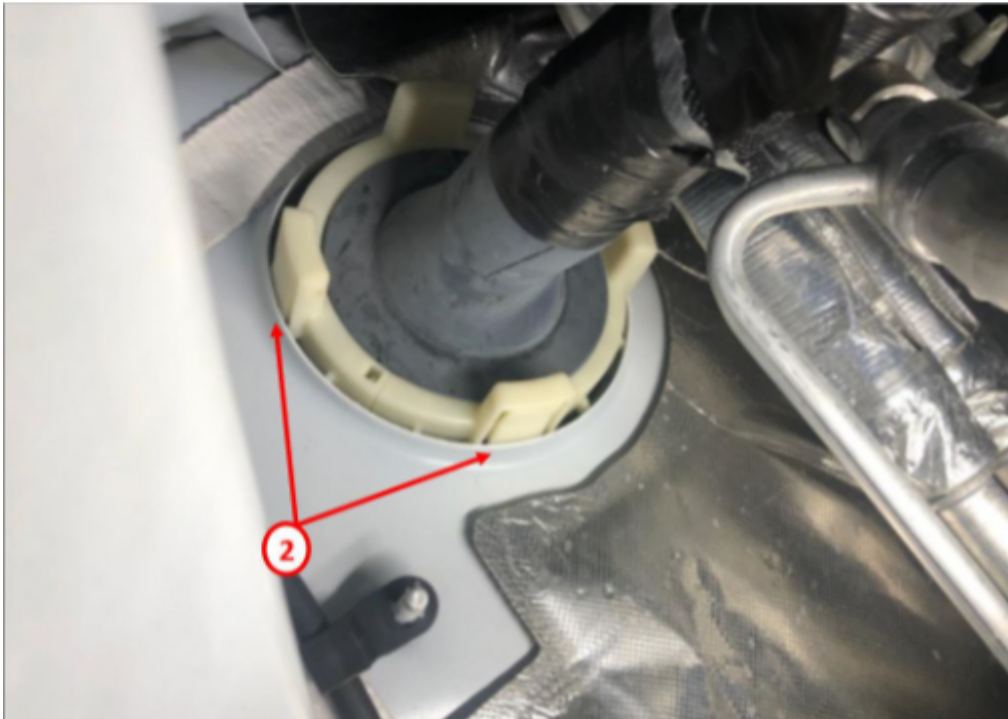
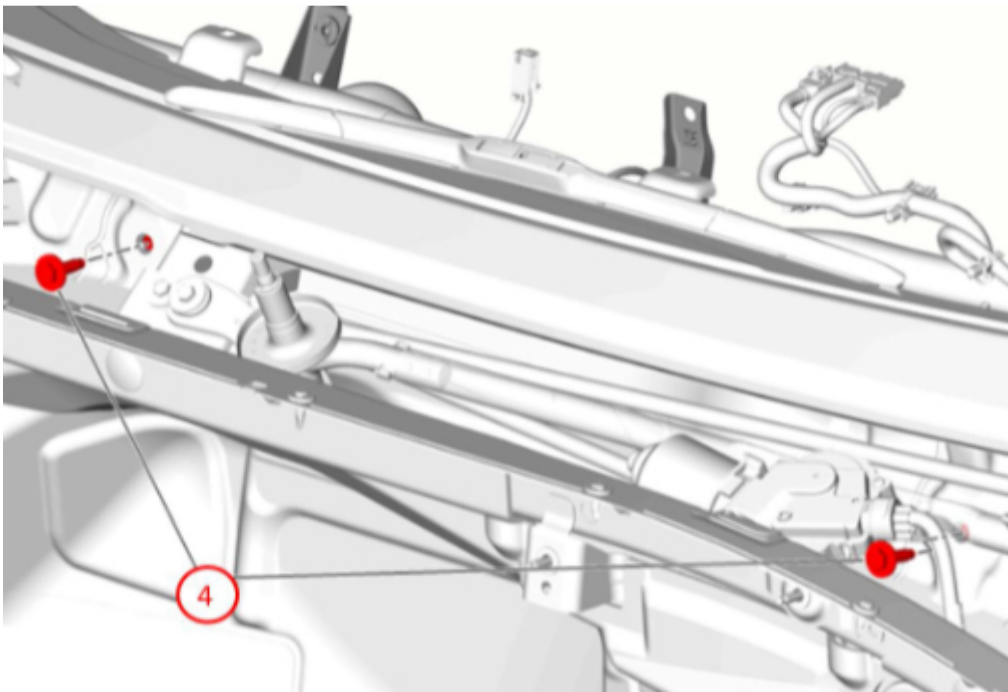
Involved Region or Country	North America
Condition	Some customers may comment of a hoot, howl, whistle type wind noise coming from either the left or right side of the dash / front end while driving at highway speeds. This noise may change depending on the HVAC setting being set to either fresh air or recirculation mode. In some cases, the complaint could be a squeak or creak noise from the I/P dash, which could occur while driving at any speed.
Cause	The cause of these concerns could be either of the following: <ol style="list-style-type: none"> 1. Either the left or right body harness pass-through (1) not fully seated into the cowl (2), as shown below. 2. Either the left or right I/P tie bar bolts loose or missing (4), shown below.

1. Fully seat the body harness pass-through so that each of the 4 retainers (3) are locked into position, as shown below.
2. Install and/or tighten the I/P tie bar bolts to 22 Nm (16 lb. ft).
