## Technical product information

<b>Topic</b>	Air spring fault finding
<b>Market area</b>	Bentley: worldwide (2WBE)
<b>Brand</b>	Bentley
<b>Transaction No.</b>	2053492/9
<b>Level</b>	EH
<b>Status</b>	Approval
<b>Release date</b>

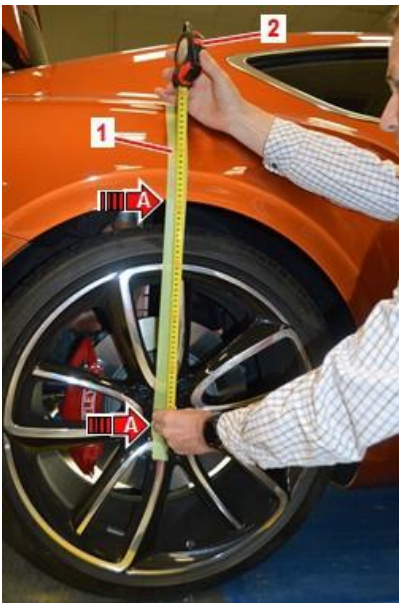
**Figure 5**

Apply strips of masking tape (1) from the centre of each wheel to the highest part of the wheel arch as shown, making sure the masking tape is applied 'taut'

Using a tape measure (2), measure and take note of the ride heights (A-A) at all four corners of the vehicle. See Figure 5.

Leave the vehicle overnight and again measure the ride heights (**A-A**) at all four corners of the vehicle. Compare these values with those taken previously.

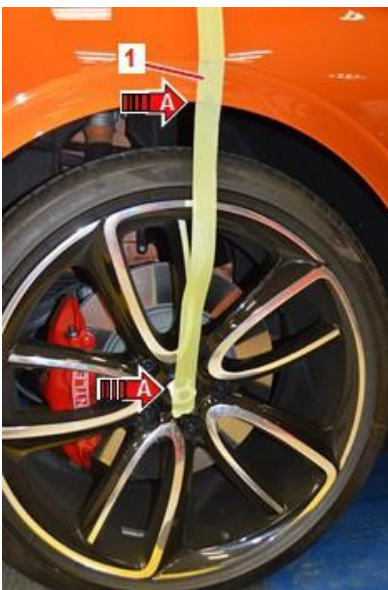
**Figure 6**

If there **IS** a difference in ride heights, and the strips of masking tape (**1**) have 'sagged' (shown in Figure 6), then refer to the following leak finding procedures below.

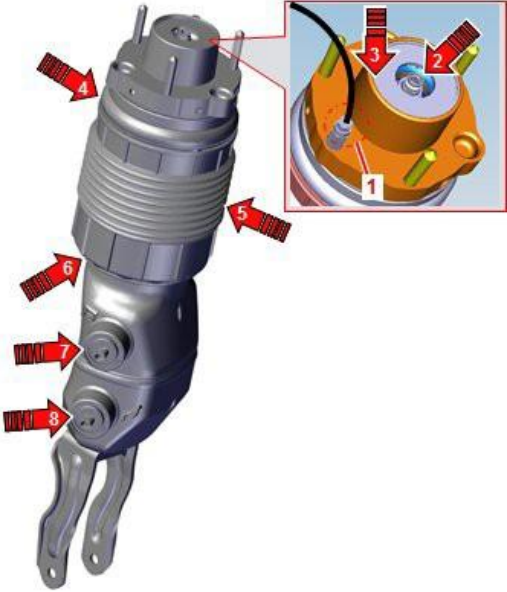
Front air spring check points – New Continental GT/C and New Flying Spur

Check	Yes	No	Comments
Air connection to air spring (1) Sealing area of top nut (2) Top crimp area (3) Top of air spring (4) Air spring gaiter condition (5) Lower areas of air spring gaiter (6) Switching valves, solenoids and welds (7&8)

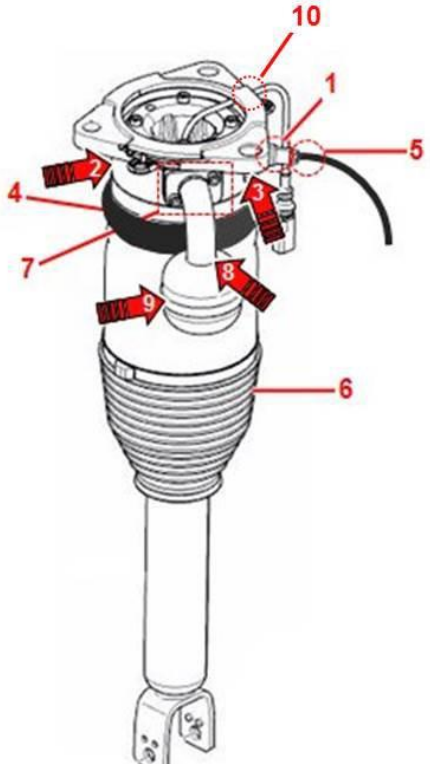
**Rear air spring check points - Continental series (pre 2018) and Flying Spur**

Check	Yes	No	Comments
Brass fitting to air spring (1) Top of air spring (2 & 3) Air spring bellows (4) Air feed pipe connection (5) Air spring gaiter condition (6) Air canister and canister to air spring (7, 8 & 9) Electrical cable route for air escaping (10)

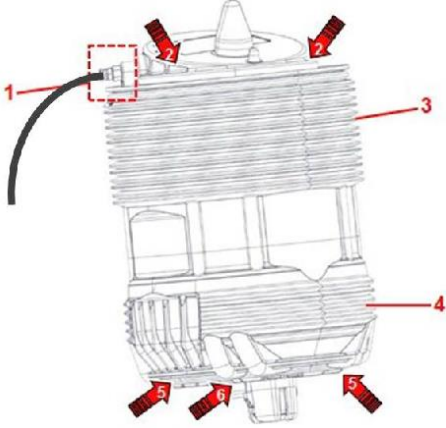
**Rear air spring check points – Mulsanne**

Check	Yes	No	Comments
Air feed pipe connection (1) Top of air spring (2 & 3) Upper air spring bellows (4 & 5) Lower air spring bellows (6 & 7) Air spring gaiter condition (8 & 9)

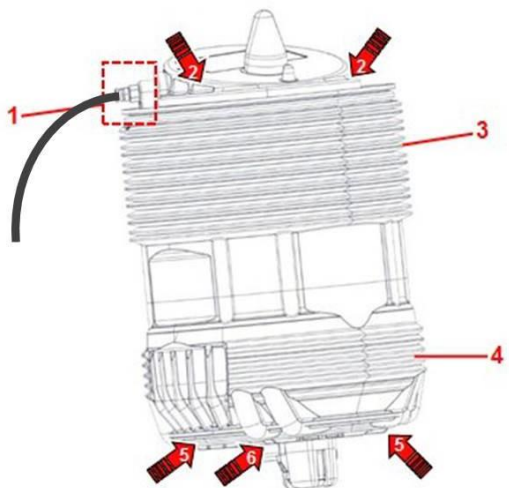
**Rear air spring check points – Bentayga**

Check	Yes	No	Comments
Air feed pipe connection (1) Top of air spring (2) Air spring gaiter condition (3 & 4) Lower areas of air spring (5 & 6)

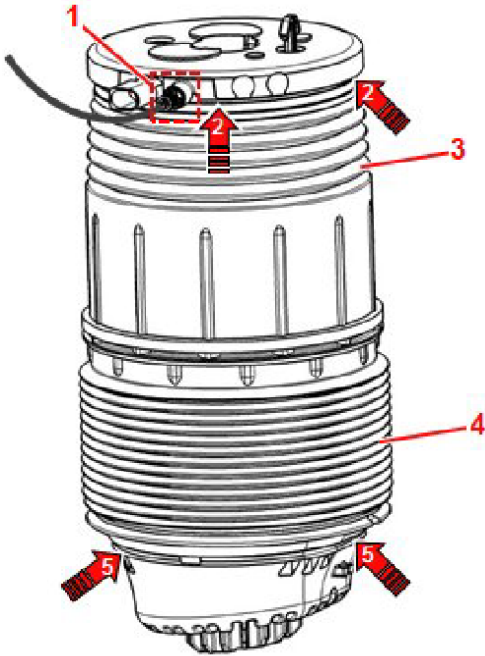
Rear air spring check points – New Continental GT/C and New Flying Spur

Check	Yes	No	Comments
Air feed pipe connection (1) Top of air spring (2) Air spring gaiter condition (3 & 4) Lower area of air spring (5)

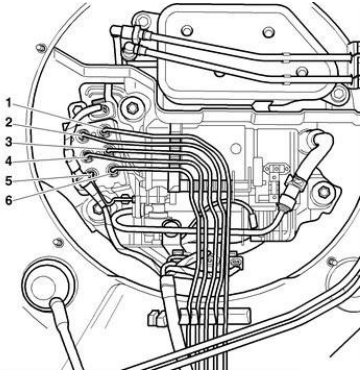
**Air supply check points - Continental series (pre 2018) and Flying Spur**

Check	Yes	No	Comments
Air pipe connections (1 to 6)

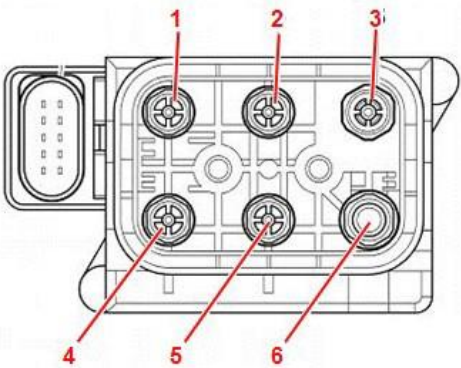
**Air supply check points - Mulsanne**

Check	Yes	No	Comments
Air pipe connections (1 to 6)

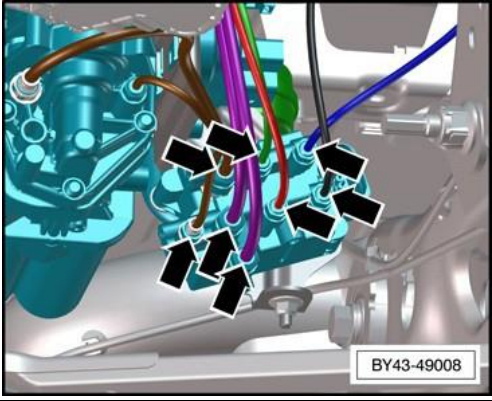
**Air supply check points – Bentayga**

Check	Yes	No	Comments
Air pipe connections ( <b>arrows</b> )

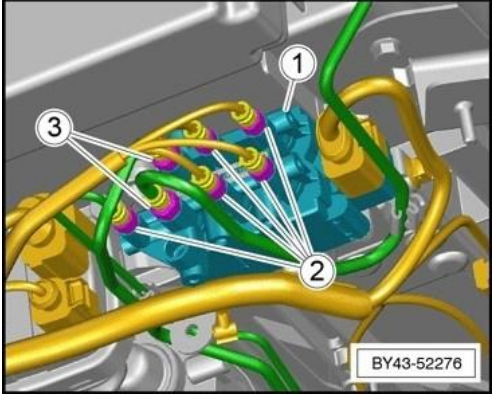
**Air supply check points – New Continental GT/C and New Flying Spur**

Check	Yes	No	Comments
Air pipe connections ( <b>2 &amp; 3</b> )

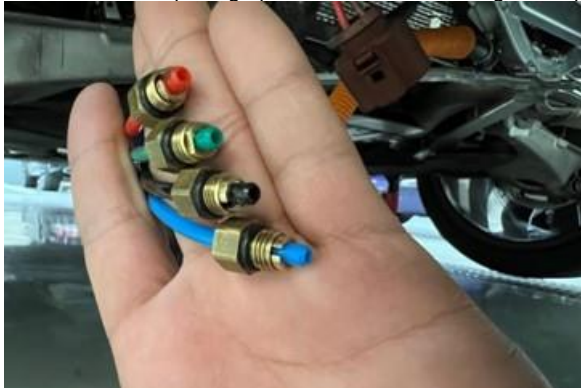
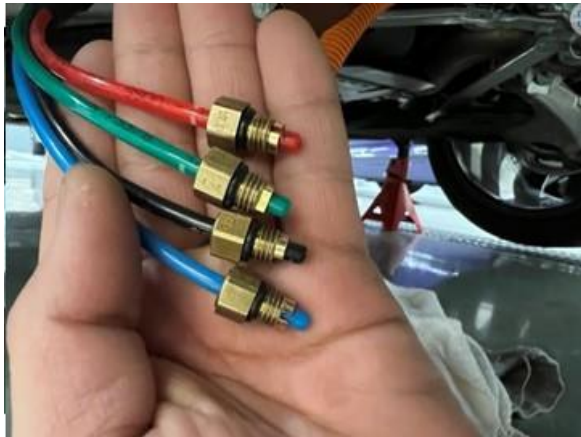
- Attach clear photographs to the new or existing DISS query as per the examples below showing the condition of the pipes and connectors

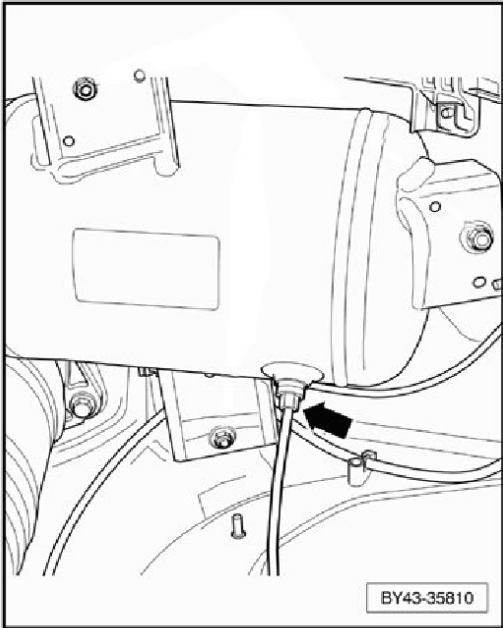
**Air supply check points - Continental series (pre 2018) and Flying Spur**

Check	Yes	No	Comments
<p>Air pipe connection (<b>arrow</b>)</p> <p>Location - GT &amp; Flying Spur: LH rear wheel arch</p> <p>Location - GTC: Behind backboard trim panel</p>

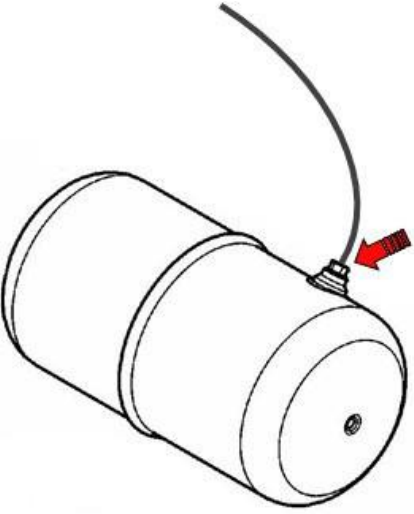
**Air supply check points - Mulsanne**

Check	Yes	No	Comments
<p>Air pipe connection (arrow)</p> <p>Location – Boot floor</p>

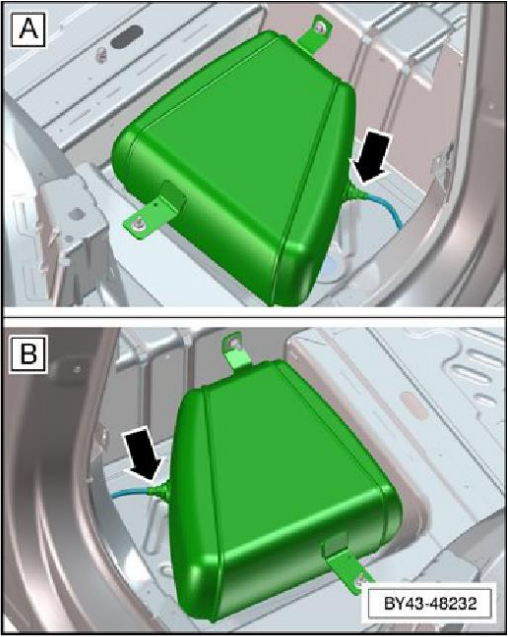
**Air supply check points - Bentayga**

Check	Yes	No	Comments
<p>Air pipe connections on the twin tanks (arrows)</p> <p>Location – Rear footwells beneath carpets</p>

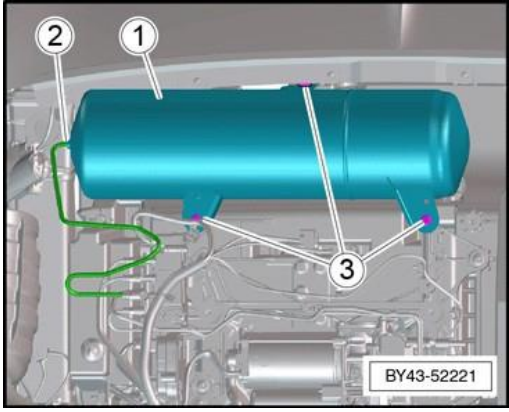
## Air supply check points – New Continental GT/C and New Flying Spur

Check	Yes	No	Comments
Air pipe connection (2) Location – Refer to the repair manual depending on model

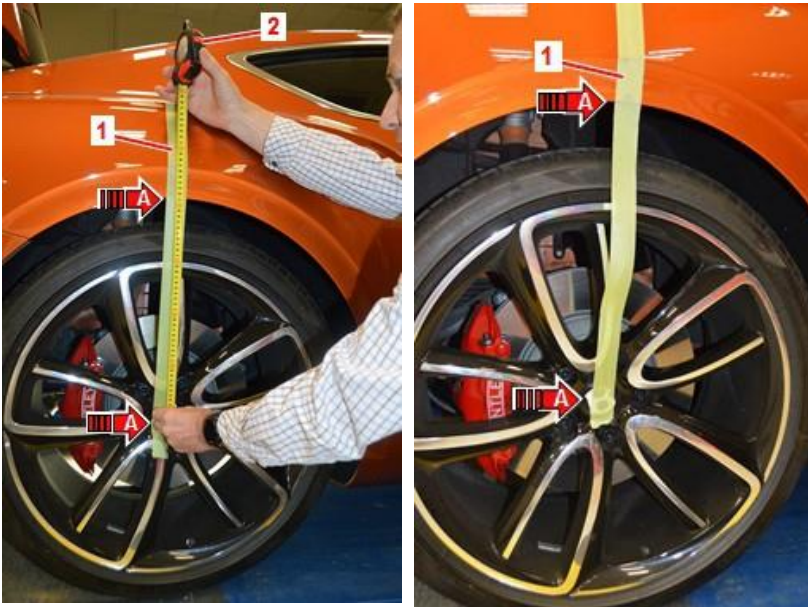
Figure 7

- Tape (1) applied before and after, showing the tape sagging. See Figure 7.
- All ride height measurements (A-A) before and after. See Figure 7.
- Soap solution bubbling at the point of air leak (where possible).
