Technical product information

Topic	Rear Seat Entertainment screens are not working
Market area	Russische Föderation (5RU),Australia E04 Bentley rest Asia and Australia (6E04),China 796 VW Import Comp. Ltd (Vico), Beijing (6796),Germany E02 Bentley rest Europe (6E02),Japan E03 Bentley Japan (6E03),Korea, (South) E08 Bentley South Korea (6E08),United Arab Emirates E06 Bentley Middle East and Africa (6E06),United Kingdom E01 Bentley UK (6E01),United States E05 Bentley USA and rest America (6E05)
Brand	Bentley
Transaction No.	2069686/1
Level	EH
Status	Approval
Release date

Rear Seat Entertainment screens are not working

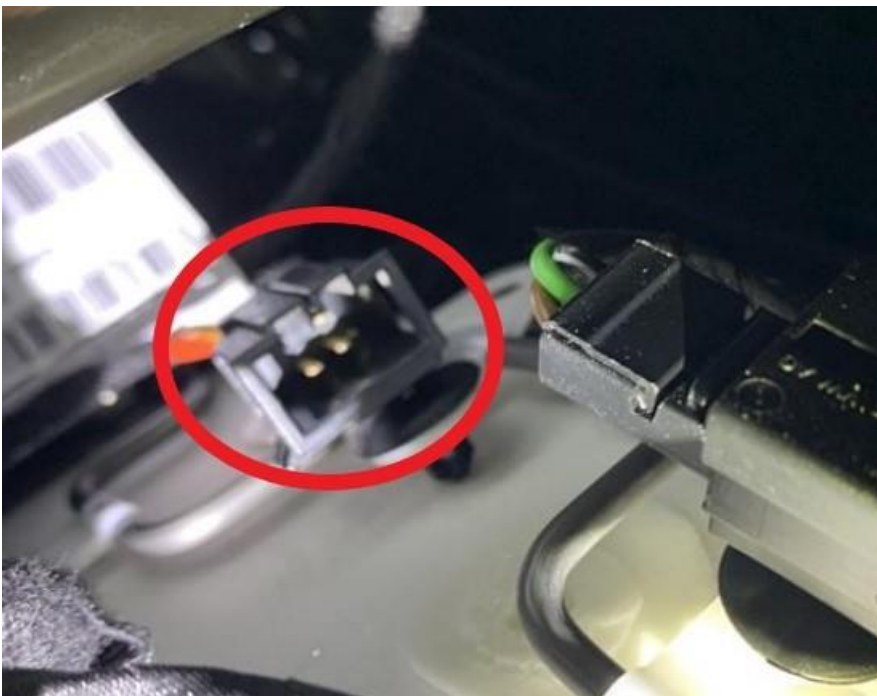
1) Referring to Figure 1 check the following:

- Check to confirm if the link harness is connected into the plug (For clarity the harness is not connected in the example shown)

2) In the event the harness is not fitted and the issue is still evident - Conduct the harness fit process from Step 3

In the event the harnesses are fitted but not connected - Connect the harnesses and check the operation of the rear screens

In the event the harnesses are fitted and the rear screens are not working the operative should conduct the following

- Referring to the applicable wiring diagram - Check to confirm the integrity of the applicable wiring circuits are to specification, in the event the wiring is to specification please also refer to TPI 2069267/-

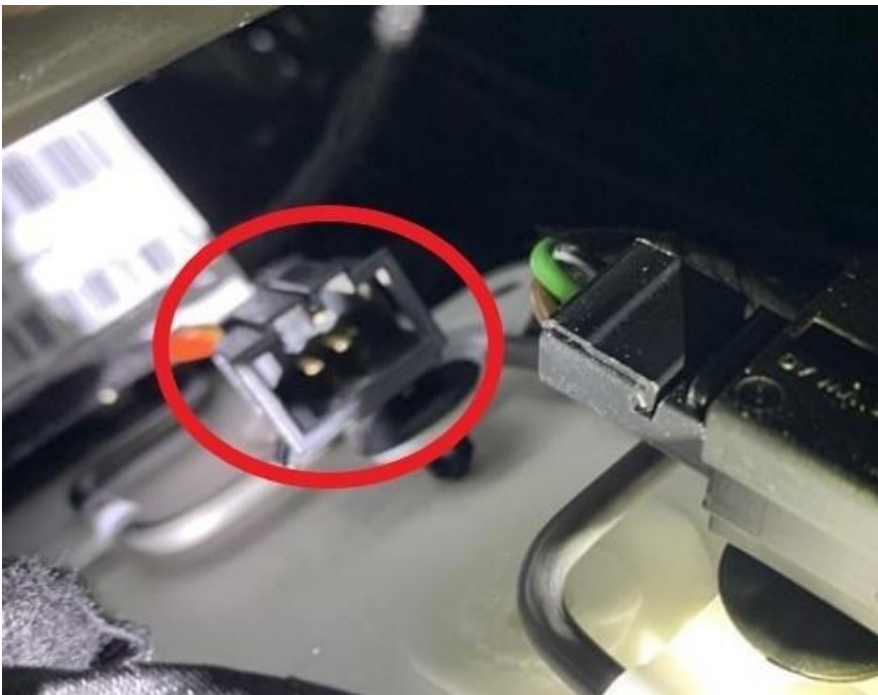
Figure 10

9) Locate the unpopulated plug on the underside of the seat cushion (Figure 10)
