# Technical product information

<b>Topic</b>	New Continental GT and GTC - Window drop glass concerns
<b>Market area</b>	Bentley: worldwide (2WBE)
<b>Brand</b>	Bentley
<b>Transaction No.</b>	2067436/6
<b>Level</b>	EH
<b>Status</b>	Approval
<b>Release date</b>

- Incorrect operation/function of the front and/or rear drop door glass
- Front and/or rear drop door glass fails to open/close or attempts to close and reopens once contact has been made between the glass and applicable seal
- DTC for window regulator motor no basic setting B148754 evident within any of the 4 window control modules (diagnostic address 42, 52, BB and BC) for loss of basic settings

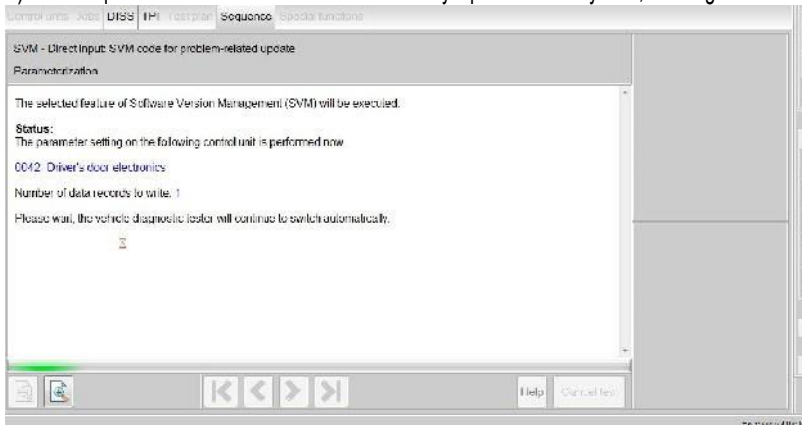
Figure 3

4) The Required control units will be automatically updated one by one, starting with 0042 – Door electronics Drivers side
