March 3, 2023

Moisture in the Headlights

AFFECTED VEHICLES

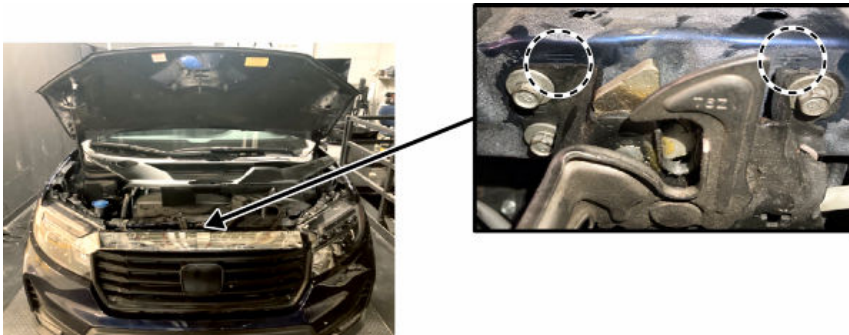
1. Replace the affected headlight(s). See the service information, *Headlight Removal and Installation*.
2. Inspect the hood striker setting height. Loosen the 3 bolts and adjust the hood striker to the lower position. The striker should sit below the 3 marks on each side.

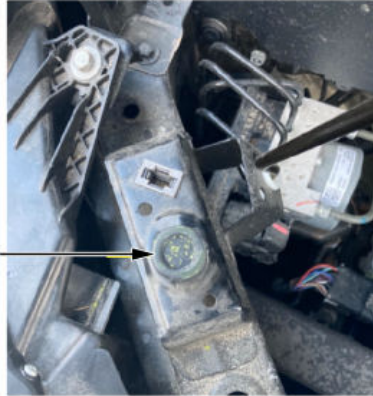
RH - Passenger Side Top View

4. Rotate the hood stoppers counterclockwise **1.5 turns (540°)**. After rotating **1.5 turns**, measure the height of the stopper to confirm the stopper height is **41mm** on the passenger's side and **37mm** on the driver's side.

SCALE
PLACEMENT

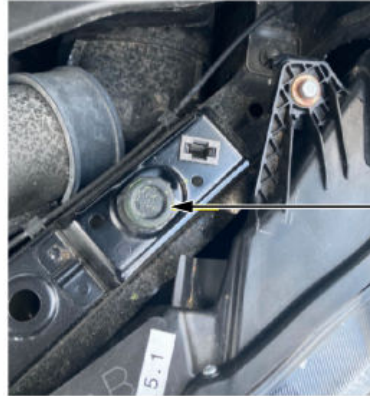
LH - Driver Side Side View

SCALE
PLACEMENT

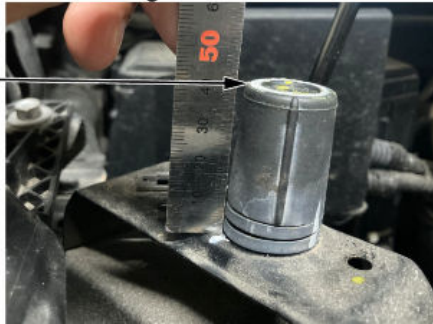
RH - Passenger Side

41mm

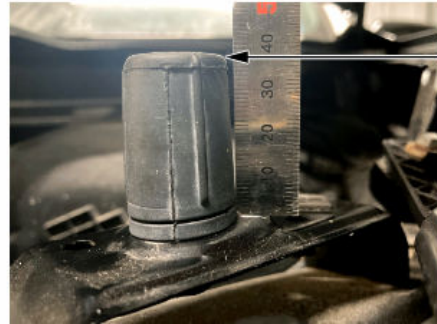
LH - Driver Side

37mm
