# Rapid Update 575

## Grecale – Air suspension system leak check

DATE: FEBRUARY 21 2023

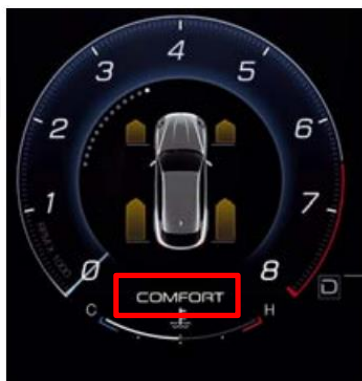
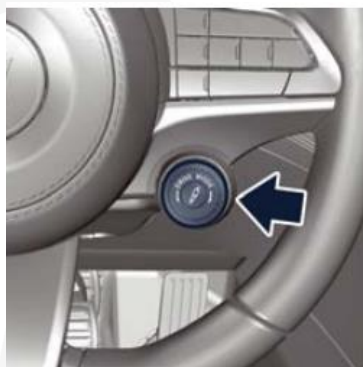
1. Always check ModisCS+ to see if the vehicle is involved in this action and if it has not been previously performed.
2. Start the Engine and make sure "Comfort" mode is activated via the instrument cluster (IPC) display using the selector located on the steering wheel.

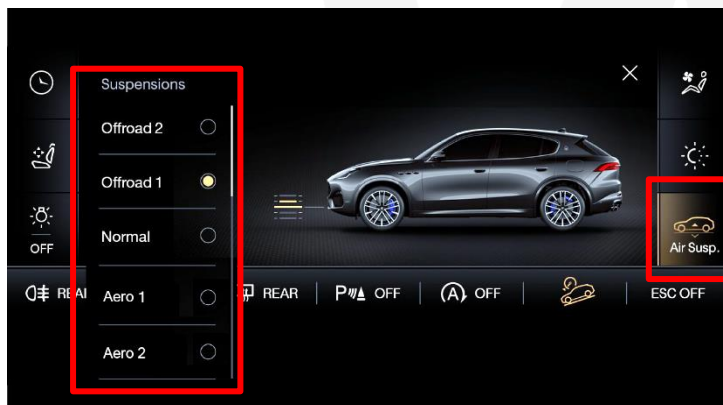
3. Cycle from "Off Road 2" to "Aero 1" position (highest to lowest) 5 (five) times, via the "Suspension" menu" in the MIA. **Wait 10 seconds between cycles to avoid overheating the system.**

Perform 5 cycles.  
Wait 10 secs between cycles

**NOTE:** If the message "**superheated air suspension system**" appears on the display, wait until the system has cooled down to proceed with the height change, and continue the test. This message is not indicative of a system malfunction.

4. Test result:
  - OK ► Vehicle height adjustment went through all 5 cycle tests without incident and has always allowed the desired height to be reached. The inspection procedure is finished.
  - NOT OK ► Air Suspension system failed to set height and/or complete all 5 test cycles. Proceed to the section below (Air Pipe Couplings Leak Check page 3)

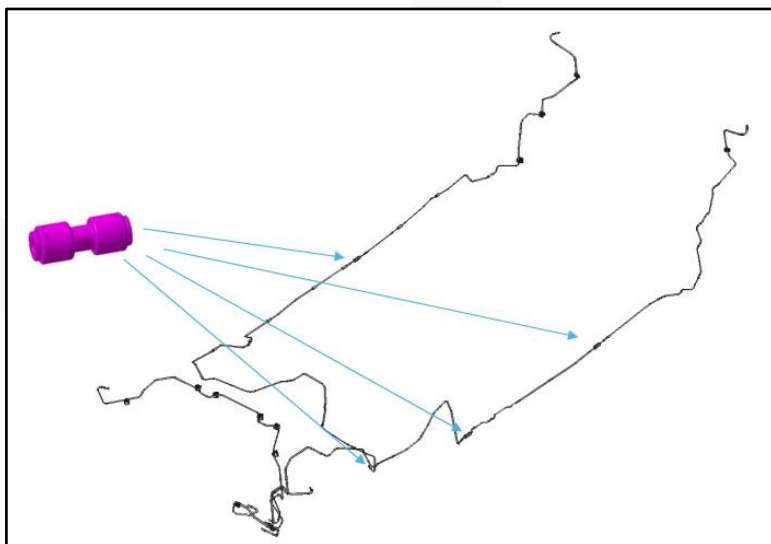
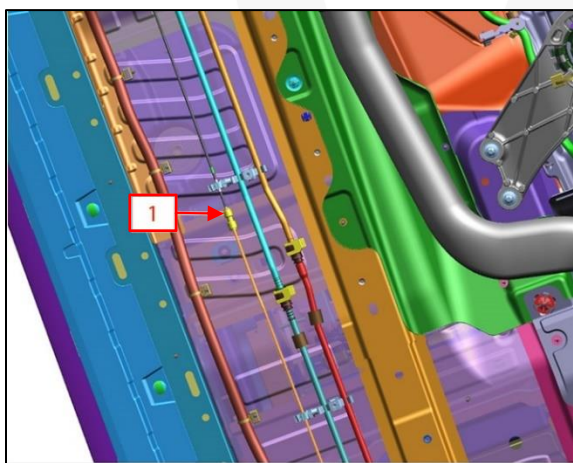
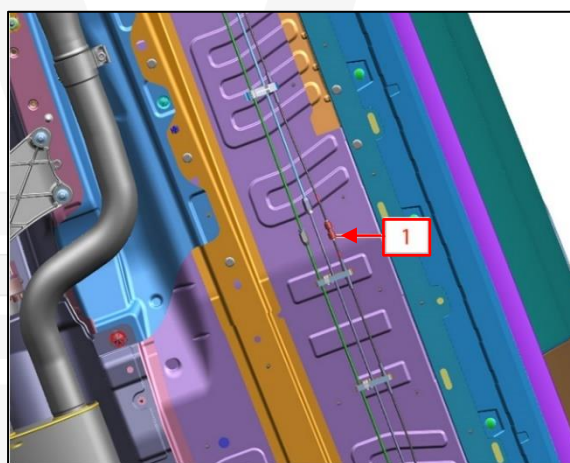
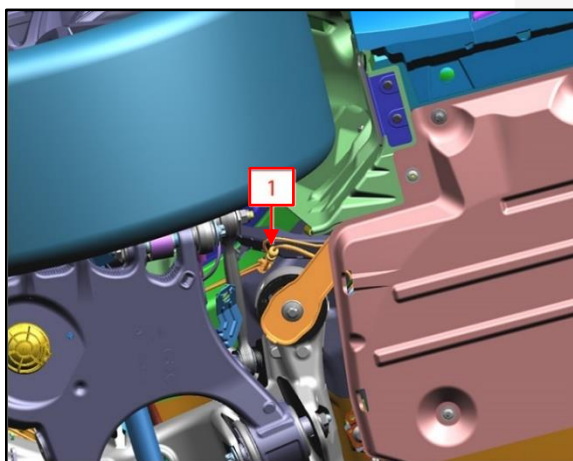
If any anomaly is detected in the procedure for operating the air springs, it is necessary to check all 4 air pipe couplings in which the circuit is divided and the connections on the air springs.

- Remove the underbody guards according to the procedures in the workshop manual:
  - **9.14.044.0**      **CENTRAL LH UNDERBODY GUARD**      **00**
  - **9.14.043.0**      **CENTRAL RH UNDERBODY GUARD**      **00**
  - **9.14.097.0**      **REAR CENTRAL RH UNDERBODY COVER**      **00**
- Check for air leaks using a gas leak detector liquid (e.g., Snoop Leak Detector) or equivalent at the following points (1) as illustrated below.

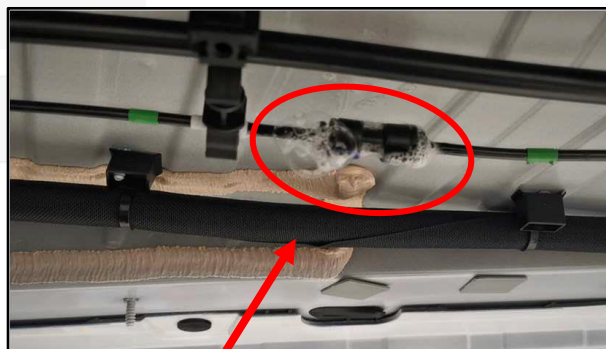
**Example:** of air leak at air pipe indicated by bubbles using a gas leak detector or equivalent

- OK = No Leaks found. ► Open a BOL as "SUPPORT REQUEST" and report findings even if there are no obvious leaks. Attach pictures and a vehicle scan. (Vehicle scan must be in PDF format)
- NOT OK ► Air leak is present. Open a BOL as "SUPPORT REQUEST" and attach pictures of the leak, including a vehicle scan and report all the information collected throughout all the above checks. . (Vehicle scan must be in PDF format)

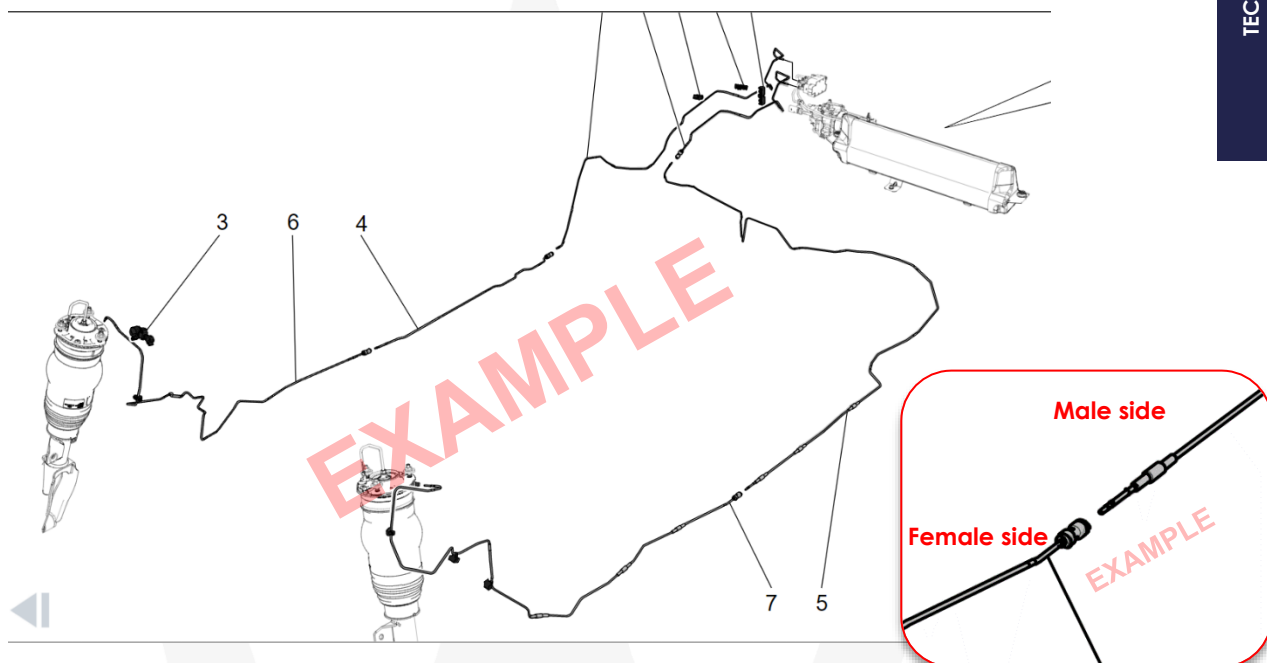
**NOTE:** If an air leak is evident from any of the areas of the air pipe couplings, it is necessary to replace the two components of the sections (male end and female ends) following the workshop procedure.
