MAS003436 RU 22-07

# Rapid Update 589 MC20 Recirc A and M display icons missing

DATE: February 3 2023

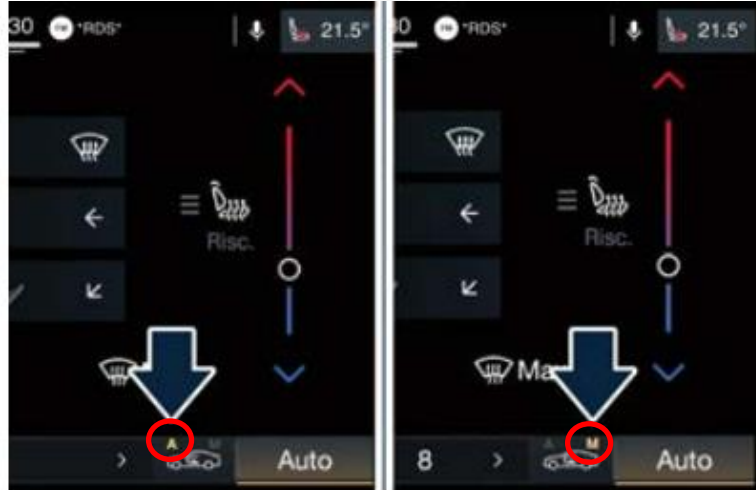
- First pressure - "**Auto**" mode: the A/C system activates the automatic recirculation control. The button with the symbol "A" on the MIA lights up with white light.
- Second press - "**Manual**" mode: the A/C system activates the recirculation, the LED lights up on the button and the respective button with the "M" symbol on the MIA lights up with white light.
- Third pressure - "**Open**" mode: the A/C system returns to outdoor air mode (default operating mode) and all symbols are turned off.

Due to a bug with the latest update of the radio SW these symbols may have been disabled and must be restored, according to the procedure below.

1. Always check ModisCS+ to see if the vehicle is involved in this action and if it has not been previously performed.
2. Write the new "Vehicle Configuration" (Proxi Alignment) via MD-EVO.
3. The procedure is complete.
