March 14, 2023

Version 2

Product Update: 2023 Pilot 2WD Replacement for Incorrect Accessory Trailer Hitch Label

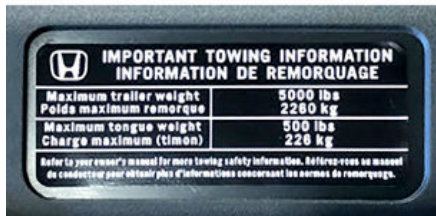
INCORRECT ❌

The Honda Genuine accessory trailer hitch towing capacity information label is incorrect for some 2WD vehicles.

1. Inspect the trailer hitch towing capacity label.

NO - Go to the REPAIR PROCEDURE.

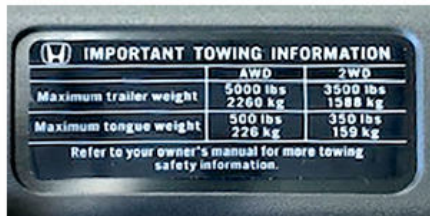
CORRECT ✅

Does the label have the towing capacity for both AWD (5000 lbs) and 2WD (3500 lbs)?

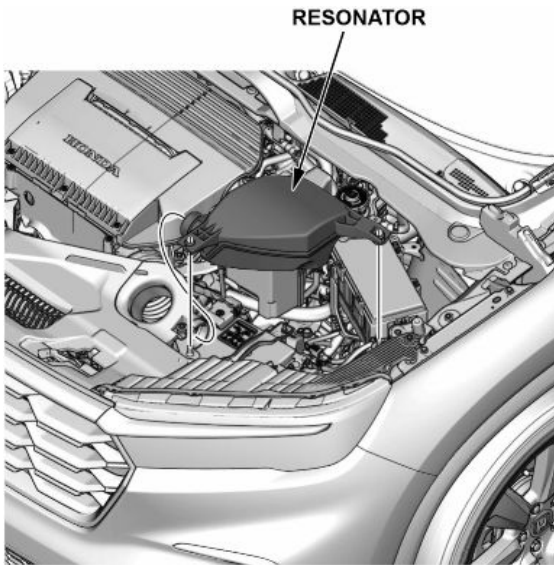
1. Remove the resonator.

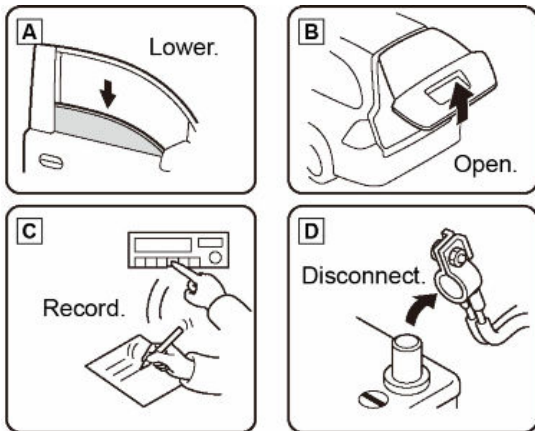
2. Disconnect the negative cable from battery.

NOTE: With the driver's door open, turn the vehicle to OFF (LOCK) mode, then wait at least 3 minutes before disconnecting the 12 volt negative battery cable.

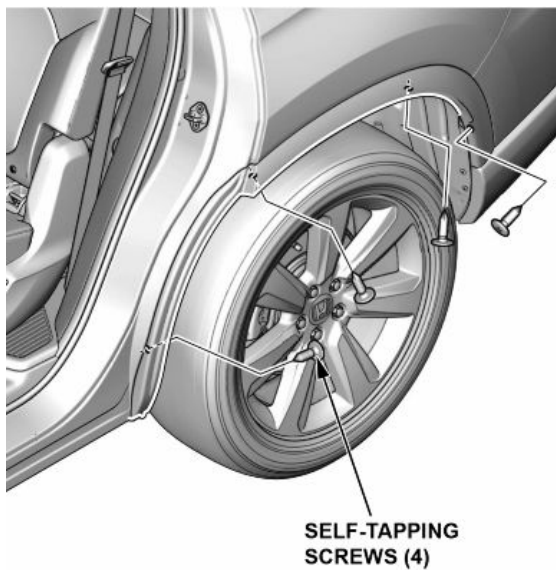
4. Remove the self-tapping screws.

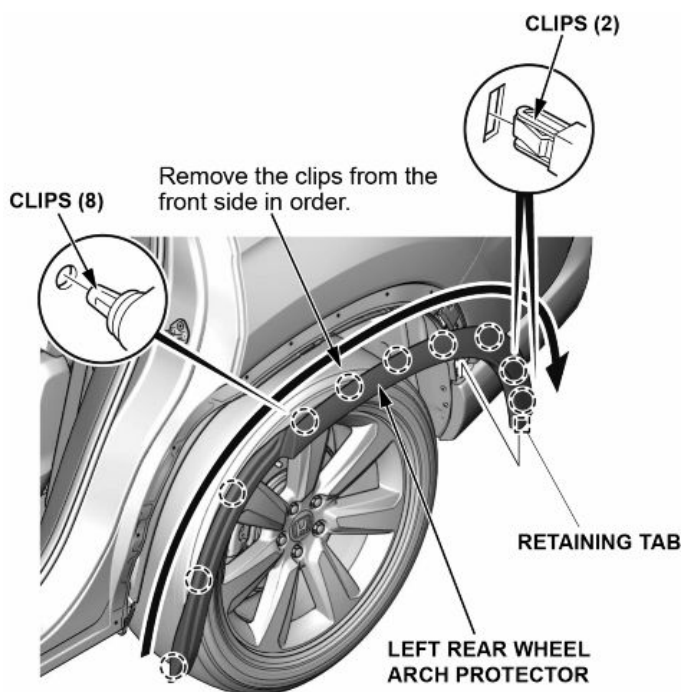
5. Remove the left rear wheel arch protector.

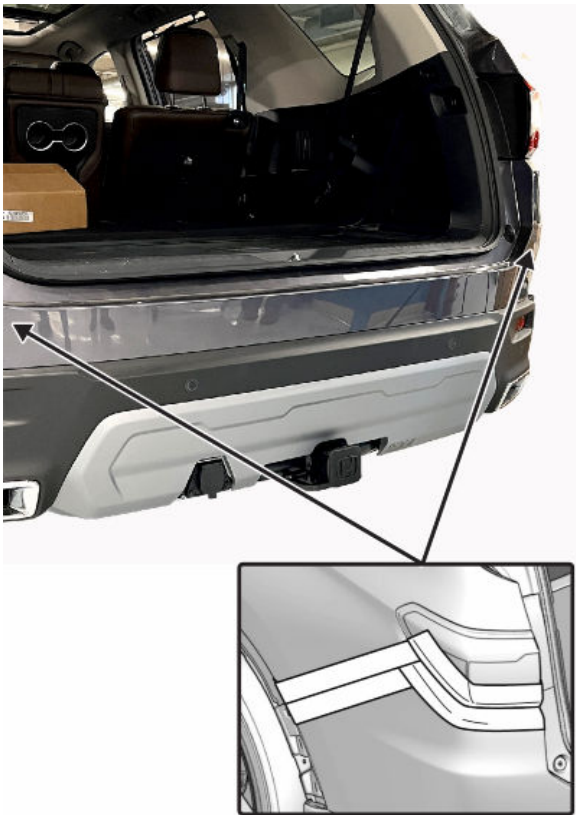
7. Attach masking tape to protect the vehicle.

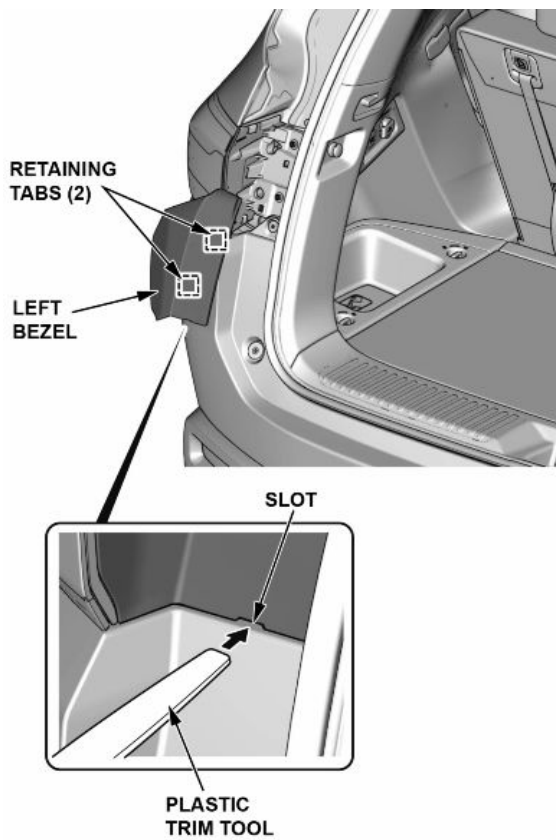
8. Remove the left bezel.

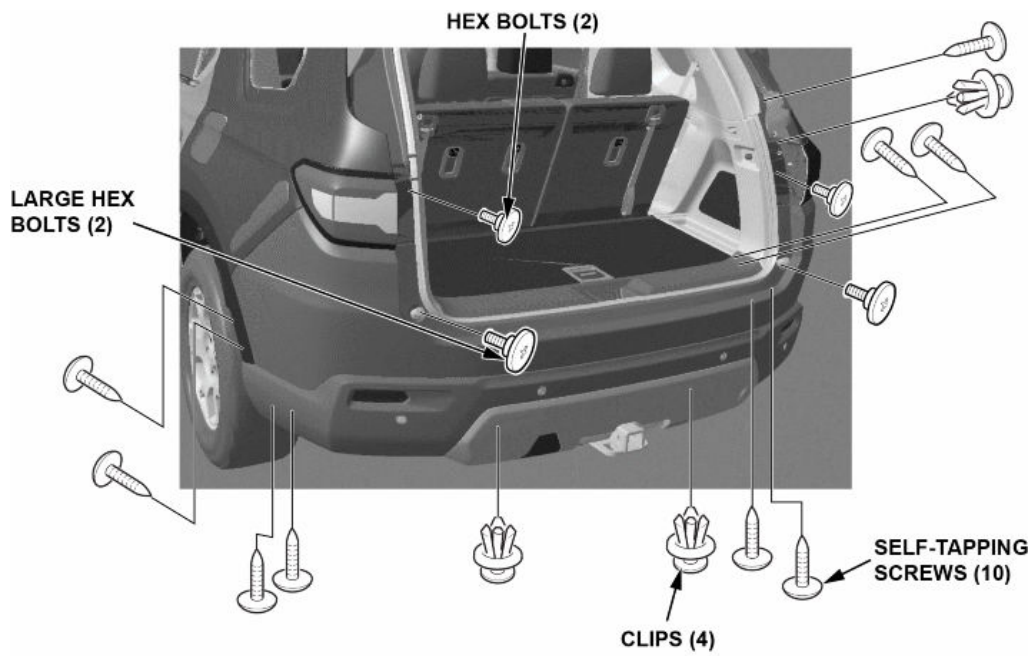
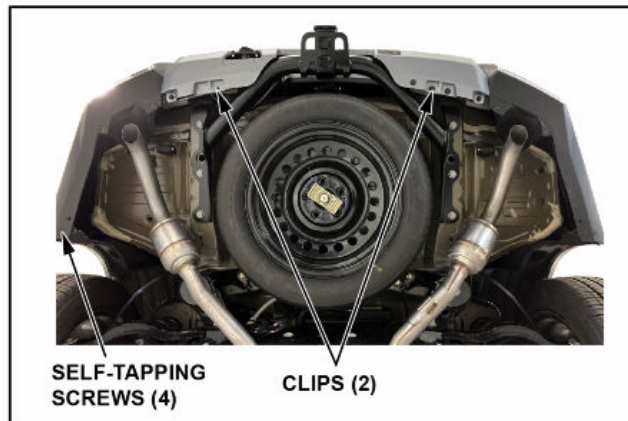
10. Remove the clips, hex bolts, and self-tapping screws.

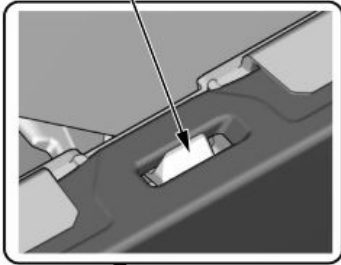
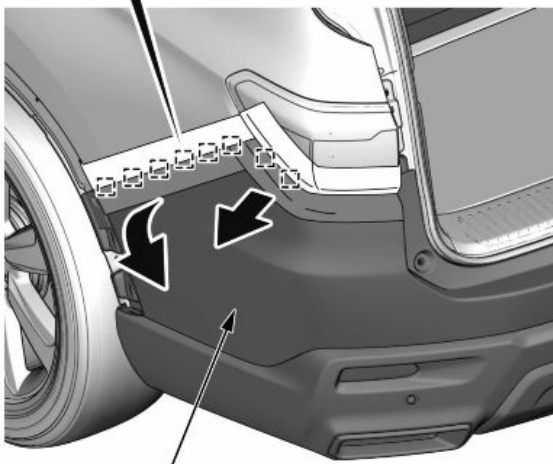
RETAINING
TABS (8)

11. Remove the retaining tabs.

- Release the retaining tabs starting from the outside working in.
- Make sure to release the retaining tabs in the correct orientation.

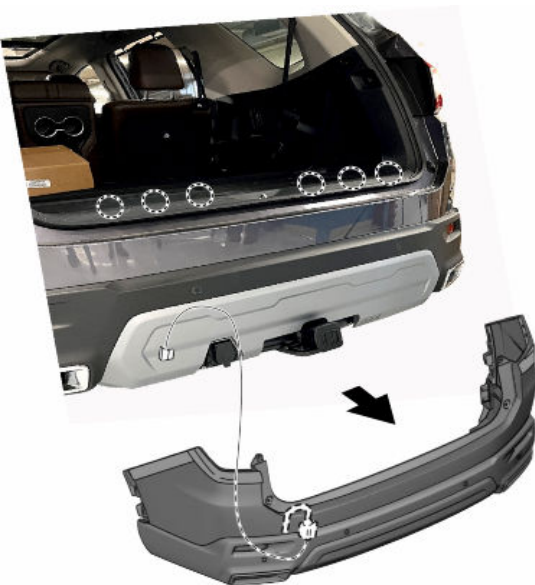
13. Remove the rear bumper.

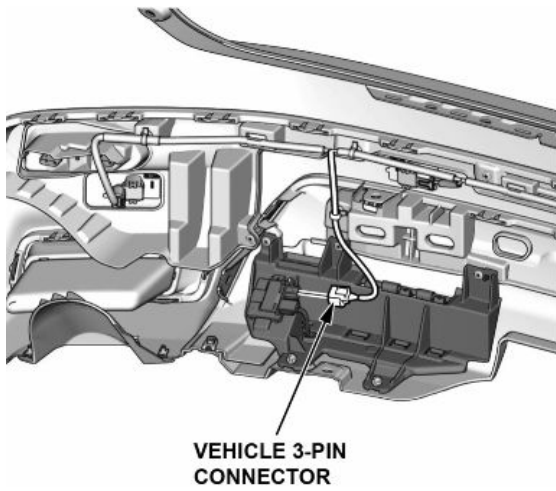
14. Unplug the vehicle connector (if equipped).

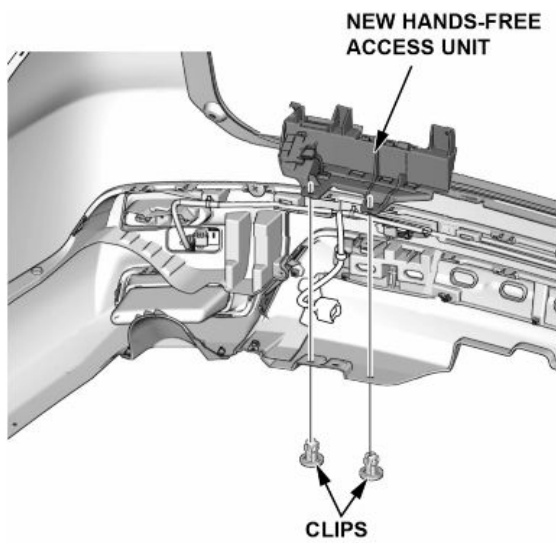
15. Remove the 2 clips if vehicle is equipped with Hand-Free Access power tailgate.

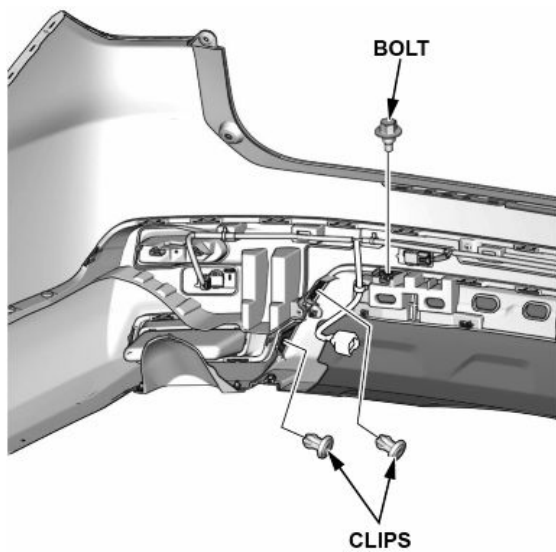
16. Remove the bolts and clips.

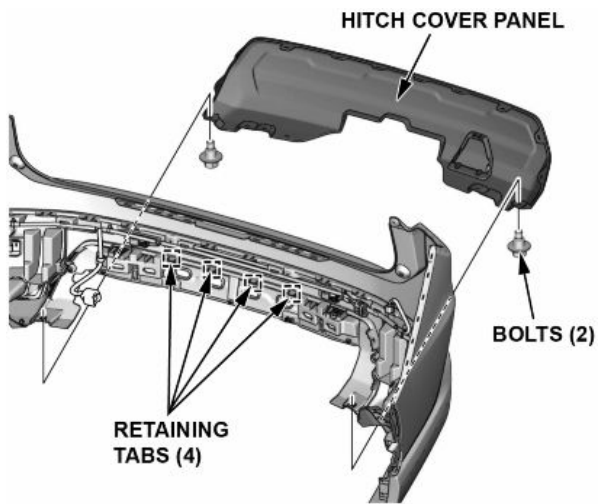
18. Remove the hitch cover panel and discard .

19. Install the replacement hitch cover panel in reverse order.
