# Technical Journal

**Blown fuse, compressor - air suspension**

<b>REF NO:</b> TJ 31423.18.3	<b>ISSUING DEPARTMENT:</b> Technical Service	<b>CAR MARKET:</b> United States and Canada	
<b>PARTNER:</b> 3 US 7510 Volvo Car USA		<b>ISSUE DATE:</b> 2023-02-14	<b>STATUS DATE:</b> 2023-02-15
<b>FUNC GROUP:</b> 7641	<b>FUNC DESC:</b> Level control, complete	Page 1 of 14

TJ Instruction VCC-514118-1

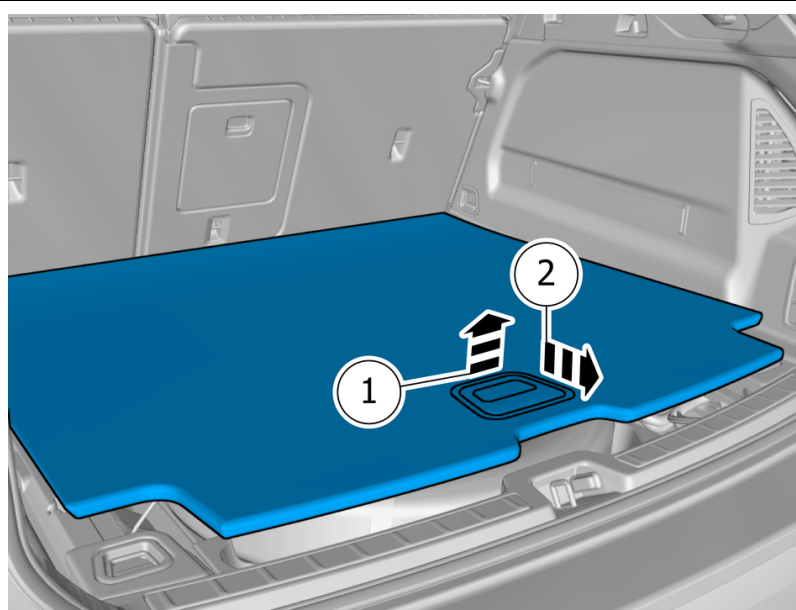
**Caution! Observe caution when carrying out this step.**

Remove the marked part.

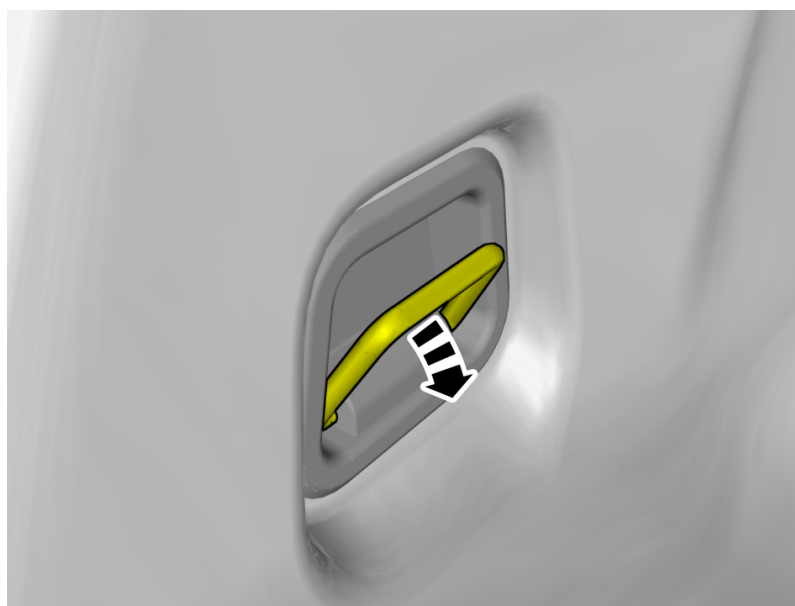
Remove the marked part.

Special Tool: T9995919, PULLER (SEAL-PINION,CAM-CRANKSHAFT)B200-6304

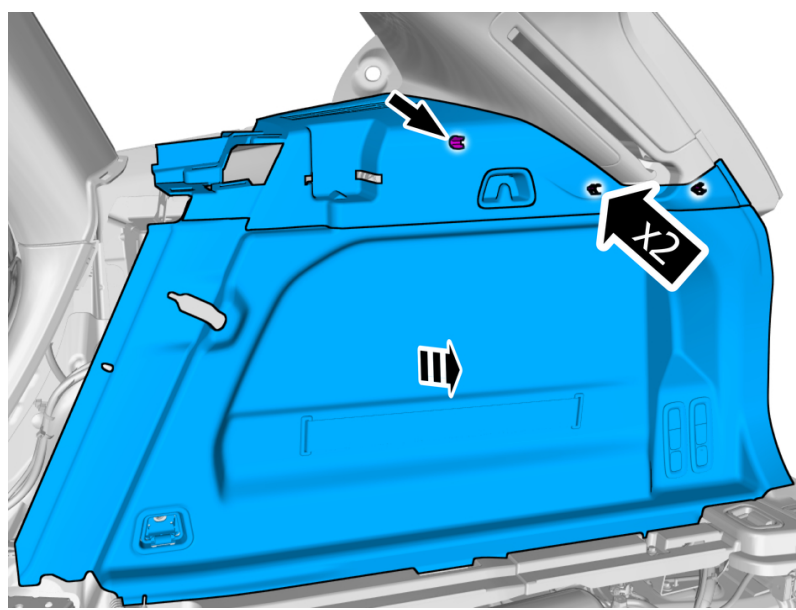
Loosen the clips.  
Remove the marked part.

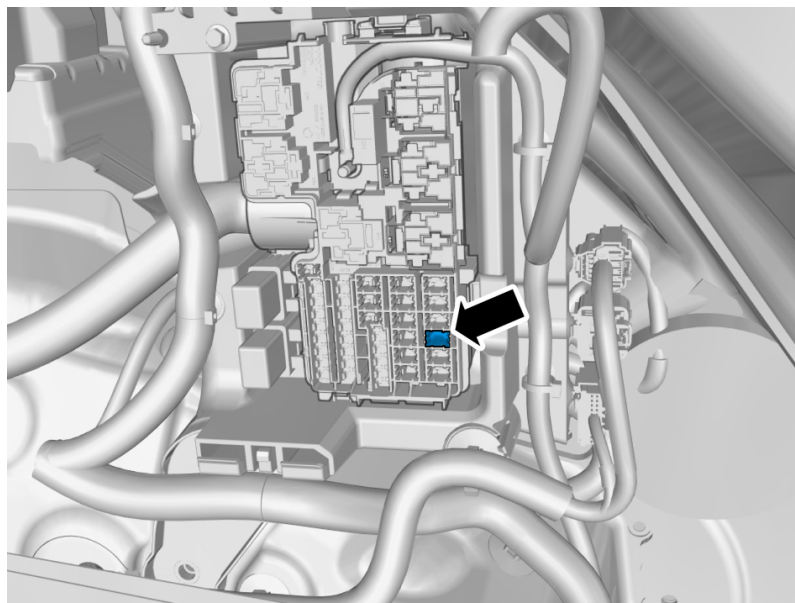
Remove the marked part.
