REFERENCE:	Nova Bus Manuals
SECTION:	12: Interior Furnishing
RS N°:	MQR 7621-2566
EFFECTIVE IN PROD.:	N/A

SUBJECT:	American seating lower bracket hardware missing.
JUSTIFICATION:	Seating lower bracket hardware is missing due to insufficient torque and sealant.

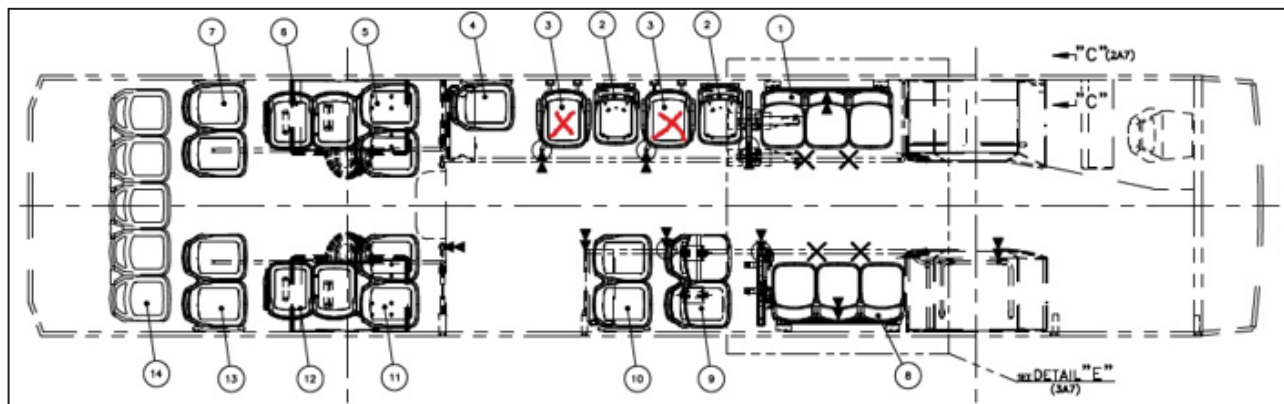
Figure 1 - LC79 and LD64 2x Seats With Pin/Screw Combo

- 1.1. Park the vehicle on an even surface with the transmission on neutral.
- 1.2. Apply the parking brake and set the master control switch to the **stop** position.
- 1.3. Set the battery disconnect switch in the battery compartment to the **off** position.
- 1.4. Locate the passenger seat. (see figure 1).

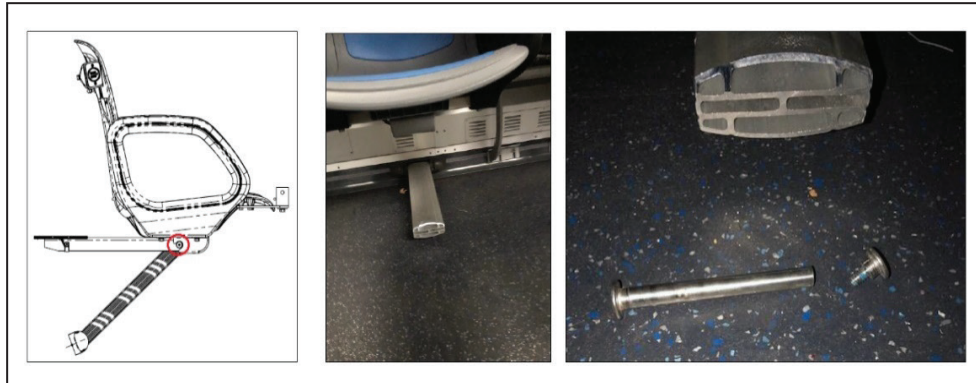
Figure 2 - Passenger Aisle Facing Seat

- 1.5. Loosen the pin screw on each side of the seat. Reuse the screws.

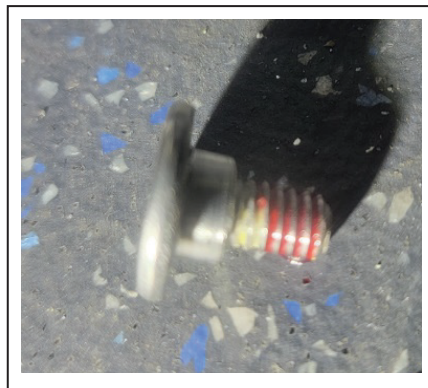
Figure 3 - Apply Loctite Thread Locker 262

- 1.6. Apply red loctite 262 on each screw and torque it to 100-125 in-lbs.
