Volvo Chassis - Electronically Controlled Air Dryer System (ECADS) Building Too Much Air Pressure; Pressure Relief Valve Opening

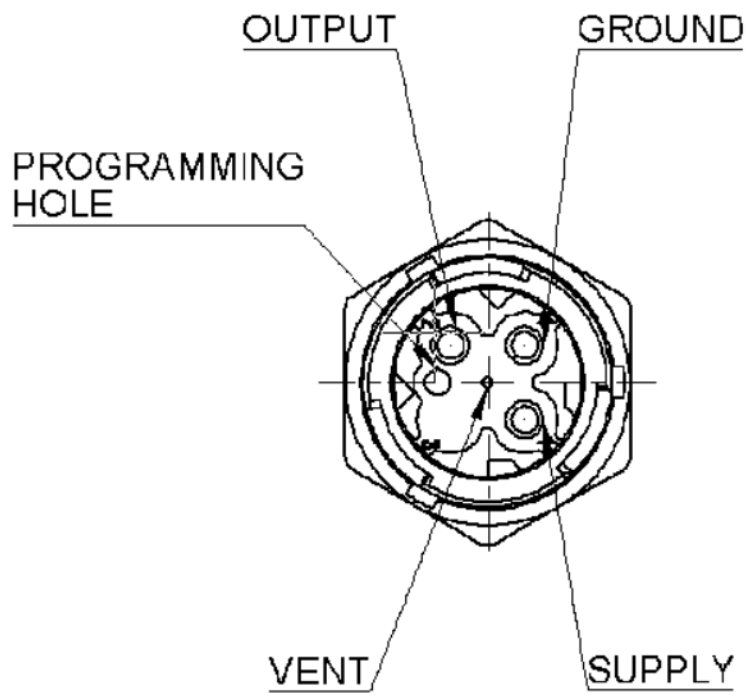
PSI	Voltage
0	0.3
10	0.5
20	0.7
30	0.9
40	1.1
50	1.3
60	1.5
70	1.7
80	1.9
90	2.1
100	2.3
110	2.5
120	2.7
130	2.9
140	3.1
150	3.3
160	3.5
170	3.7
180	3.9
190	4.1
200	4.3
210	4.5
220	4.7

1. While using Tech Tool confirm that you see a psi value in test FG5 for the primary air tank pressure, if none refer to SNV15-002 Meritor - Wabco ECAD - Electronically Controlled Air Dryer / Drier [here](#).
2. If nothing is found, next confirm that there are no circuit related issues from the sensor to the Vehicle Electronic Control Unit (VECU).
 - Pin 1 at the sensor is the 5 volt supply from the VECU pin B26
 - Pin 2 at the sensor is the air pressure signal return to the VECU pin B23 [here](#).
 - Air pressure to Voltage reference chart can be found [here](#).
