## Hub Cap, Leaking

M-773-005

(March 2023)

All Mack model trucks built from November 28, 2020 to current.

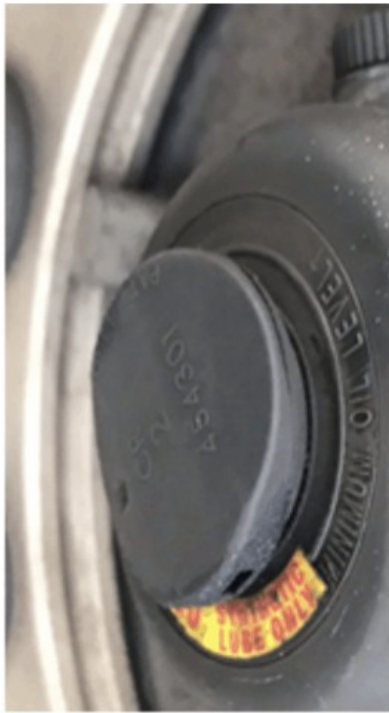
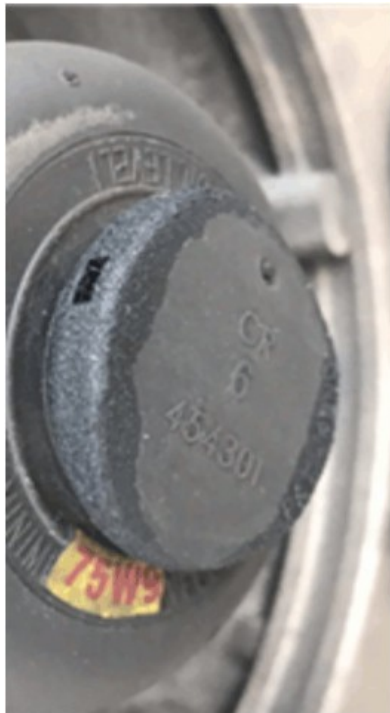
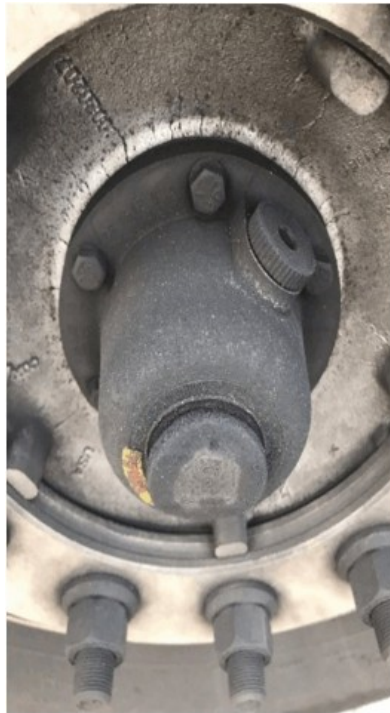
Not Accepted as Warranty Failure			
<b>Symptom:</b>  <b>Purging</b> of oil through the hub cap vent plug. Appearance may be deceptive.	<b>Light Purging</b>	<b>Medium Purging</b>	<b>Heavy Purging</b>
<b>Cause:</b>  Hub caps must vent due to buildup of pressure. There are design features built into the cap that minimizes oil purging. A minimal amount of purging can be expected after periods of higher heat.	Light film on the edge of the vent plug  NO action required Do Not remove.	Medium film on the edge and outboard face of the vent plug  NO action required Do Not remove.	Heavy film on the edge and outboard face of the vent plug  NO action required Do Not remove.
<b>Note:</b>  The inspection must not be conducted after driving in wet weather or a vehicle wash. Vent plug needs to be free from water.

Touch the film with a dry finger. If the finger remains dry, the vent plug is not leaking. If in doubt, check again in a few days.

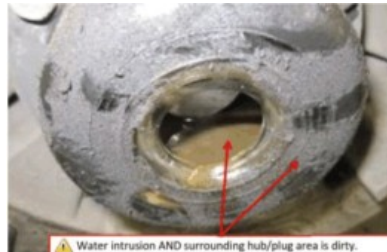
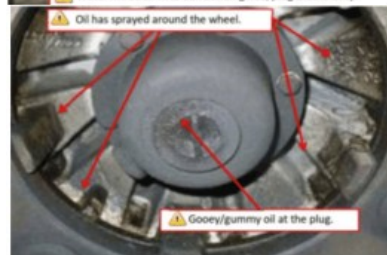
Accepted as Warranty Failure	
<b>Symptom:</b>  <b>Leakage</b> Excessive oil around the hub cap vent plug and surrounding areas including the hub itself. Gummy oil around the vent plug purge point. Oil splatter on the wheel.	<b>Leaking</b>
<b>Cause:</b>	Oil buildup on surrounding components

Damaged hub cap and / or vent plug.

Touch the film with a dry finger. If the finger feels wet, the vent plug is leaking.

Disassemble wheel end and inspect oil quality, hubs and bearings. It is recommended to replace the hub assembly in addition to the hub cap and vent plug as lack of sufficient oil can lead to damaged bearings.

**Action Required Replace damaged components.**
